Report

Date: 10/21/2019

Subject: Inspection of Woodridge Village, Perry Homes Development

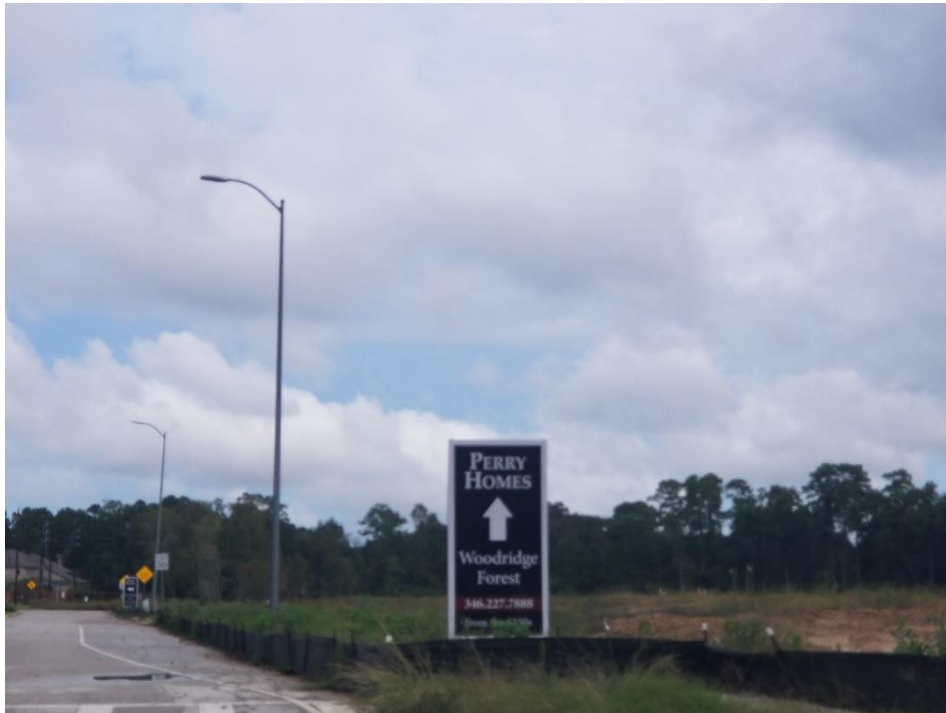
View Looking North along Woodland Hills Drive

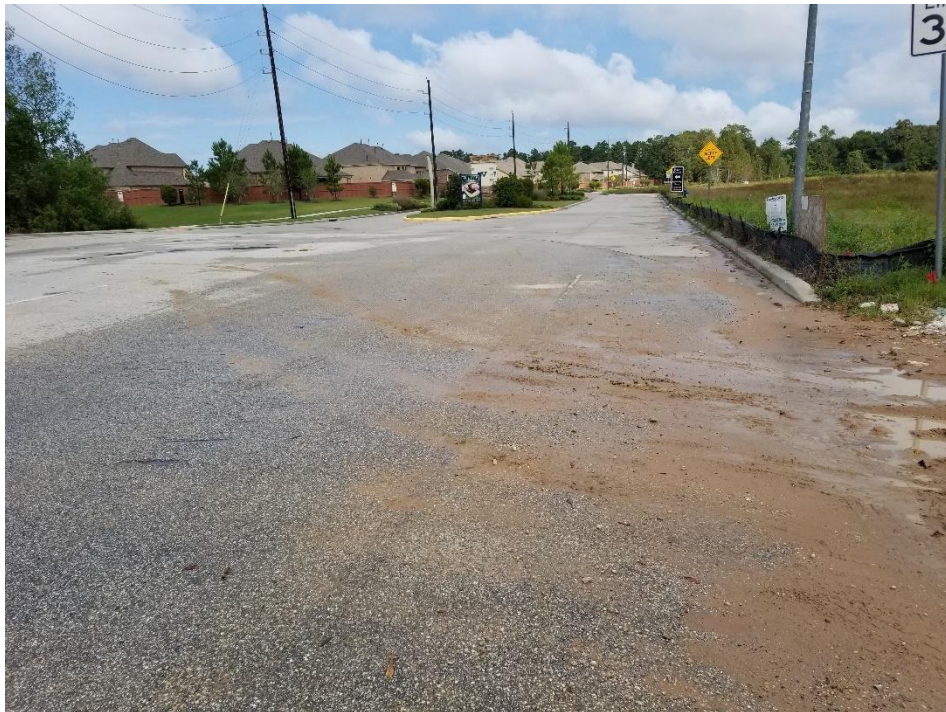
Construction Site Entrance on Woodland Hills Drive
Note: Tracking and maintenance required

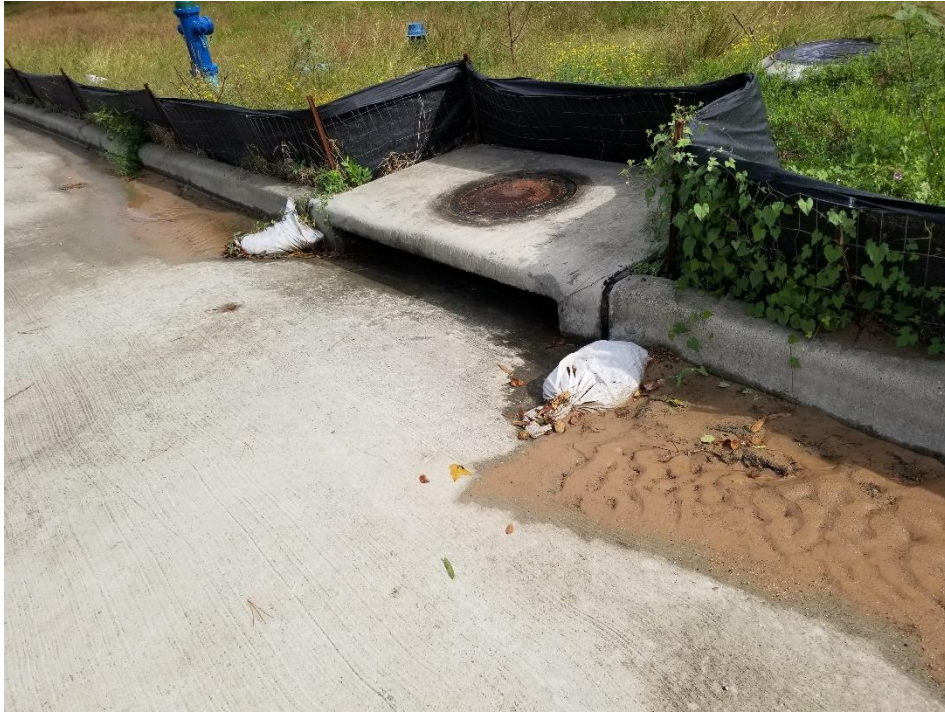
Storm Sewer Inlet on Woodland Hills Drive
Note: BMP's require maintenance

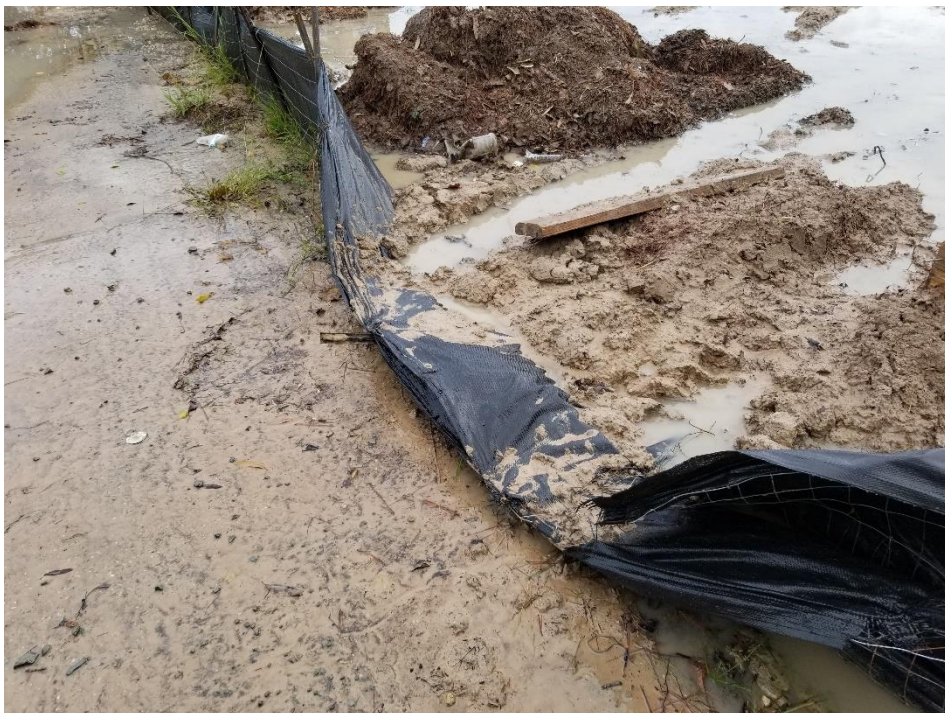
Silt Fencing on Friar Grove Drive Requires Maintenance

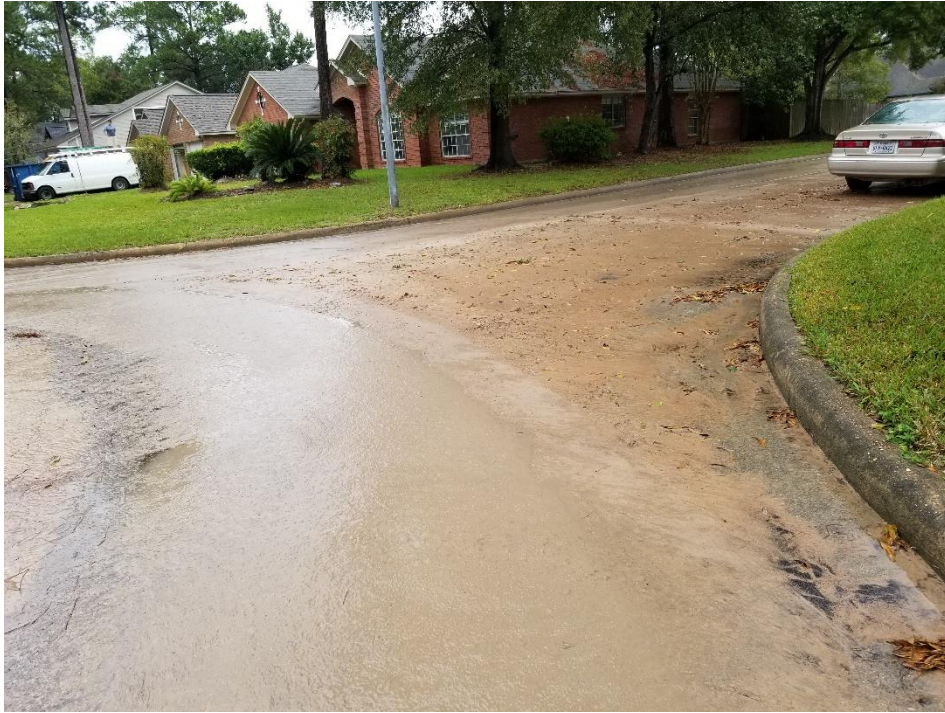
View of Sediment at Intersection of Village Springs Drive and Creek Manor Drive
Note: Additional sweeping is required

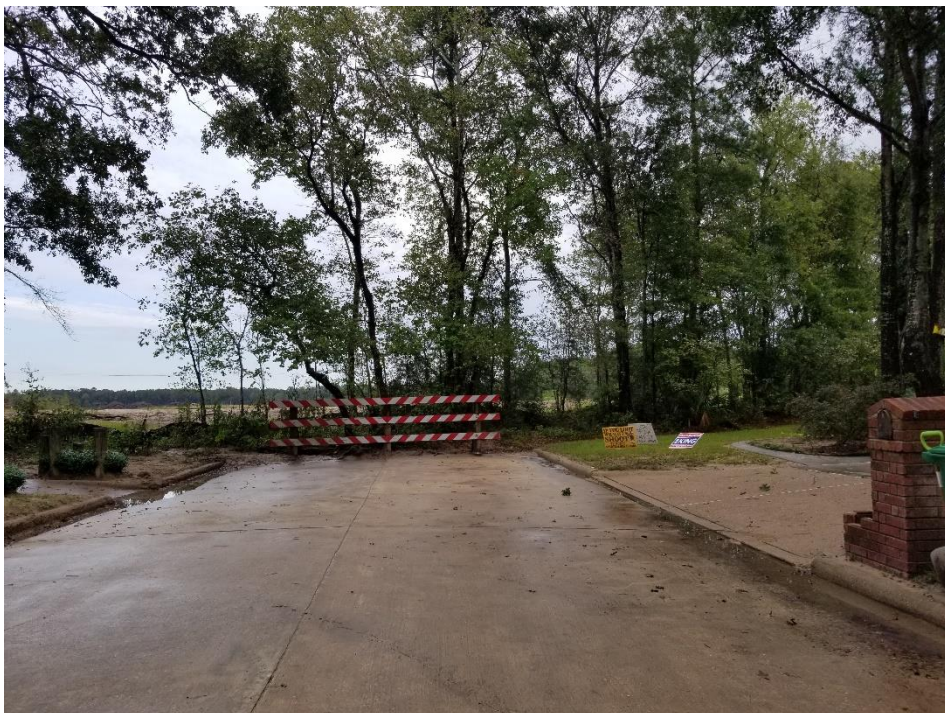
View Looking North on Village Springs Drive

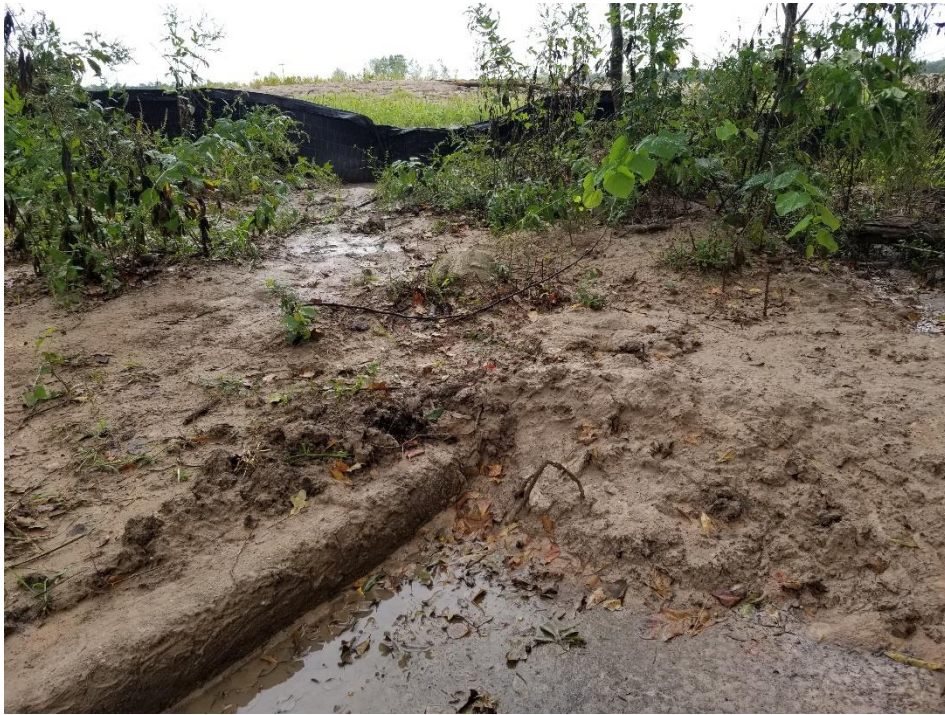
Sand / Silt on Village Springs Drive

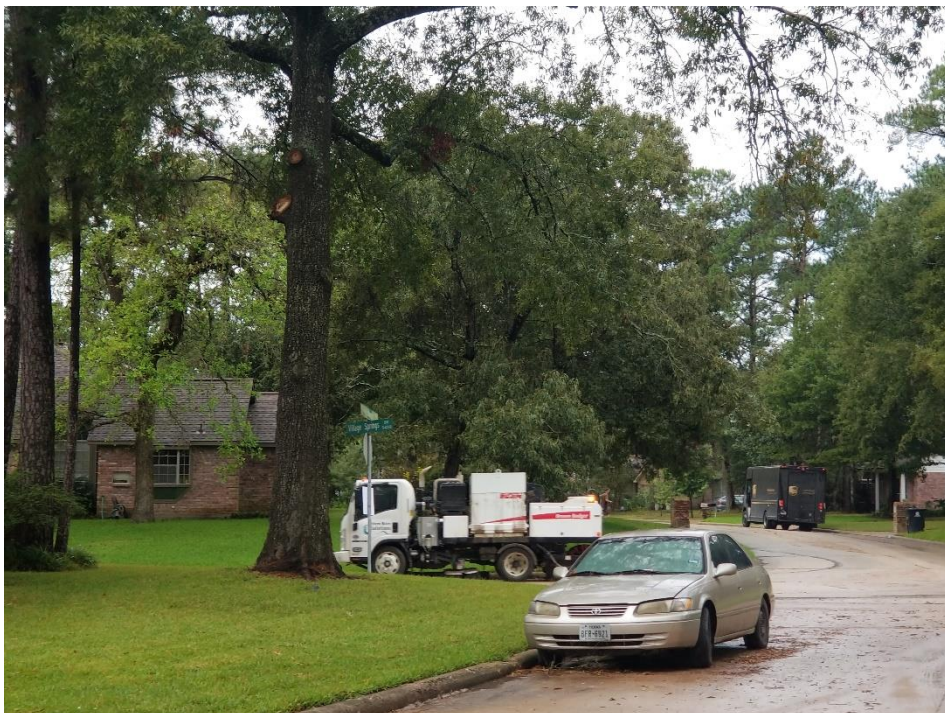
Sweeper on Village Springs Drive

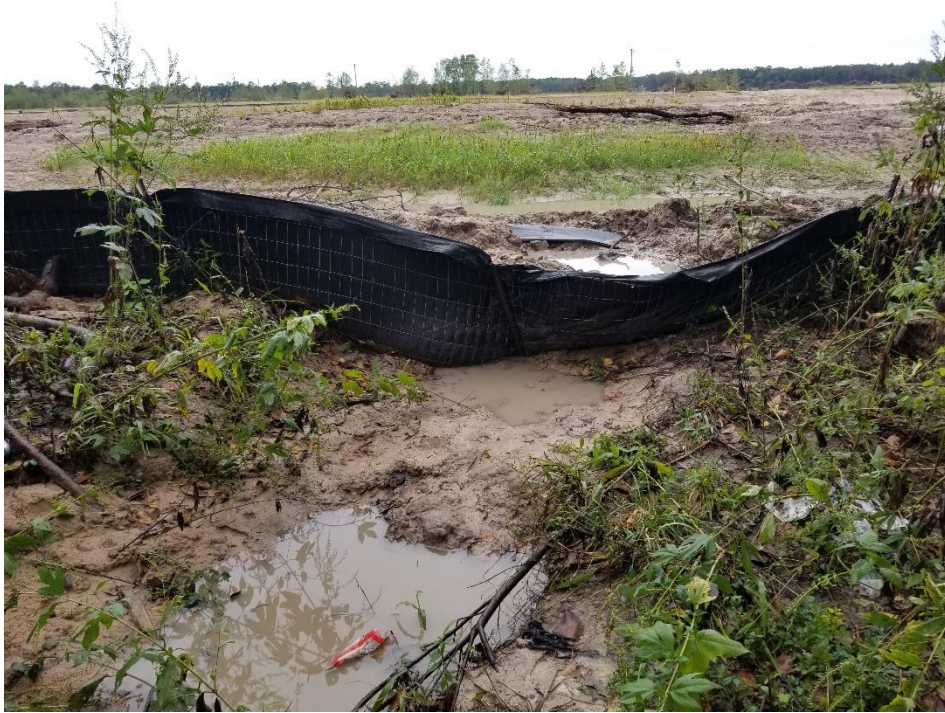
Silt Fencing Requires Maintenance

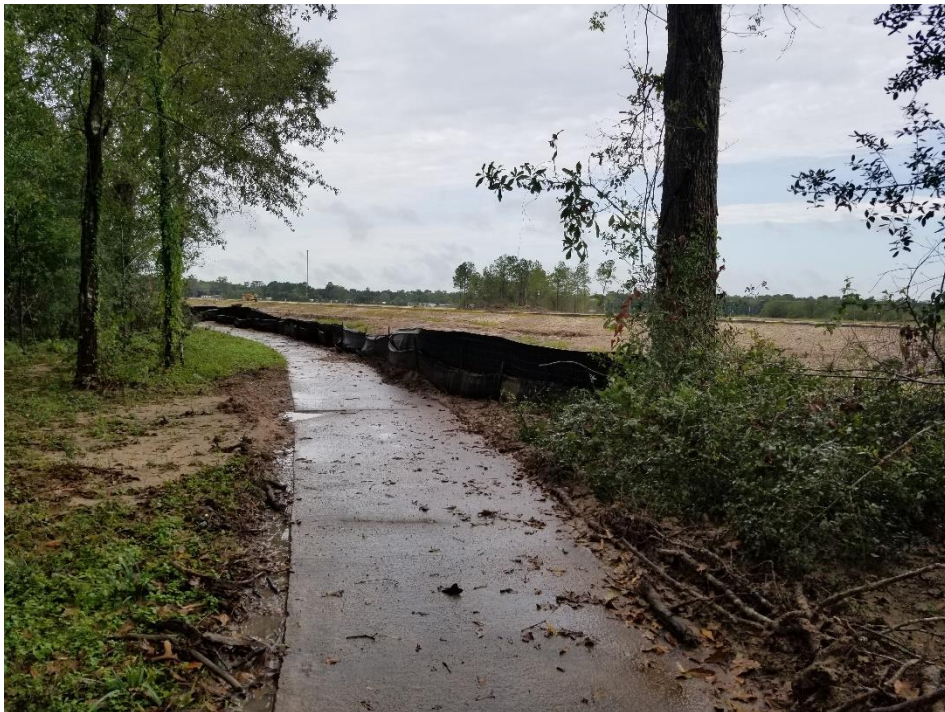
Most of Sediment Removed on Hike / Bike Trail

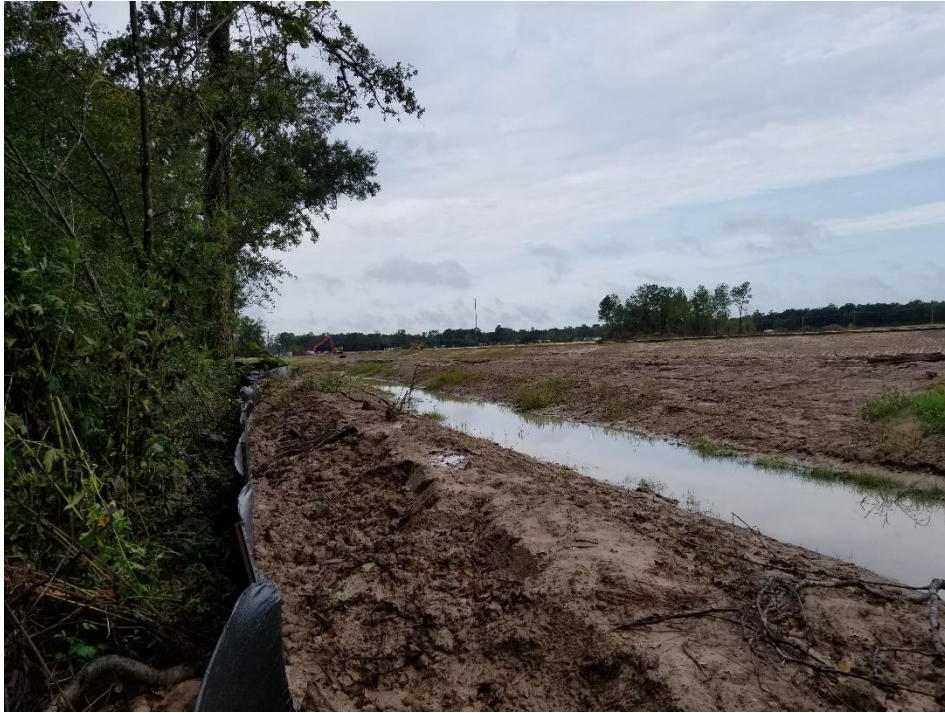
View of Long Detention Pond Looking West

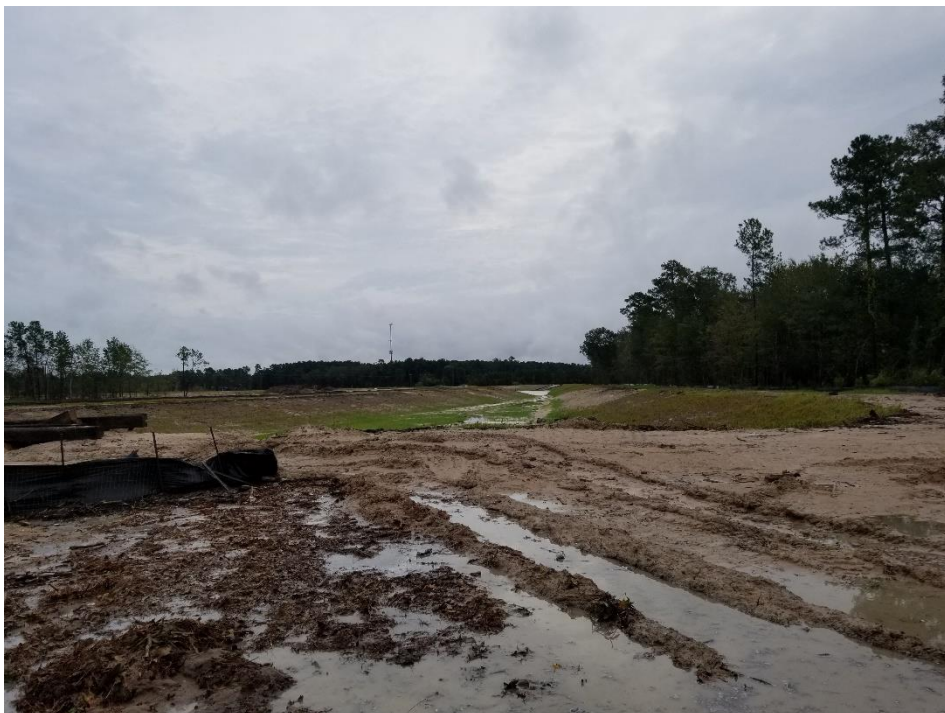
View of First Detention Pond Looking East

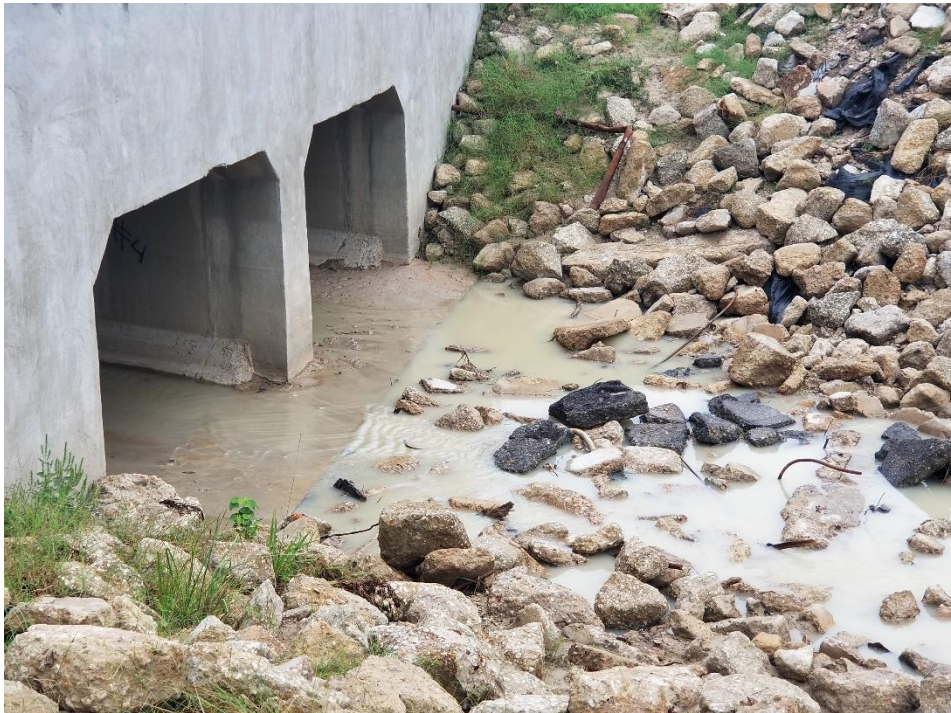
Close View of Box Culverts on Taylor Gulley

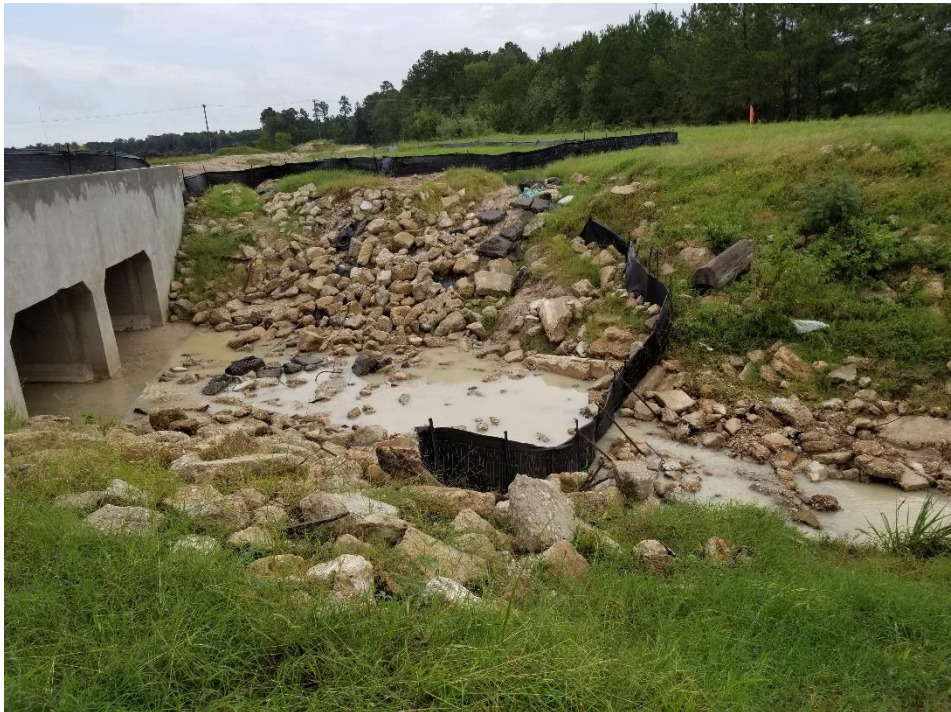
View of Taylor Gulley with Silt Fencing Down Stream of Culverts
Note: Silt Fencing along the top of slope

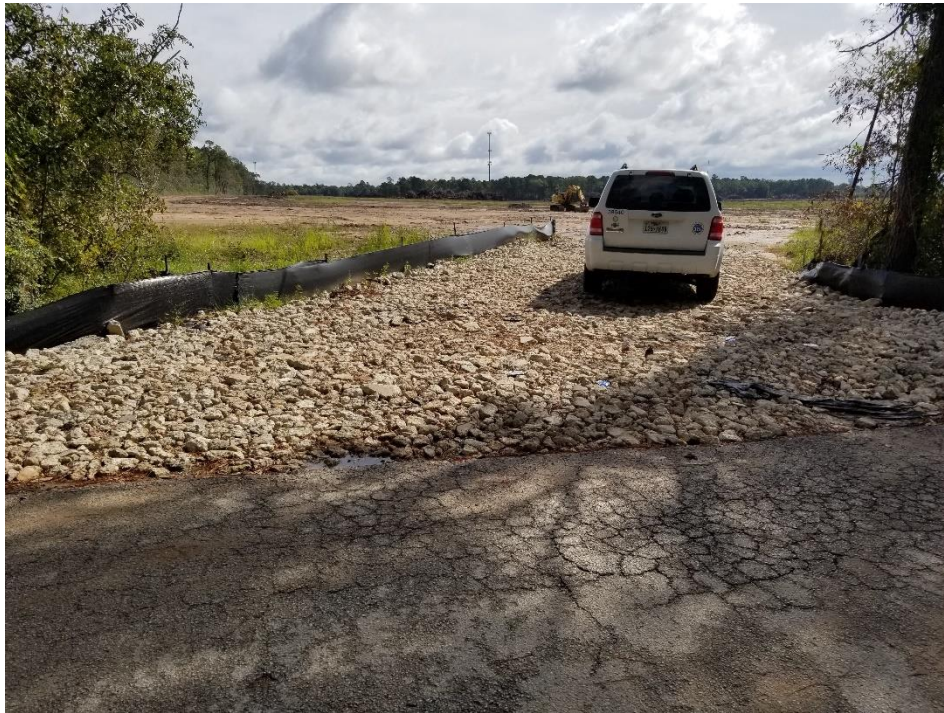
View of Construction Site Entrance on Webb Road

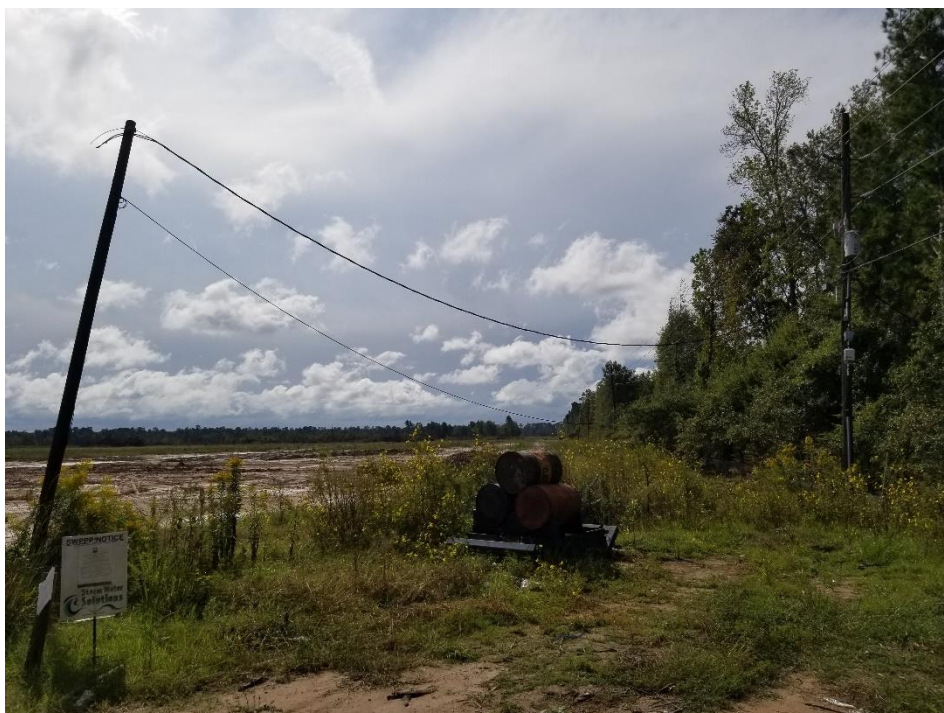
View from Construction Site Entrance on Webb Road Looking South

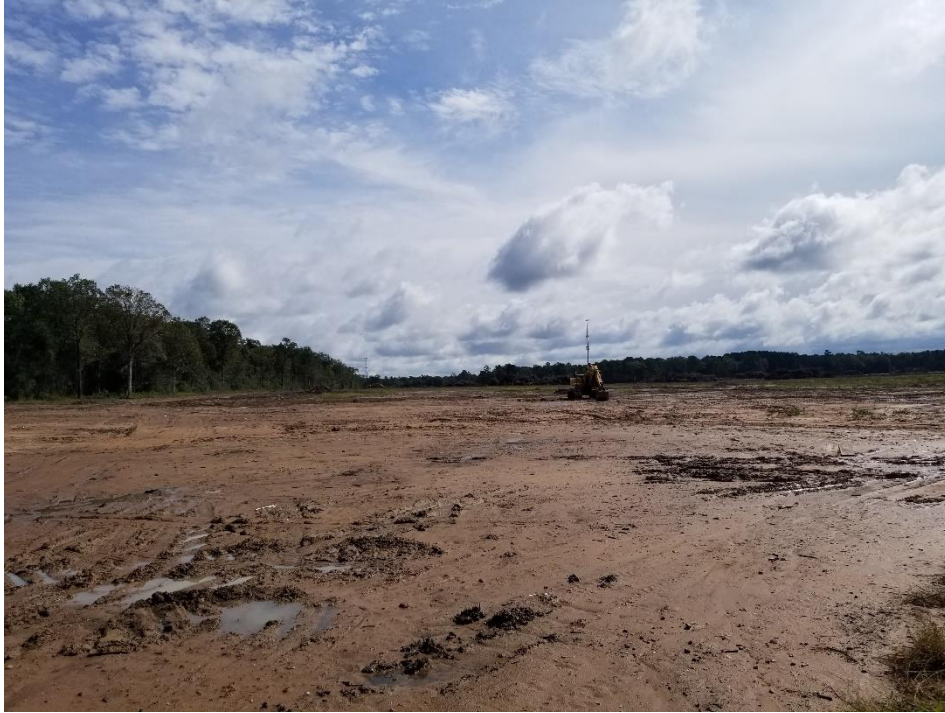
View from Construction Site on Webb Road Looking East
