CERTIFICATE OF APPROPRIATENESS

Property: 540 Frasier Street, Tracts 1 & 2, Block 1, Freeland Subdivision. The property includes a historic 1,870 square foot, one and a half-story wood frame single-family residence and a detached garage situated on a 5,000 square foot (50' x 100') corner lot.

Proposal: Alteration – Siding and windows

- To keep the vinyl windows and textured cement lap siding already installed

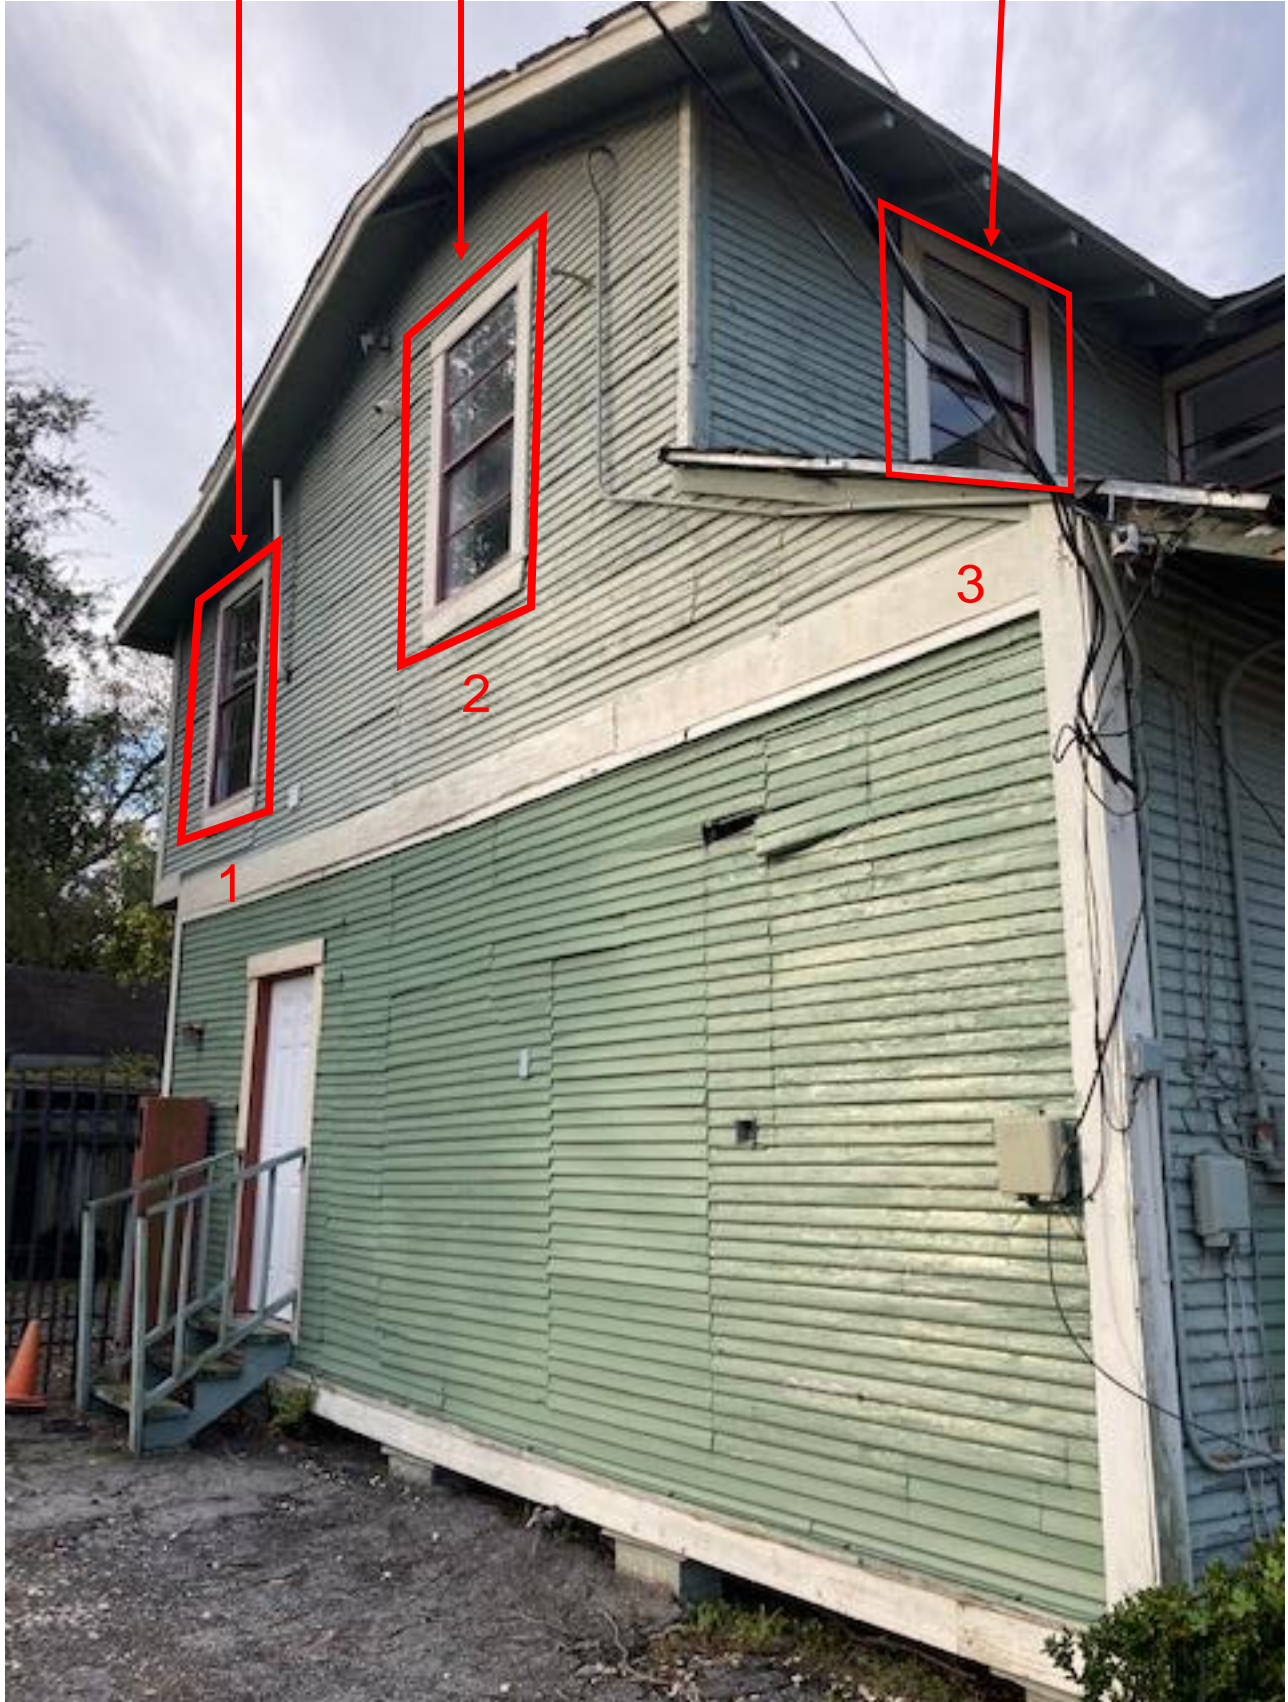
Original siding removed and replaced with textured cement lap siding.

Upper-floor windows removed.

Upper-floor window opening reduced.

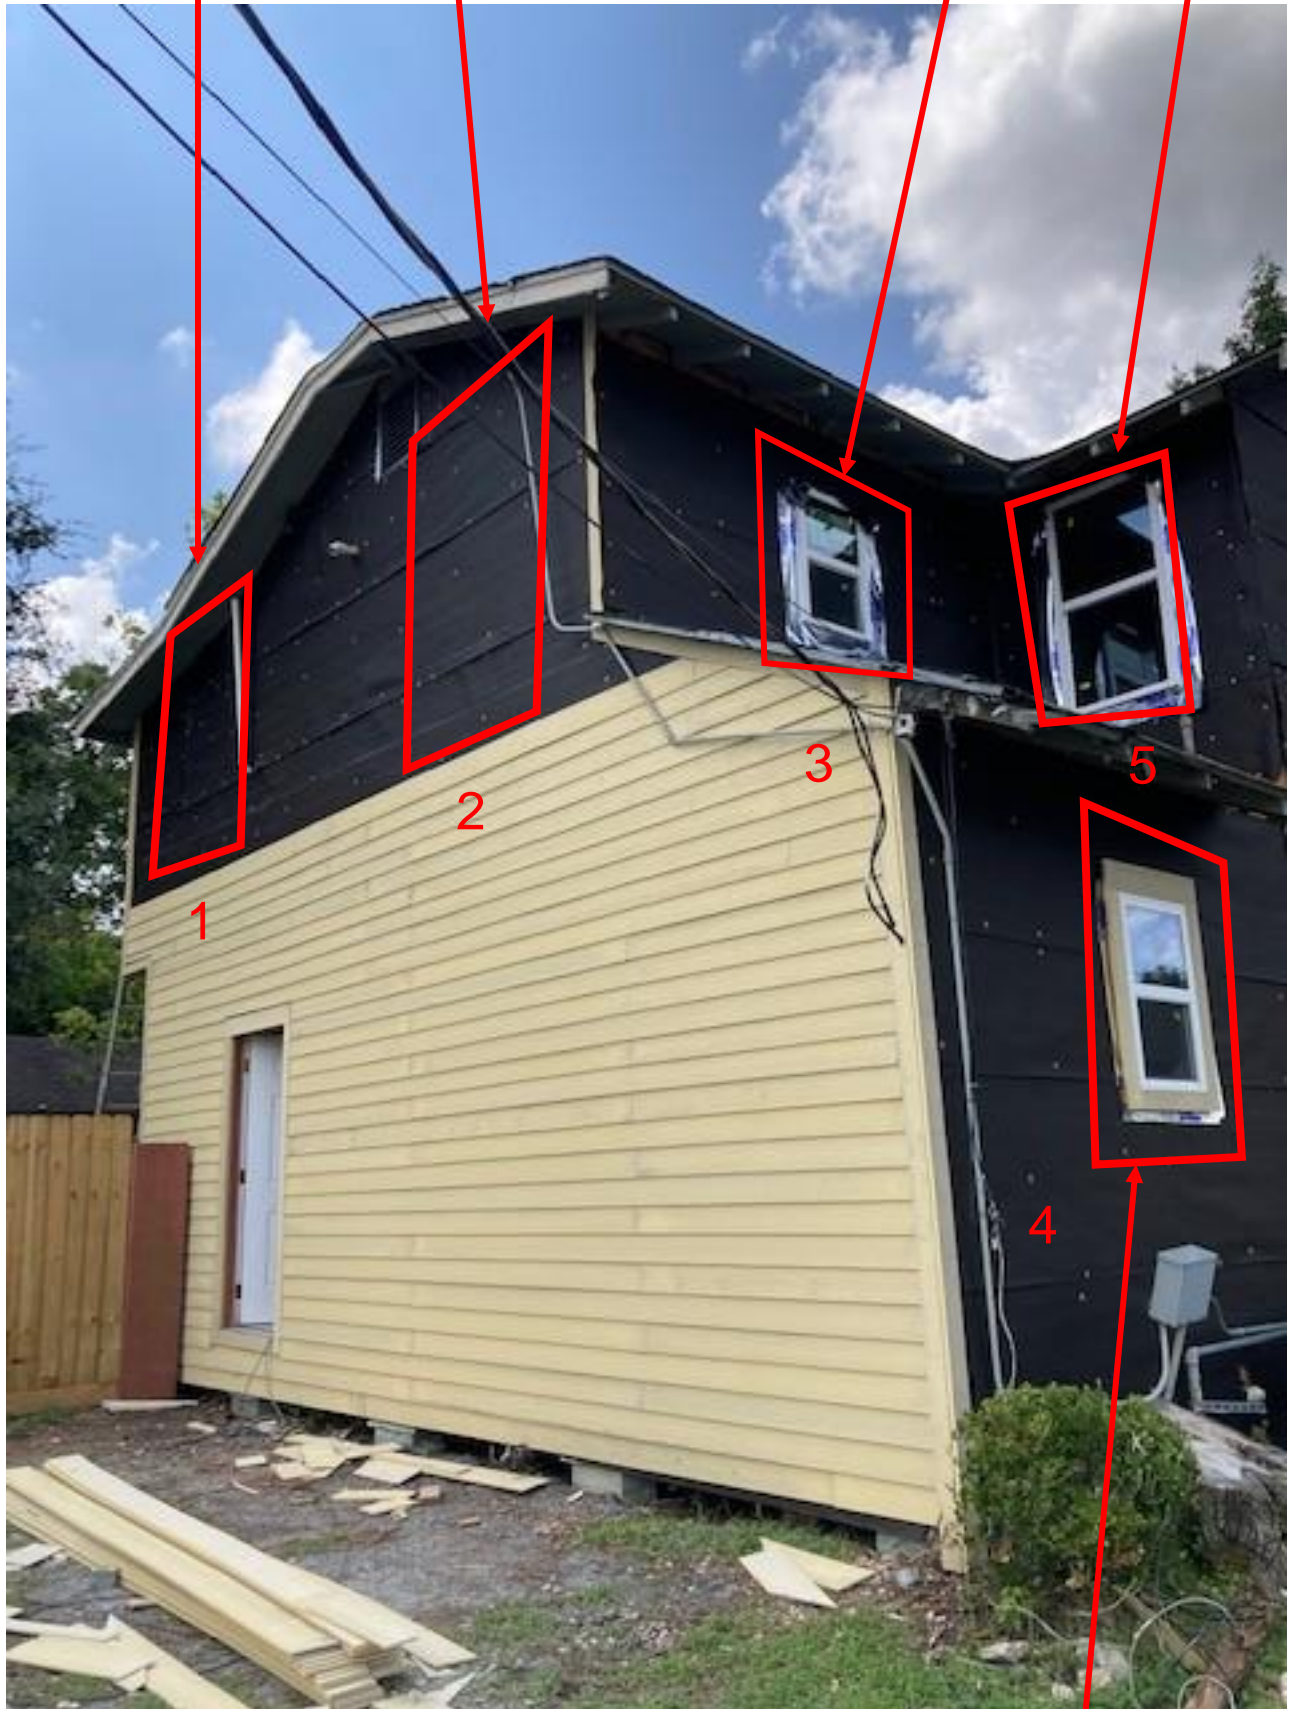
Original siding removed and replaced with textured cement lap siding.
Upper-floor windows removed.

Upper-floor window opening reduced.
Upper-floor side-by-side windows altered to a single window

Lower window's opening reduced.

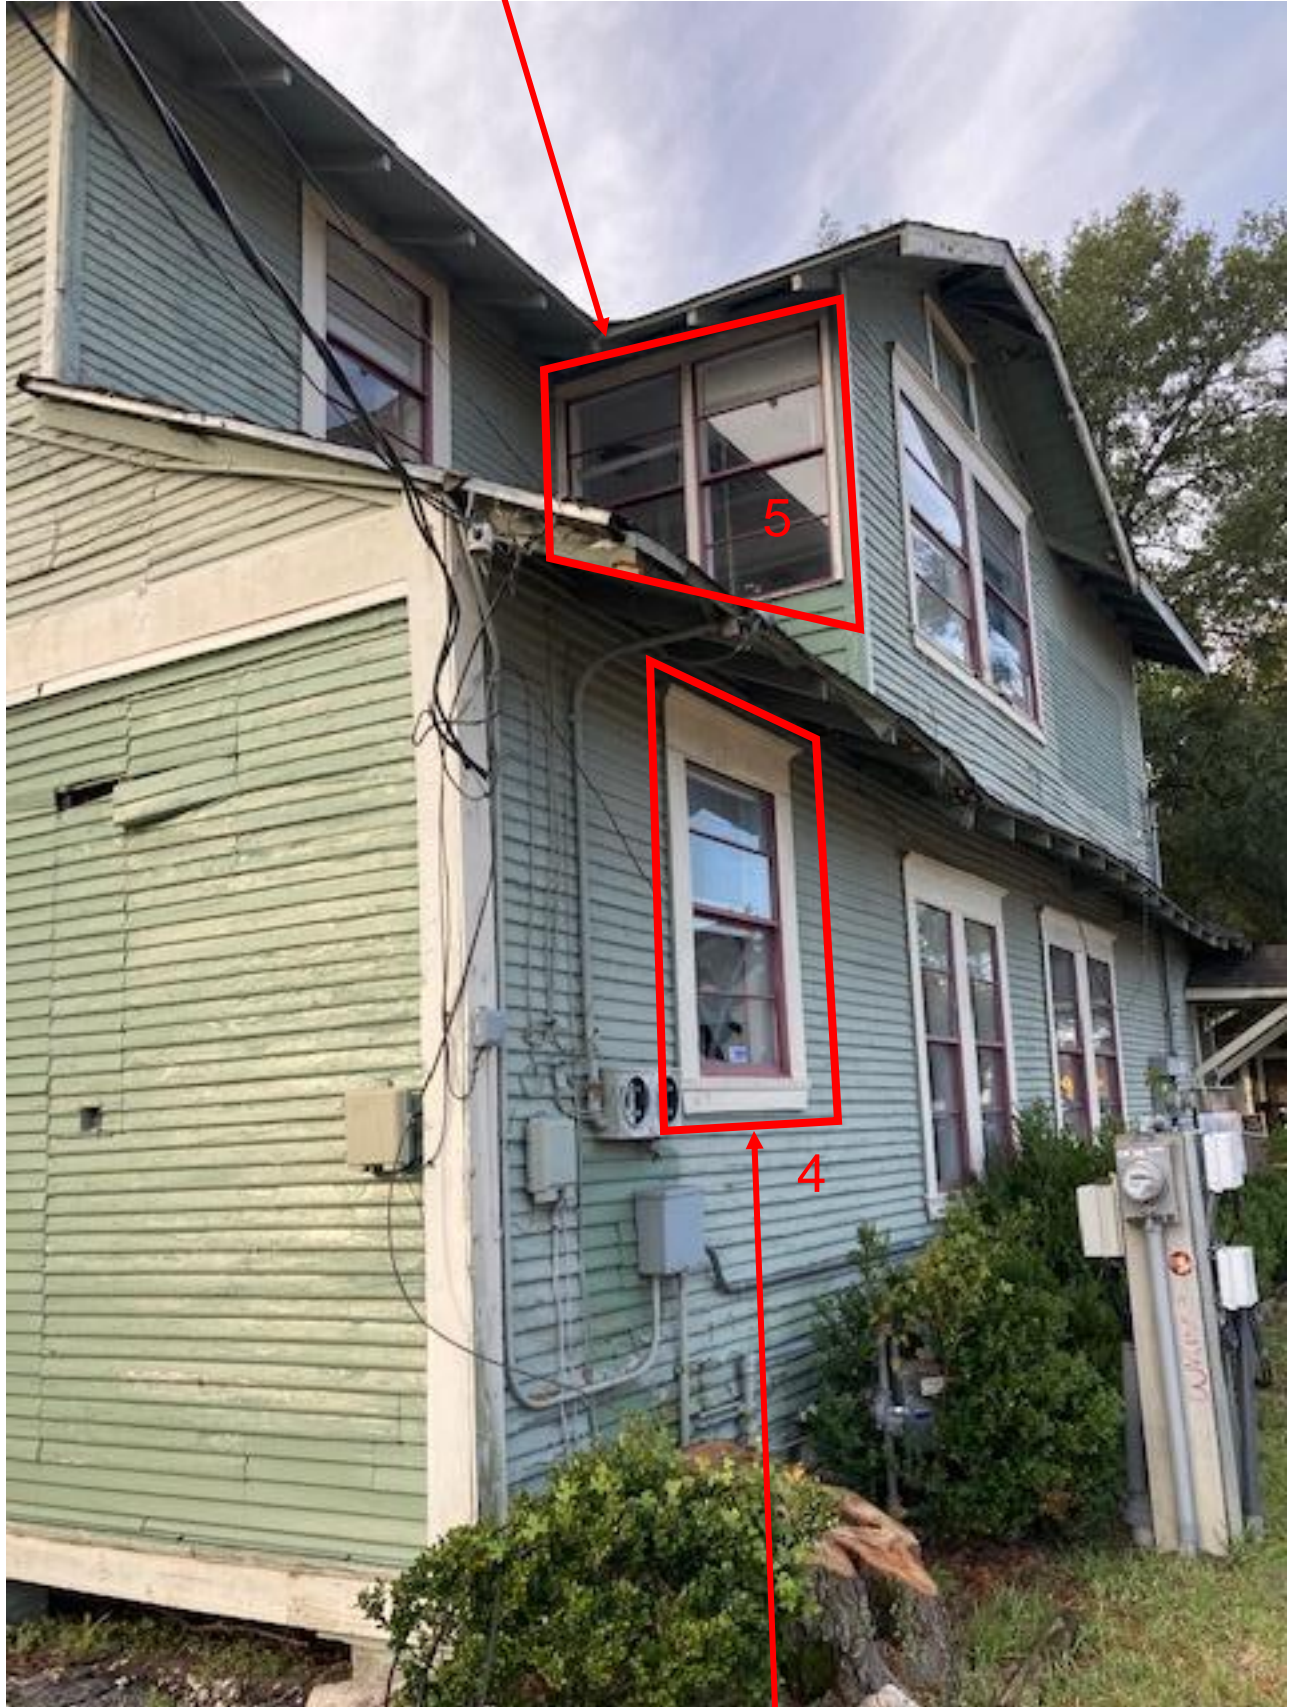
Upper-floor side-by-side windows altered to a single window.

Lower window's opening reduced.

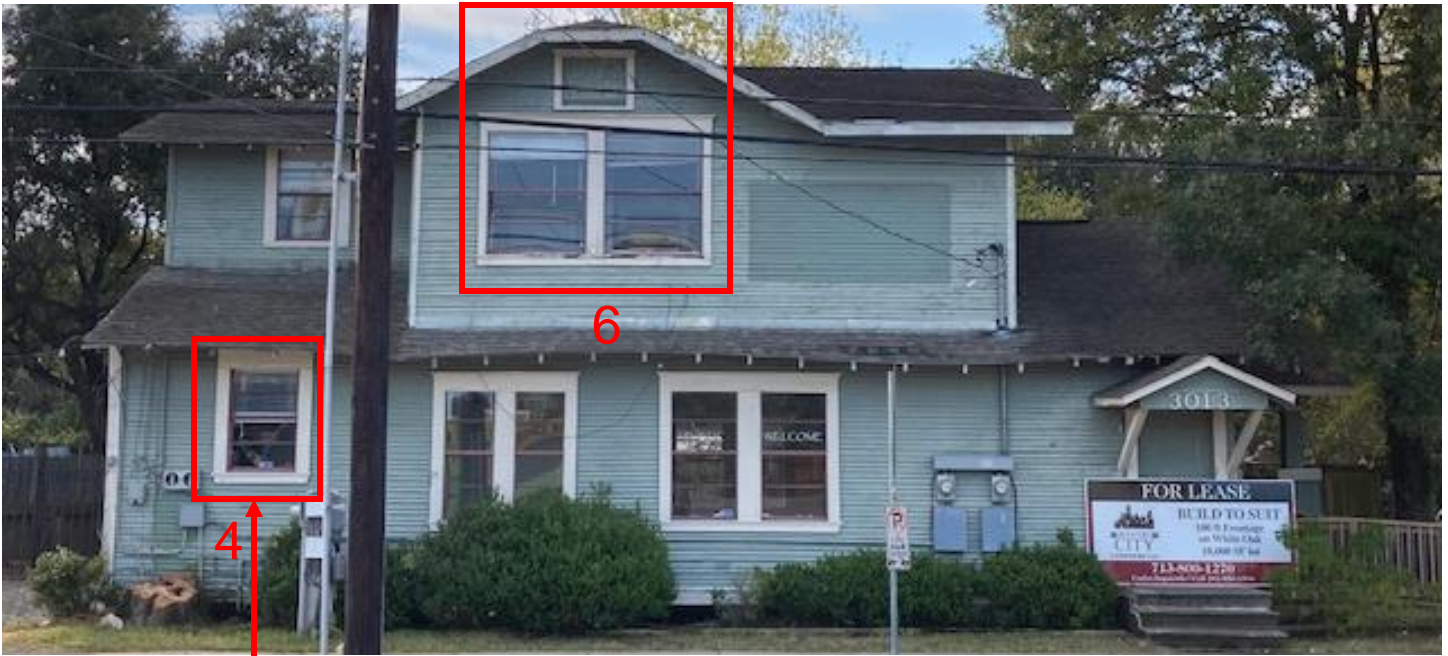
Upper-floor windows altered from side-by-side to a single window.

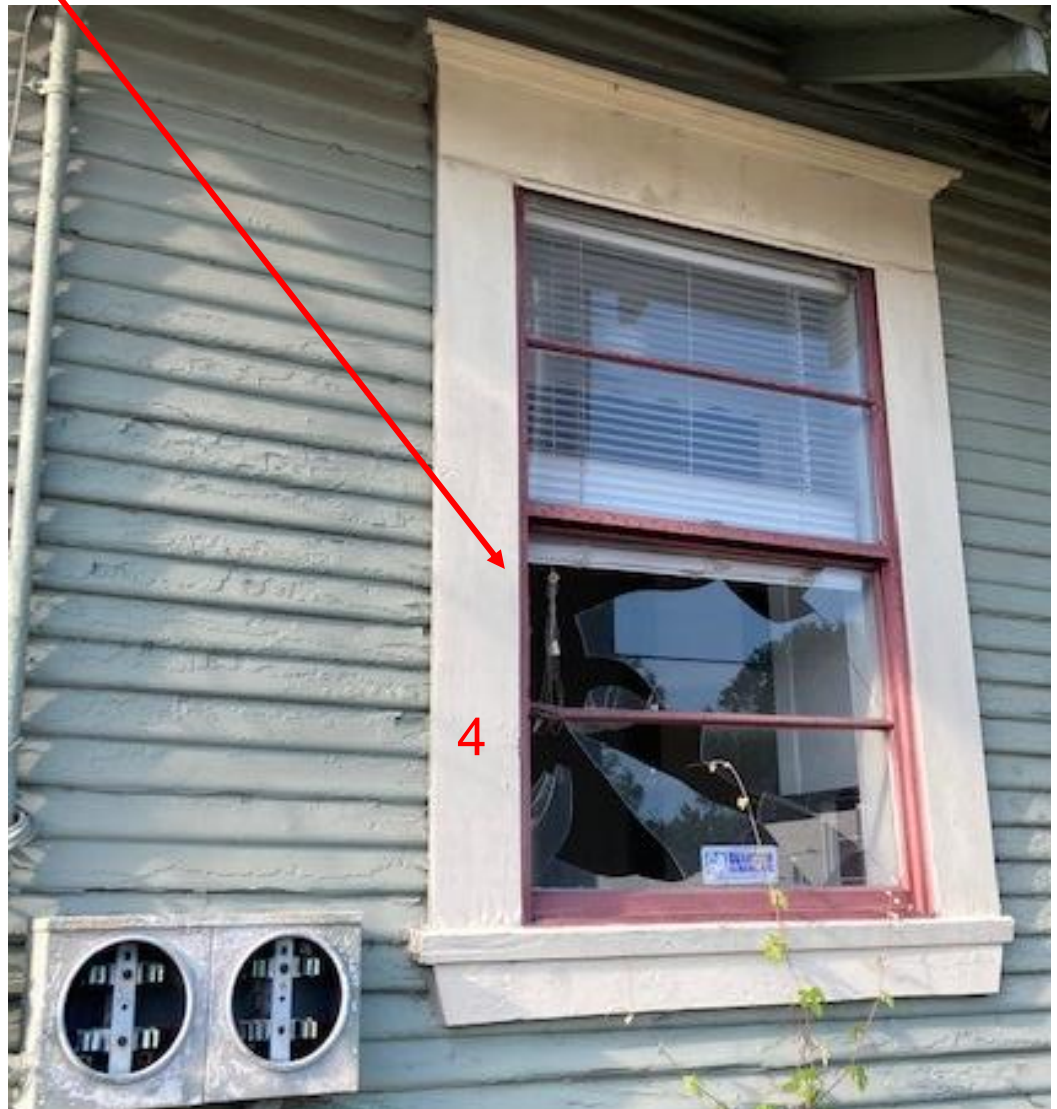
Broken window in lower-left of picture.

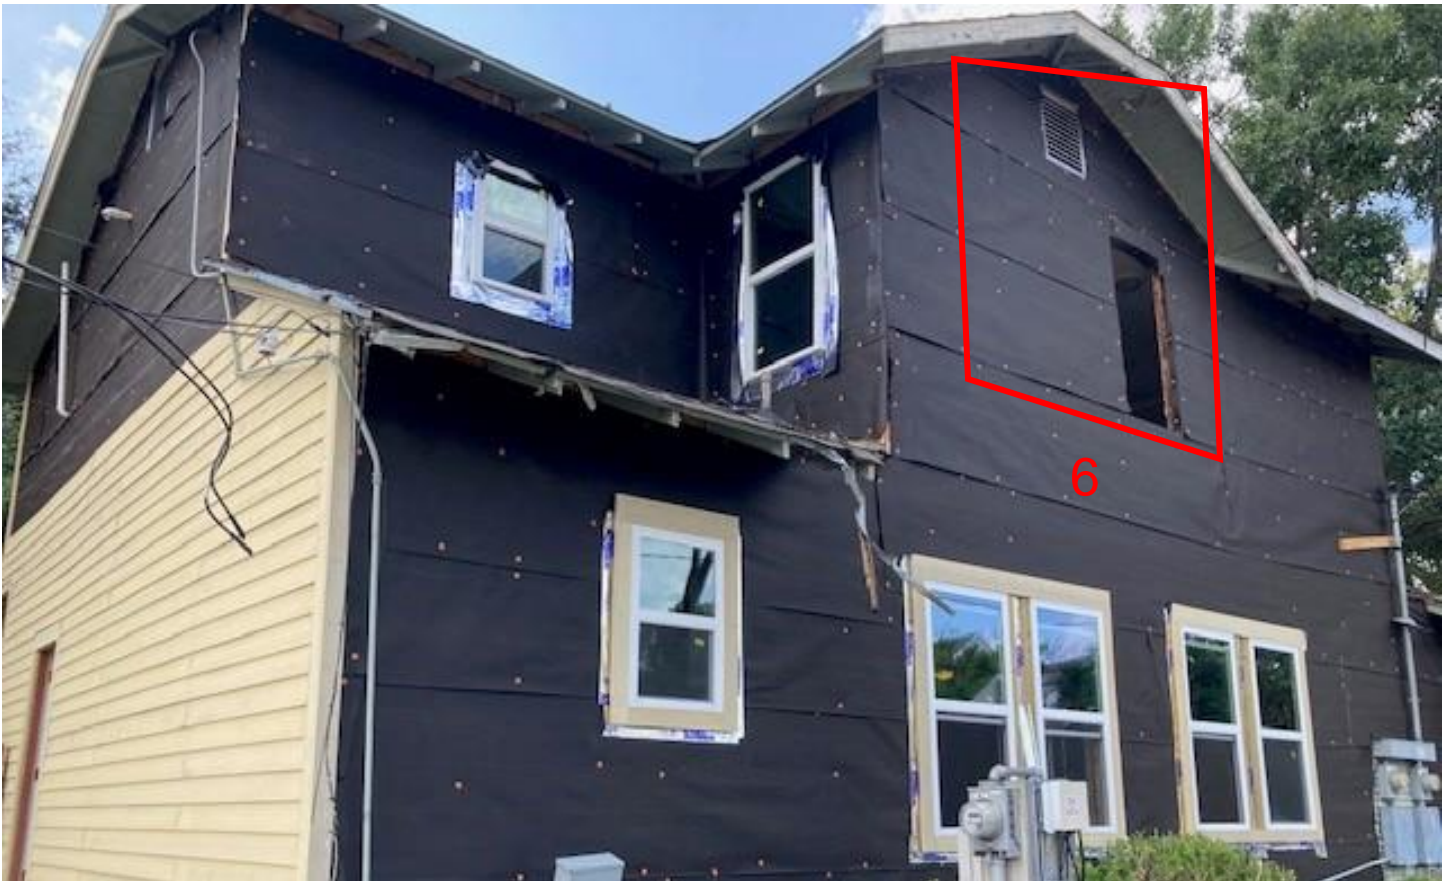
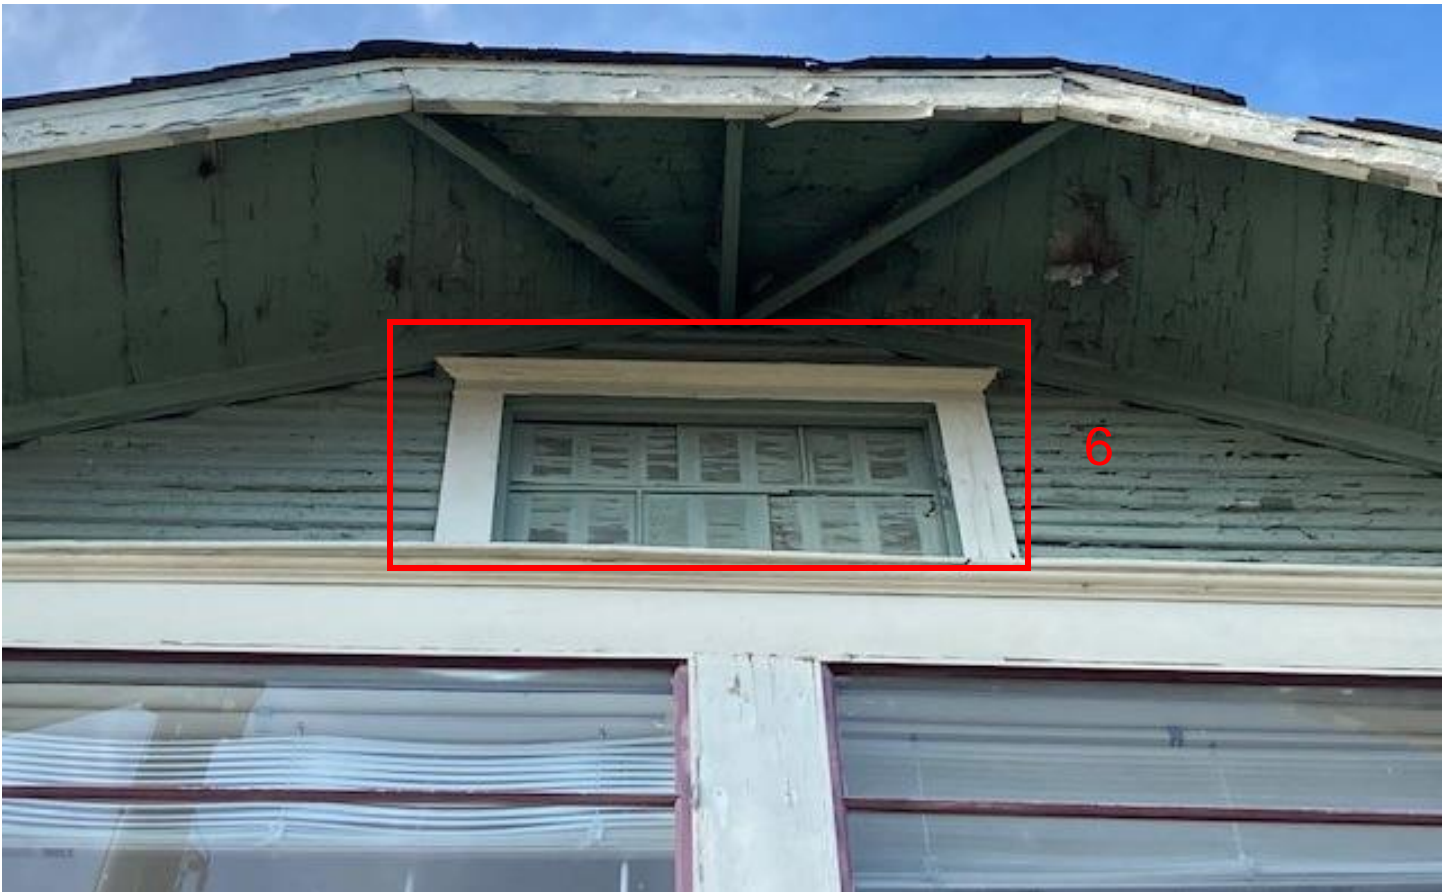
Upper-floor windows altered.

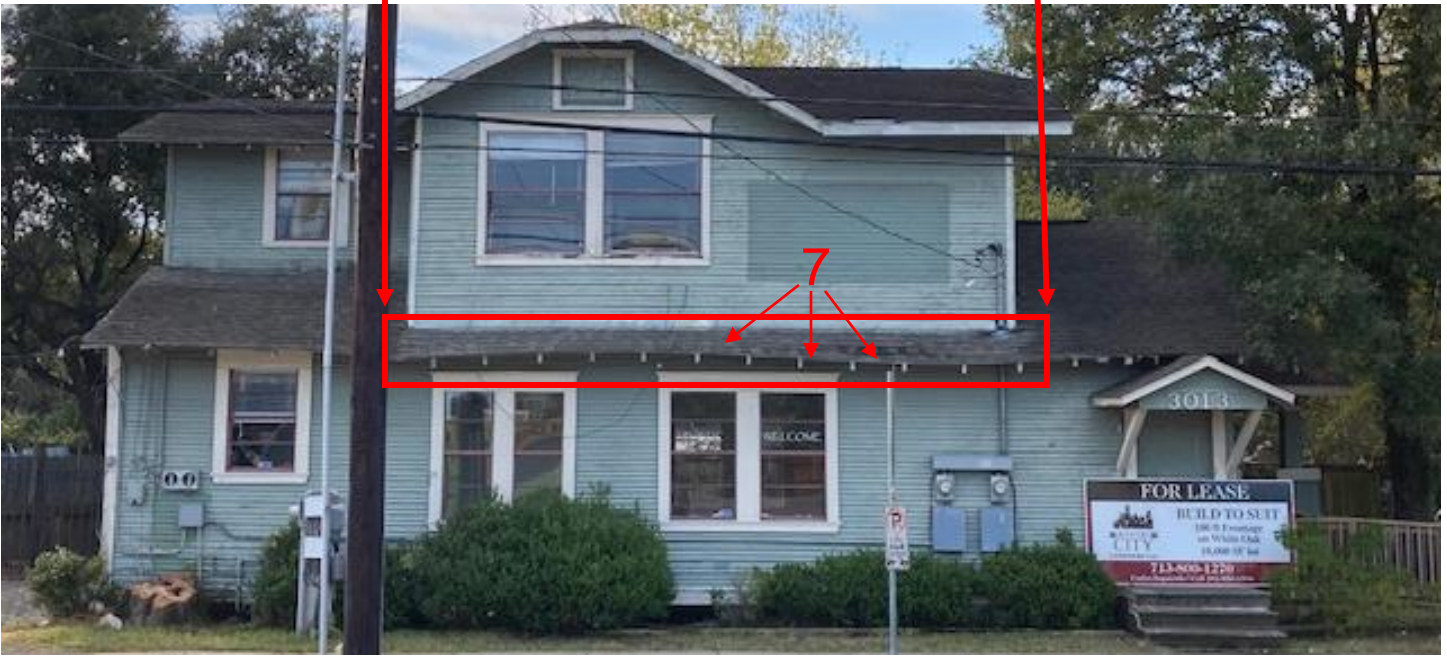
Entire eave removed from right-hand side of image to where the utility pole is in image.

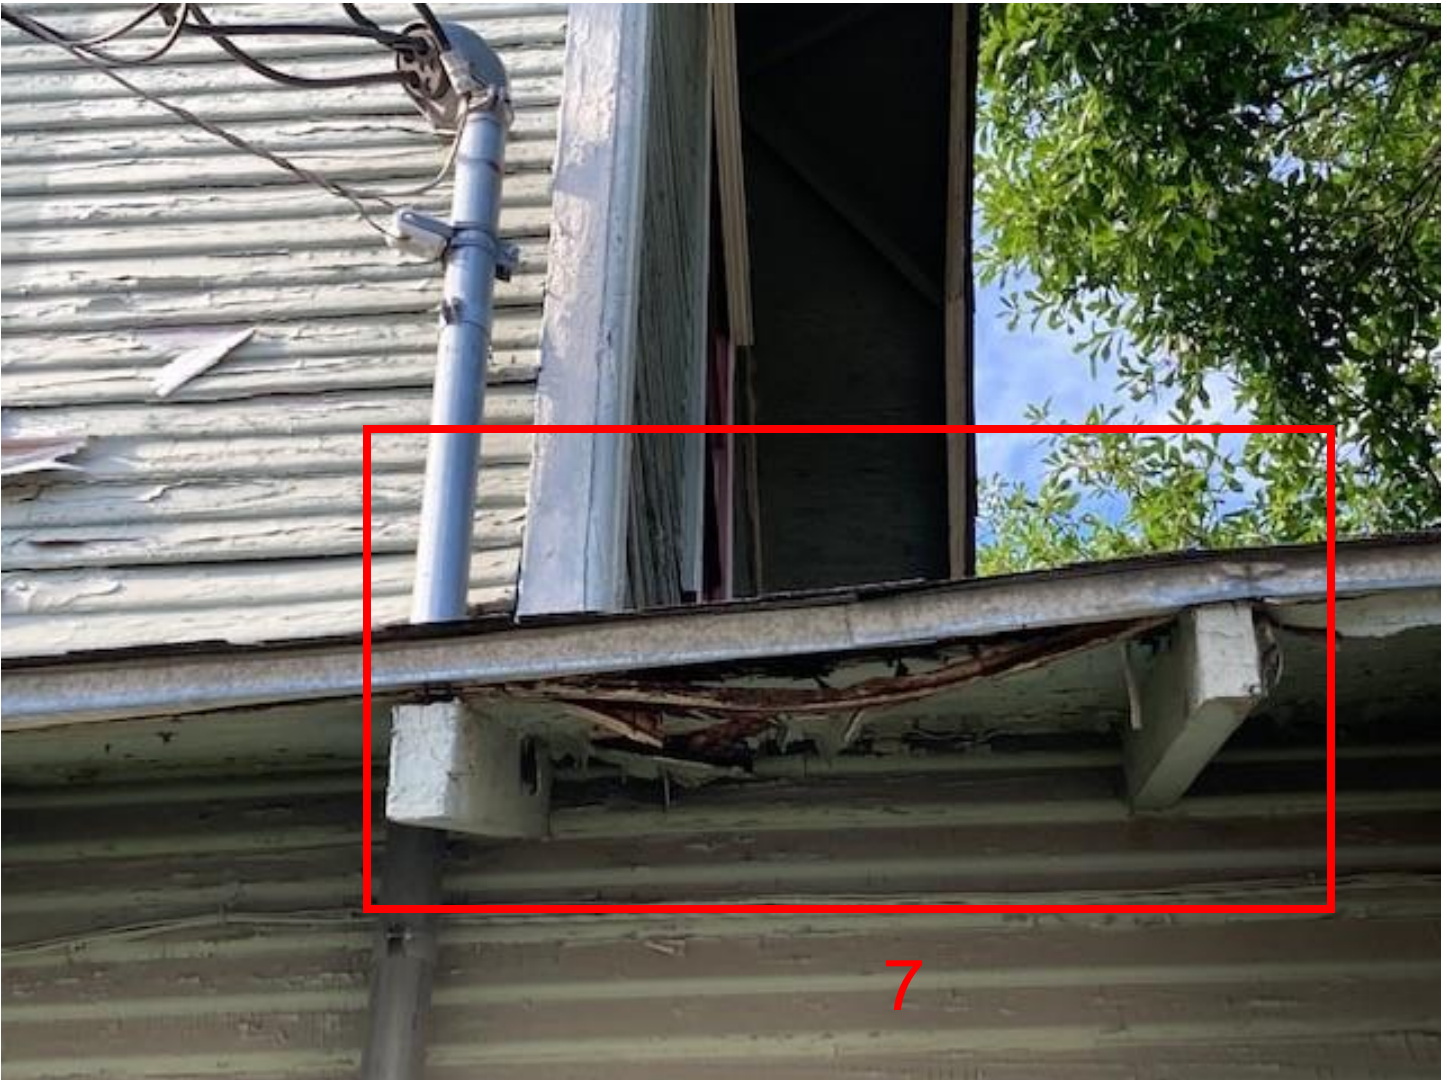
Existing rotting roof damage along eave prior to unpermitted work that removed the eave facing White Oak Drive.

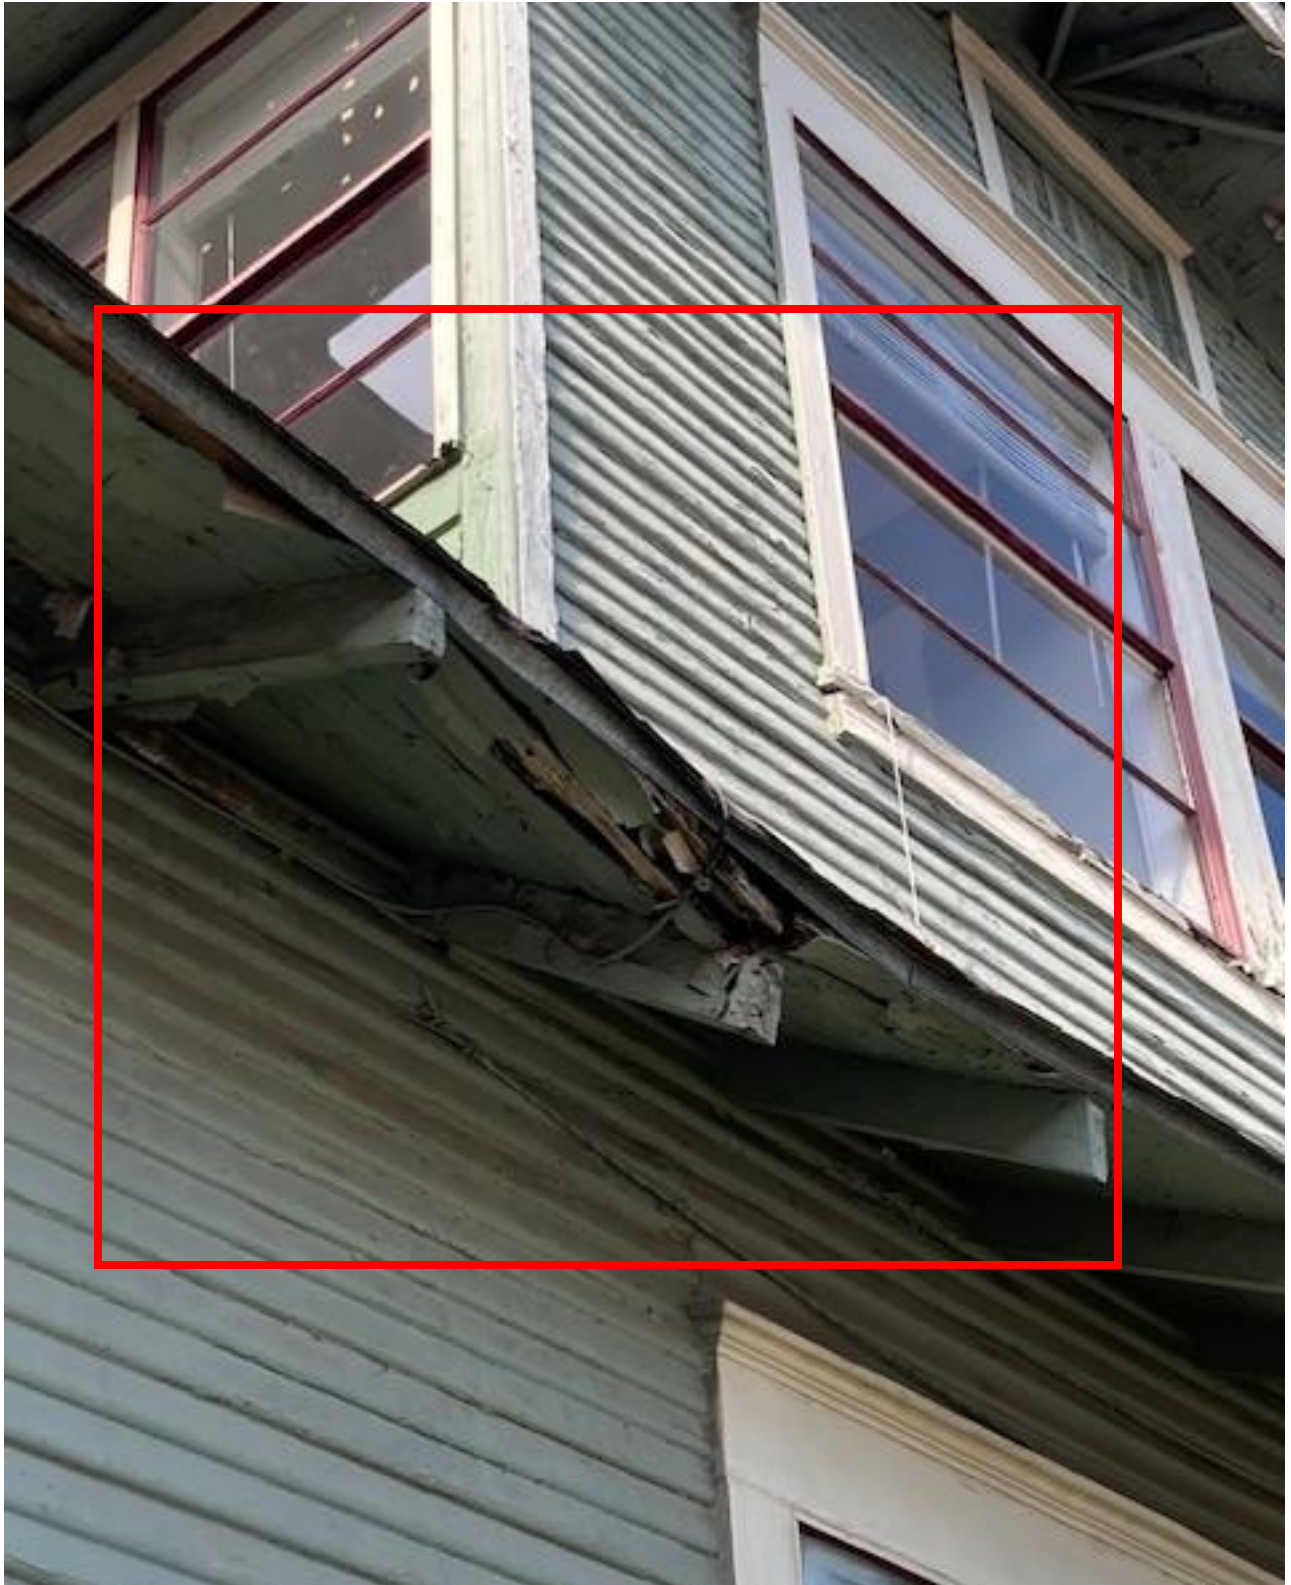
7

<i>Applicant replaced original wood siding and aluminum windows without a COA. Additionally, applicant has removed two sections of existing eave without replacement (#s 7, 12) on the north and south facades.</i> | | |

Existing roof joist damage along eave prior to unpermitted work that removed the eave facing White Oak Drive.

Recommendation: Denial - does not satisfy criteria **Issuance of a COR. Must obtain staff approval before restoring all opening patterns for doors, windows, and vents. Must obtain staff approval before replacing the removed eave sections on the north and south facades. Remove inappropriate textured cement siding and replace with 117 smooth wood siding.**

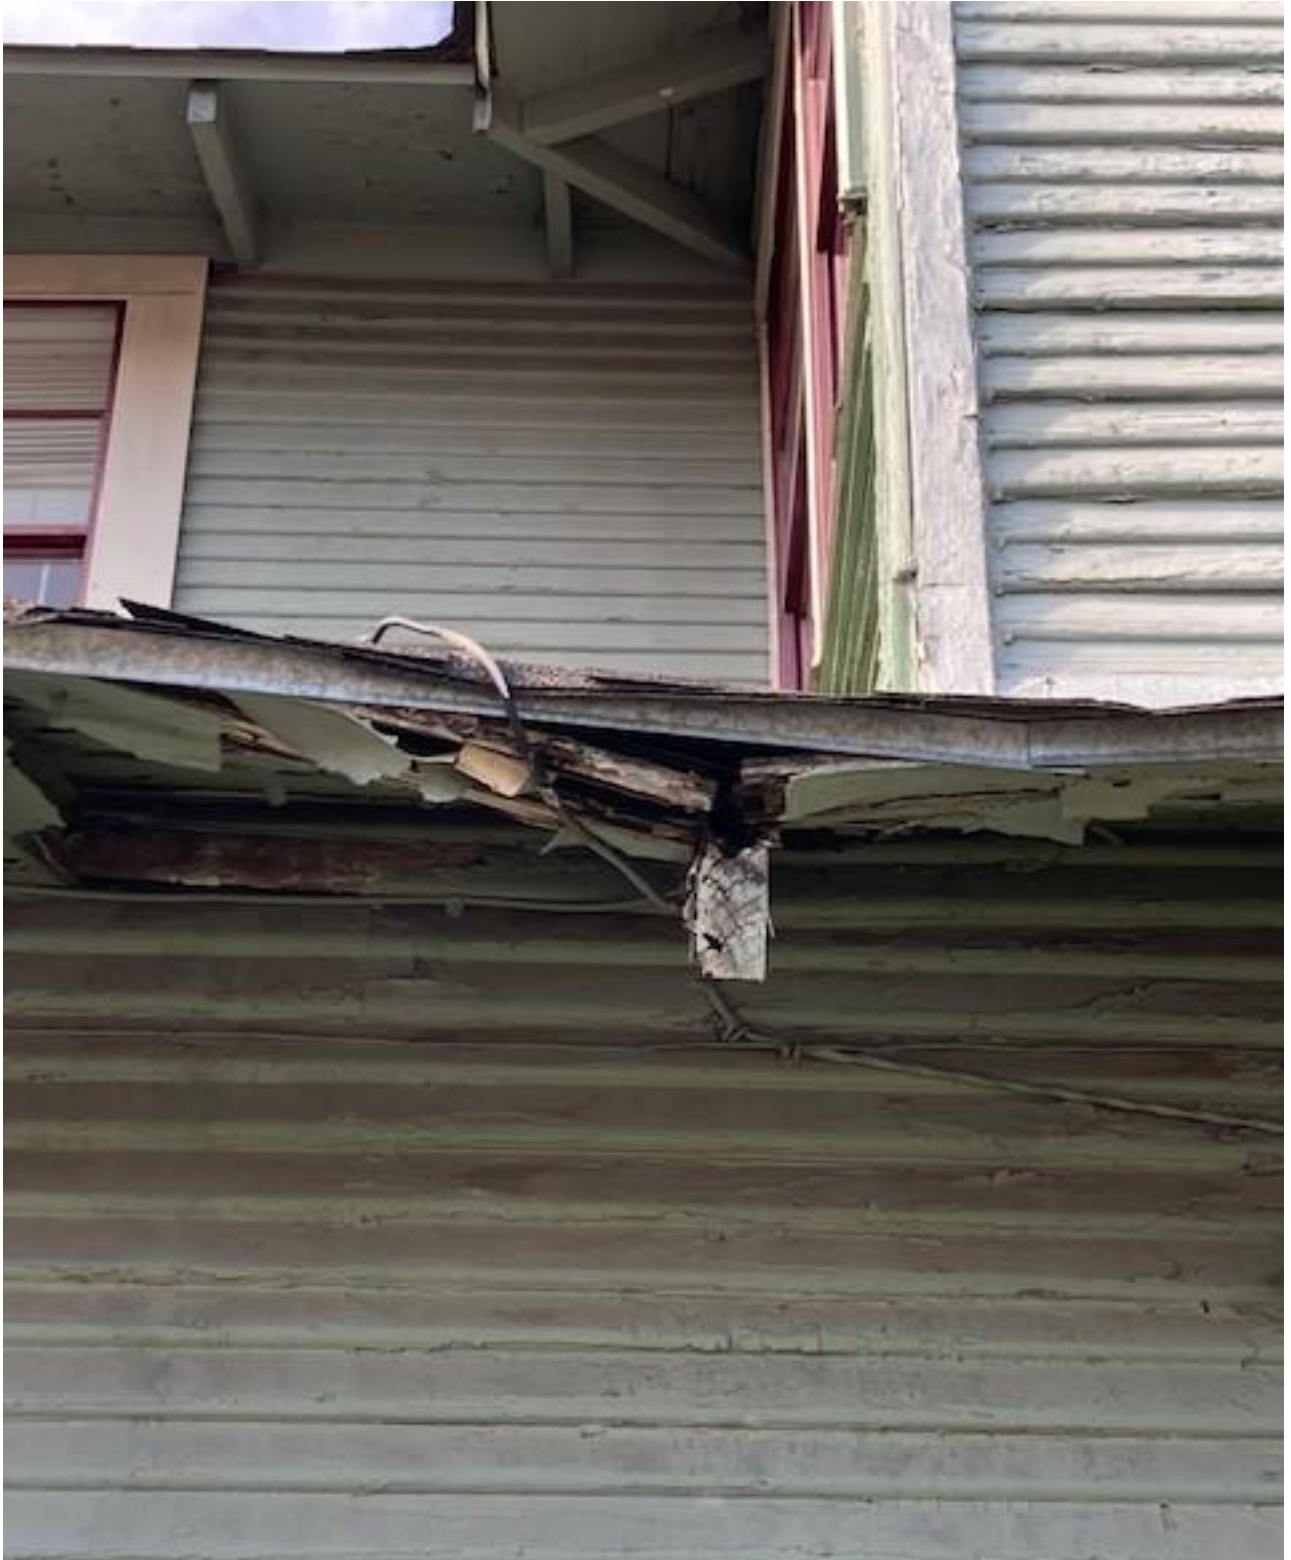
7

Existing roof joist damage along eave prior to unpermitted work that removed the eave facing White Oak Drive.

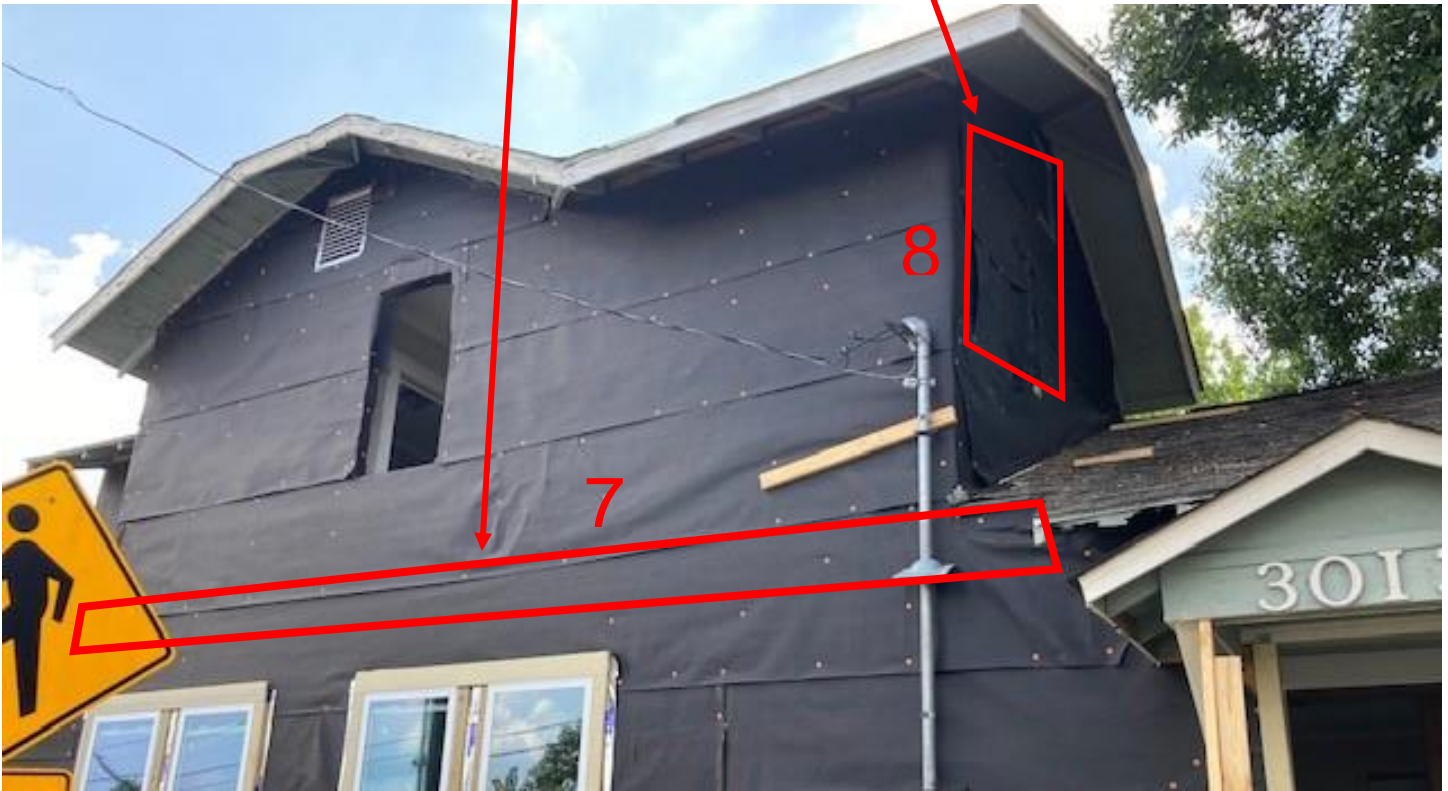
Eave removed as was an upper-floor window.

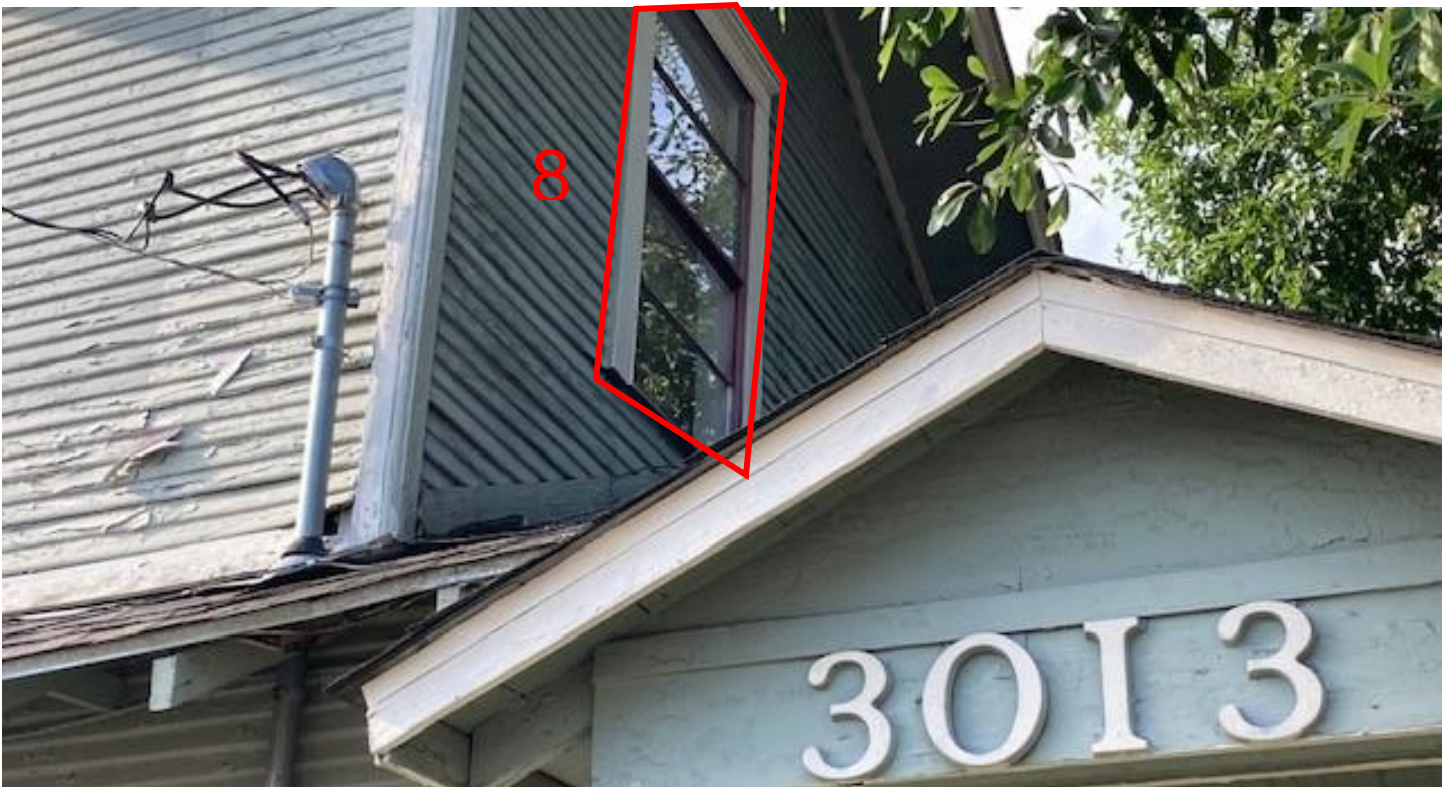
Upper-floor window removed.

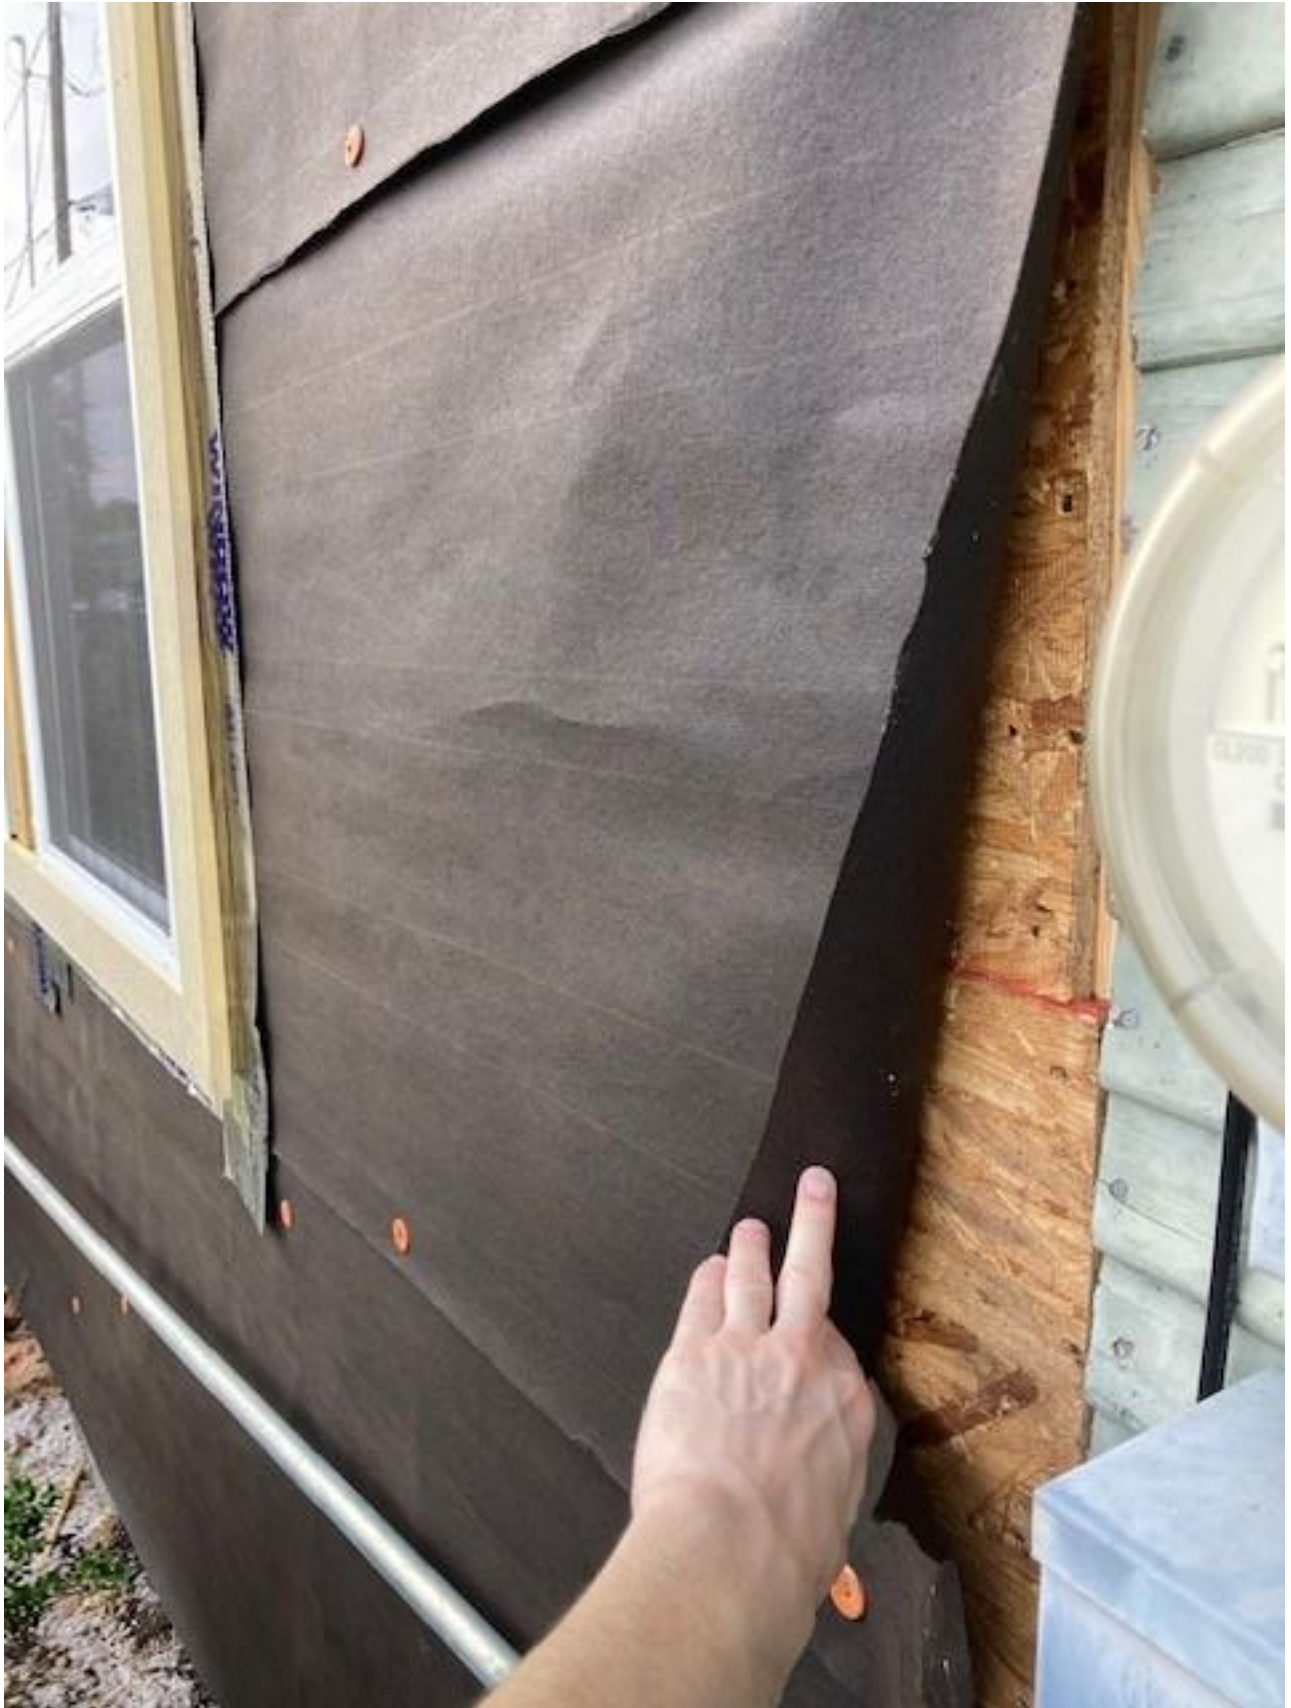
Original siding completely removed.
