CERTIFICATE OF APPROPRIATENESS

Property: 540 Frasier Street, Tracts 1 & 2, Block 1, Freeland Subdivision. The property includes a historic 1,870 square foot, one and a half-story wood frame single-family residence and a detached garage situated on a 5,000 square foot (50' x 100') corner lot.

Proposal: Alteration – Siding and windows

- To keep the vinyl windows and textured cement lap siding already installed

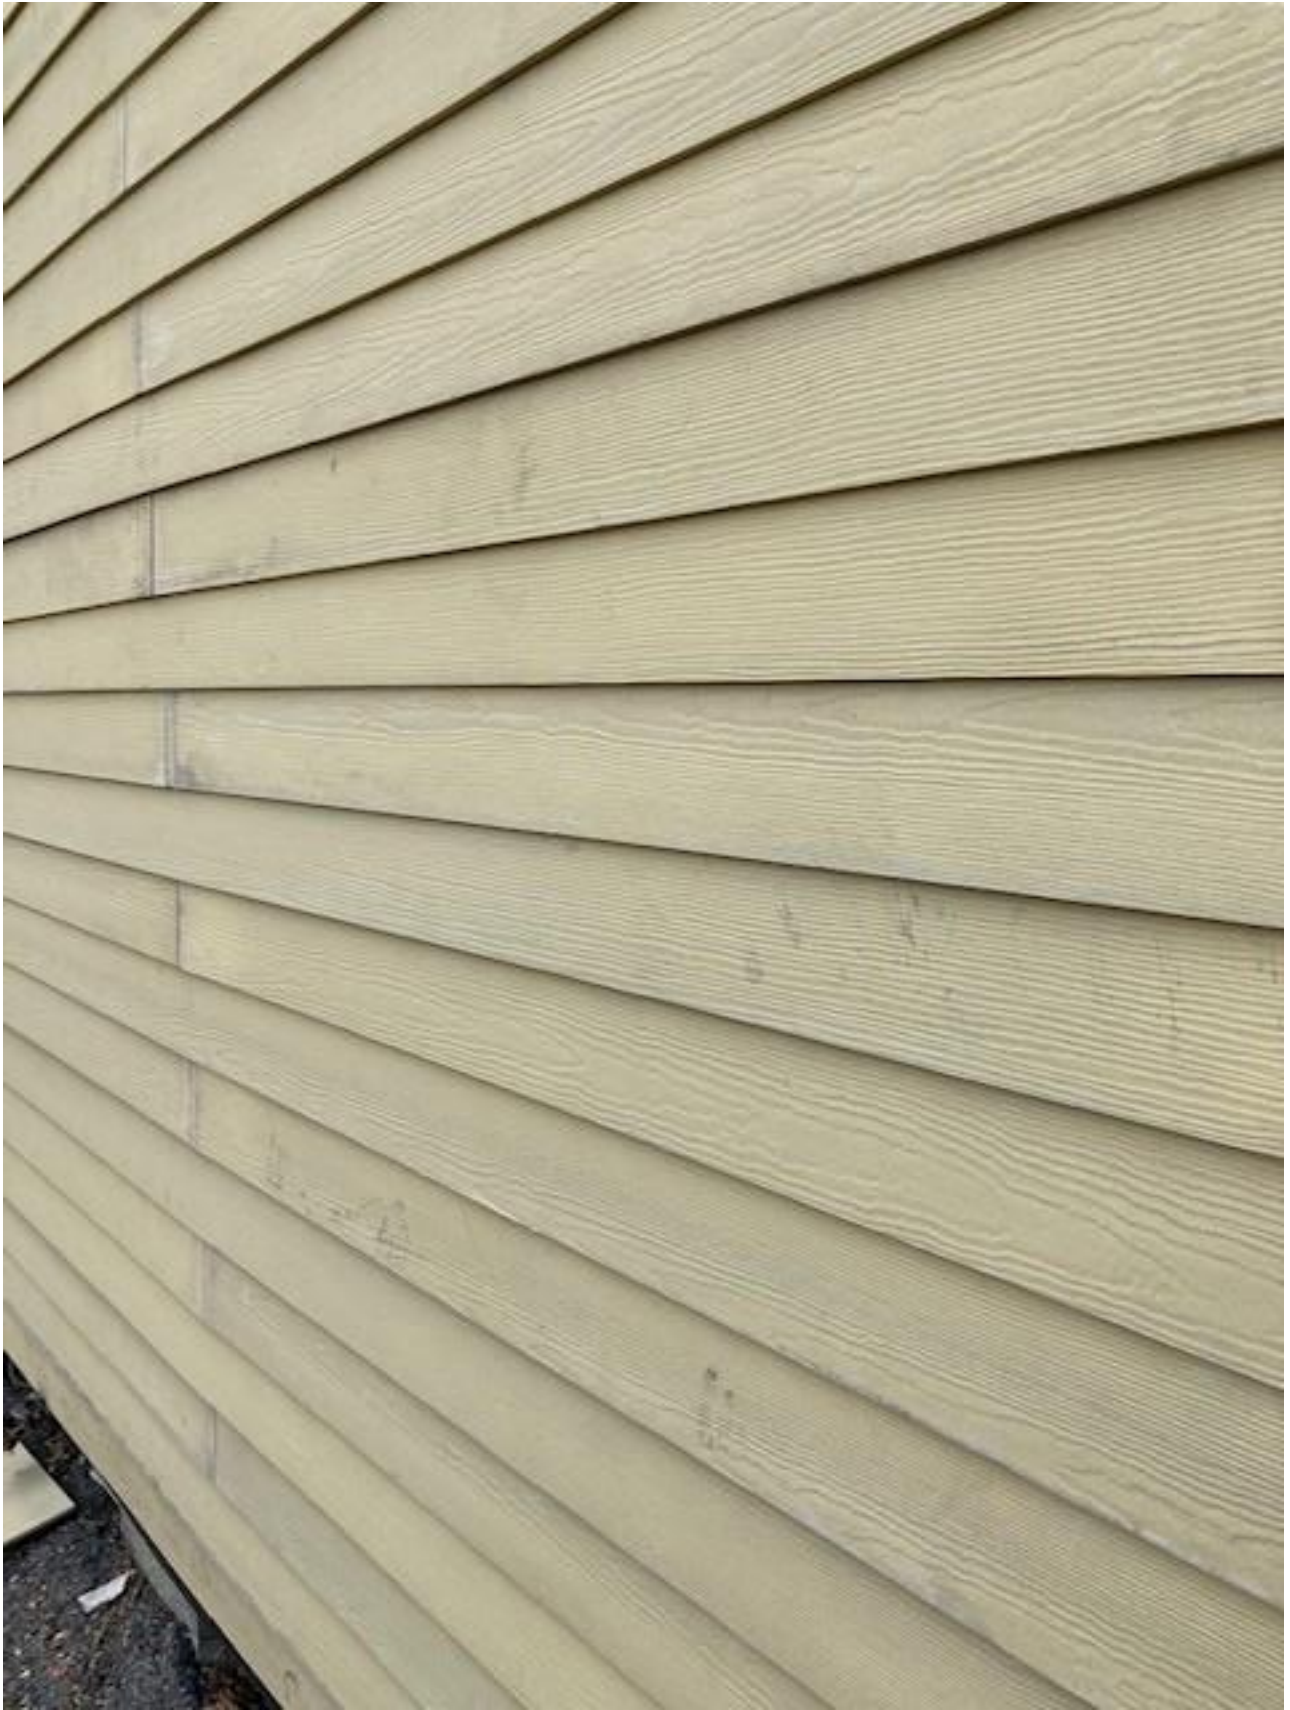
The proposed exterior alterations has destroyed the historical material that which is the original wood siding. The original wood siding is no longer at the site and has been disposed of.

Replaced original wood siding with textured cement lap siding.

Recommendation: Denial - does not satisfy criteria **Issuance of a COR. Must obtain staff approval before restoring all opening patterns for doors, windows, and vents. Must obtain staff approval before replacing the removed eave sections on the north and south facades. Remove inappropriate textured cement siding and replace with 117 smooth wood siding.**

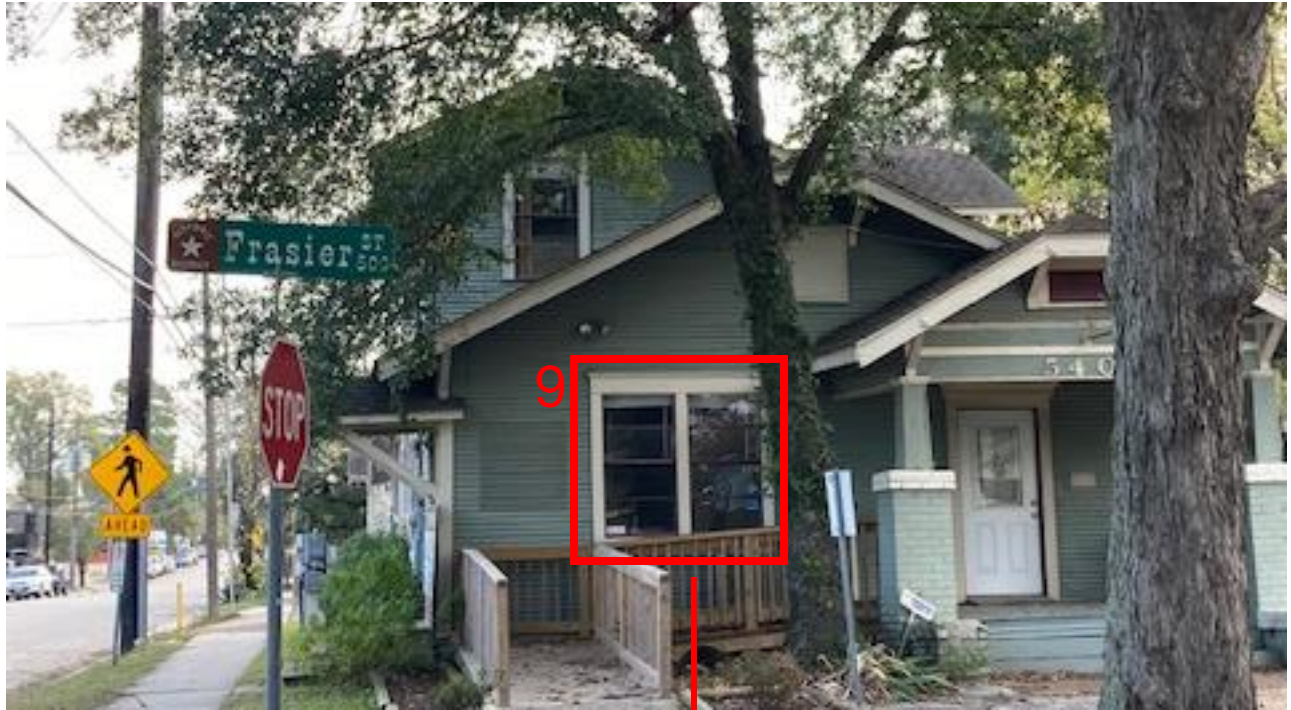
Front façade window replacement with vinyl

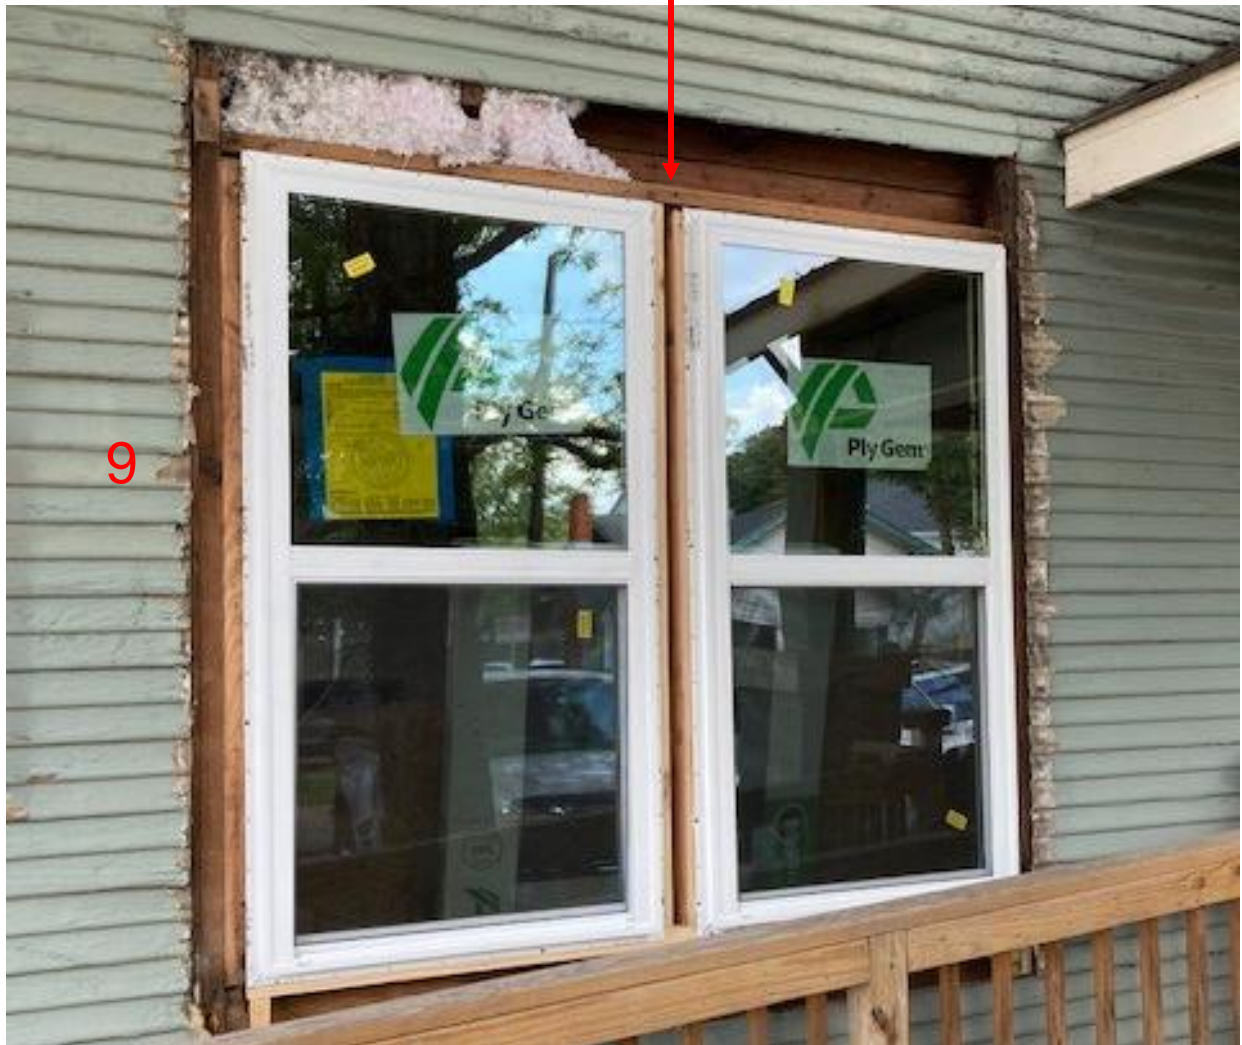
All windows replaced with vinyl windows

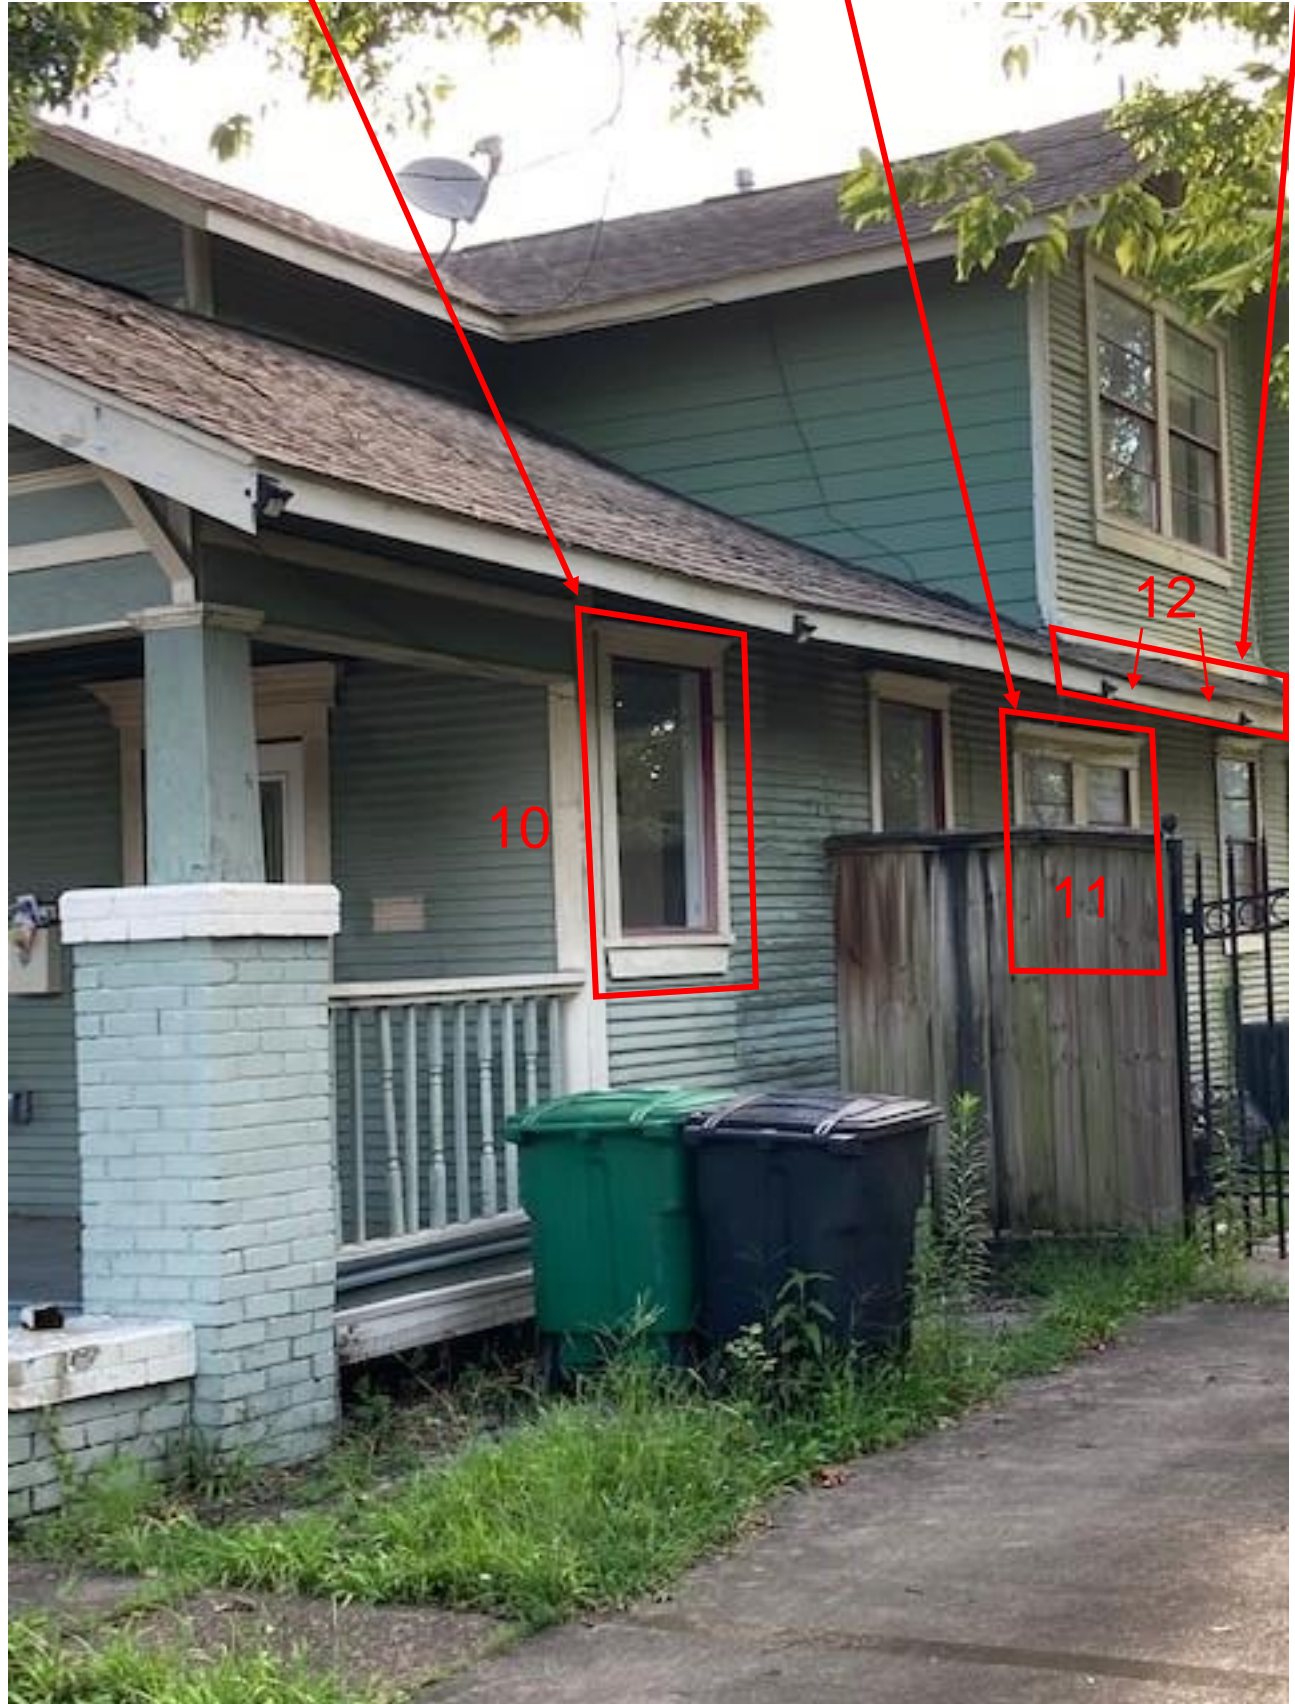
Side window removed and covered up and a window removed and replaced with a door opening. A portion of the eave removed

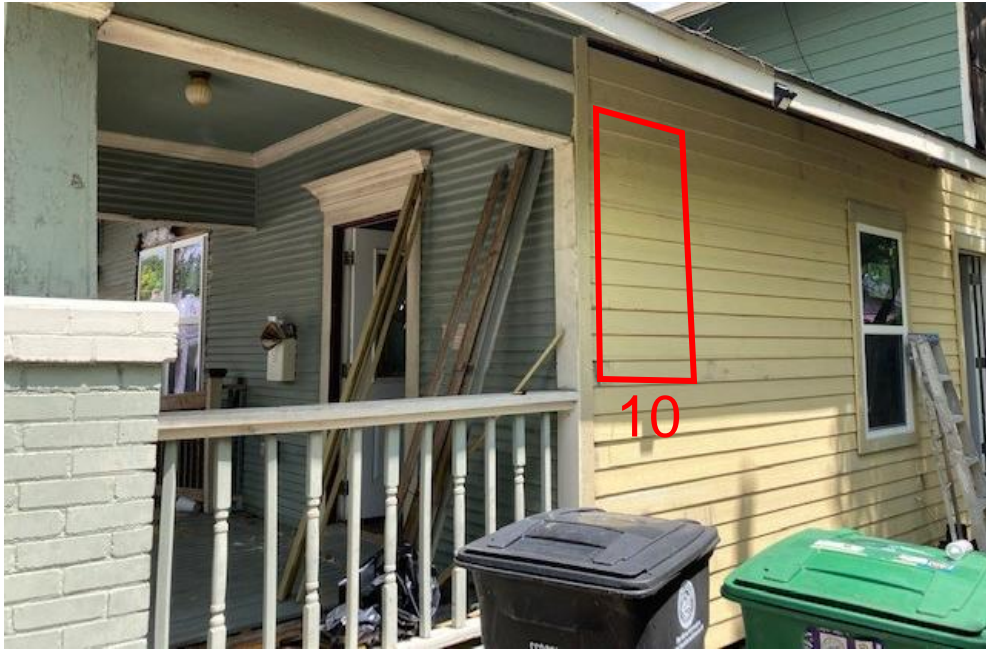
Side window removed and covered up.

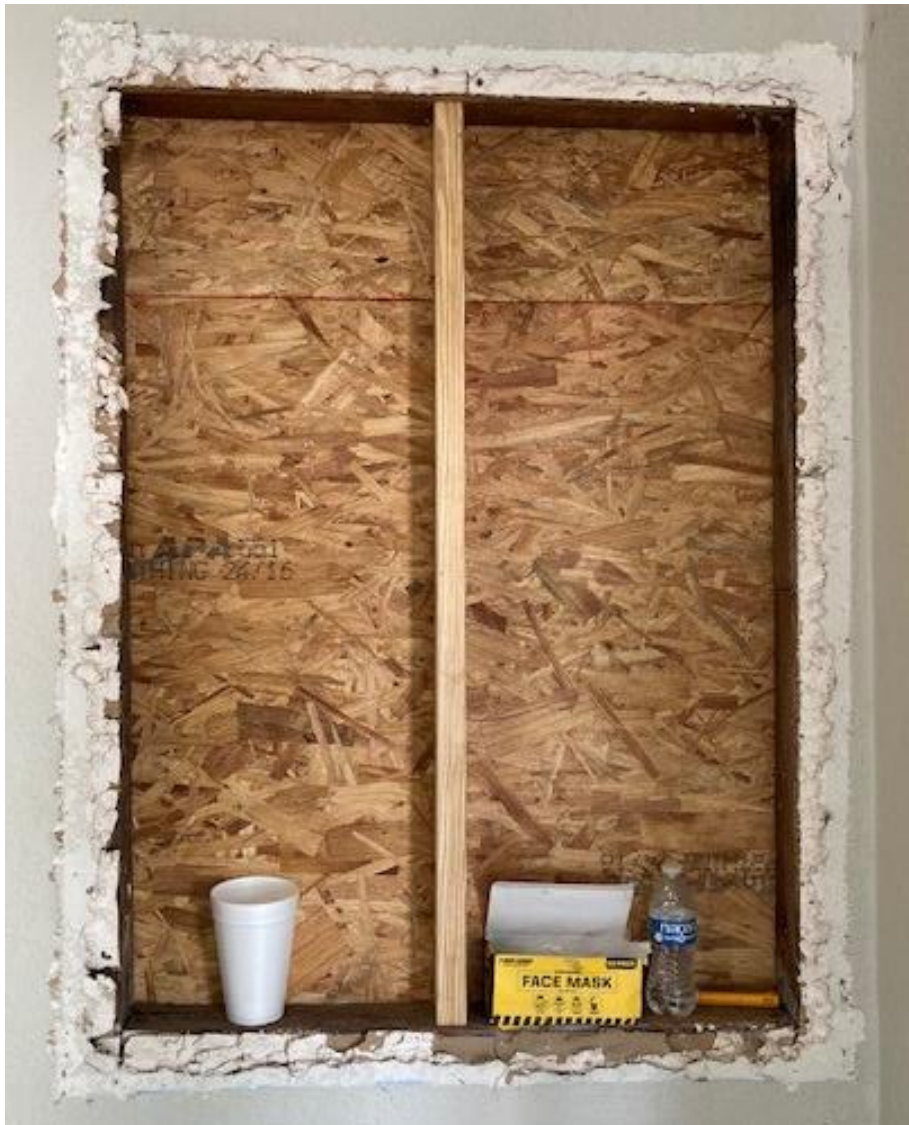
10

Interior shot of window covered up

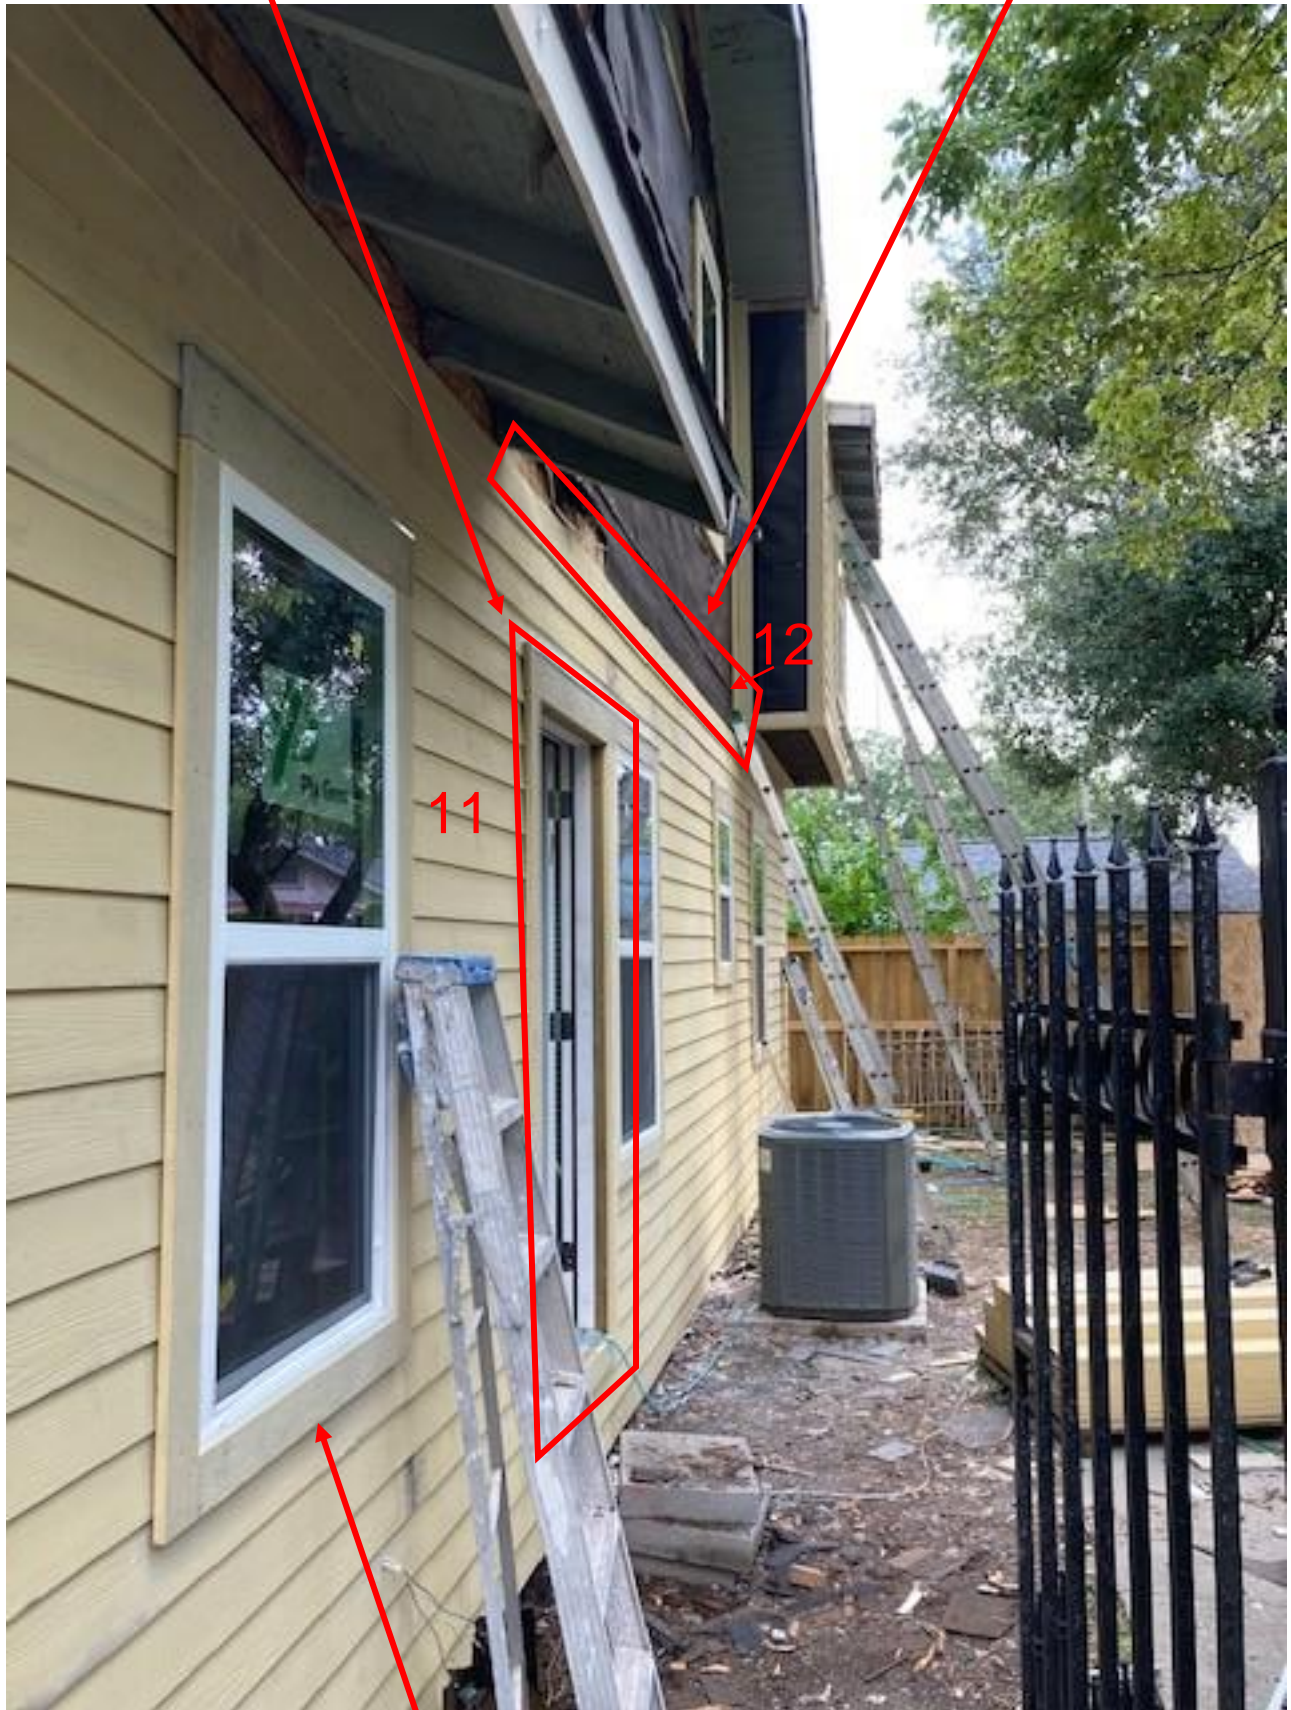
A window removed and replaced with a door opening. A portion of the eave removed.

Window profiles are not inset and recessed.

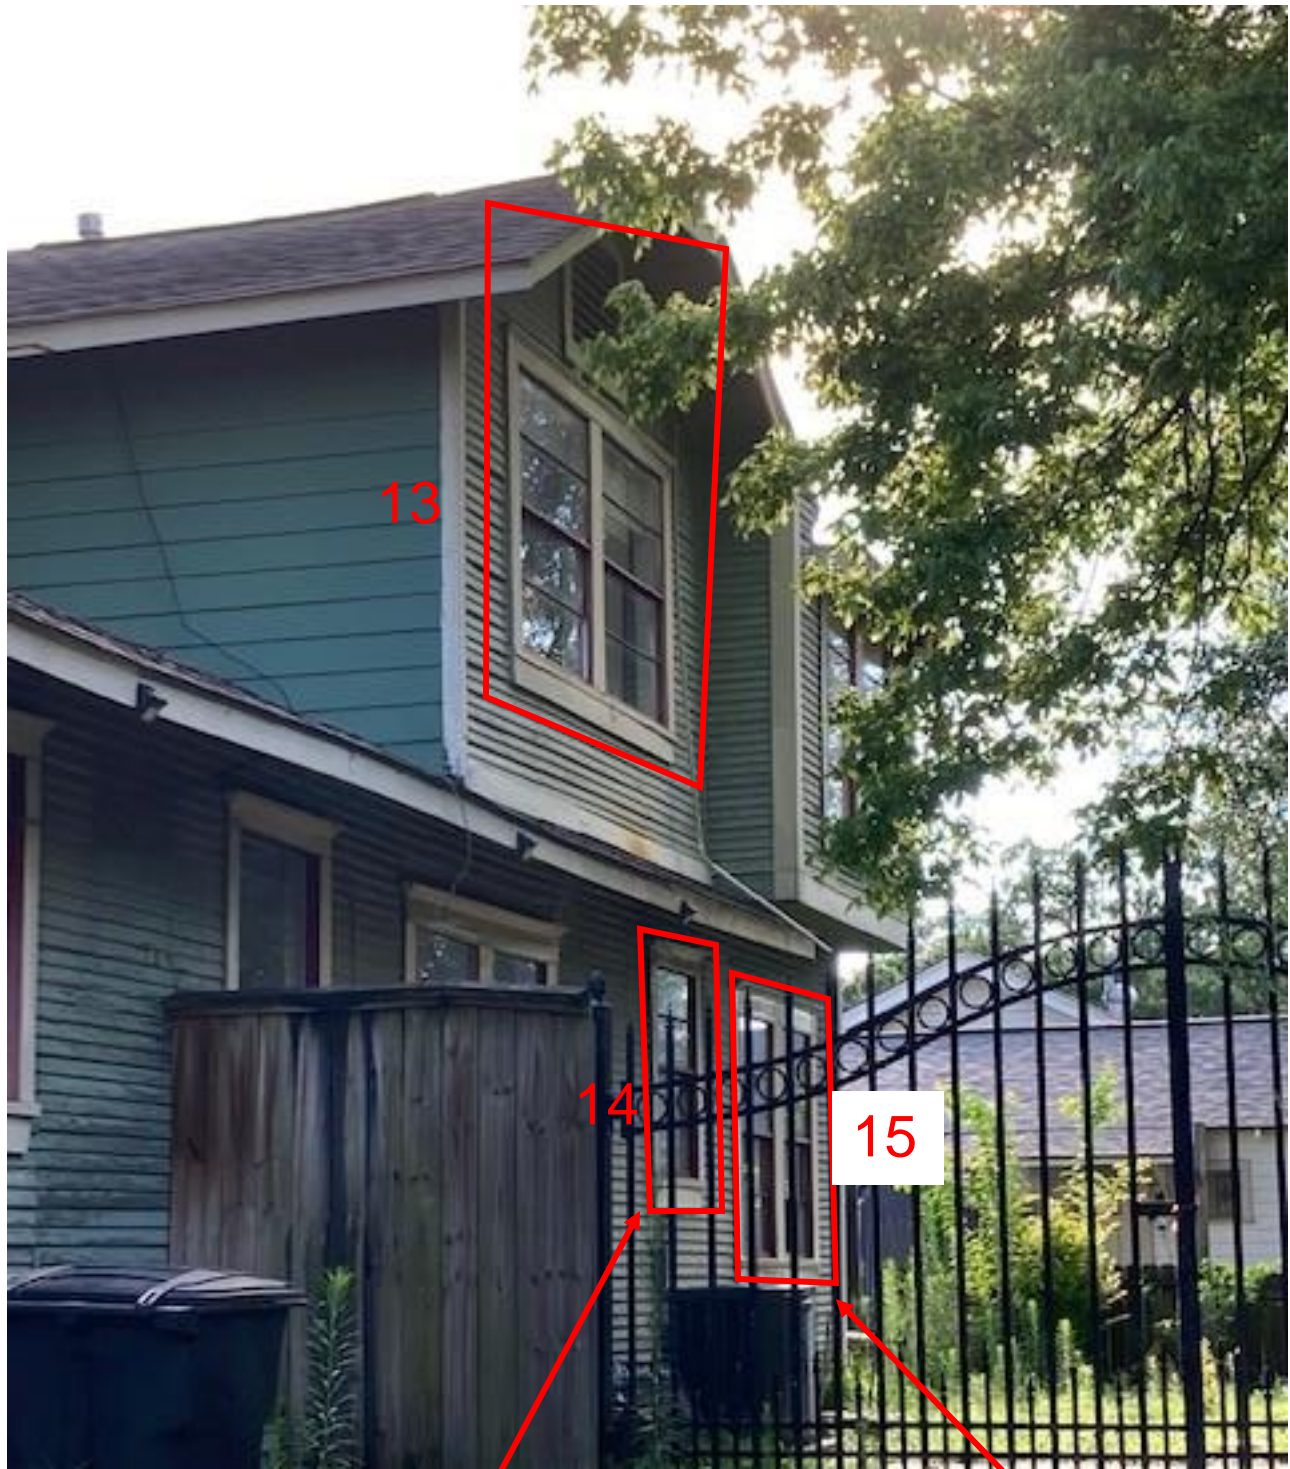
Upper-floor side-by-side windows altered to one window. Upper vent removed.

Lower-floor window reduced in size and side-by-side windows altered to one window.

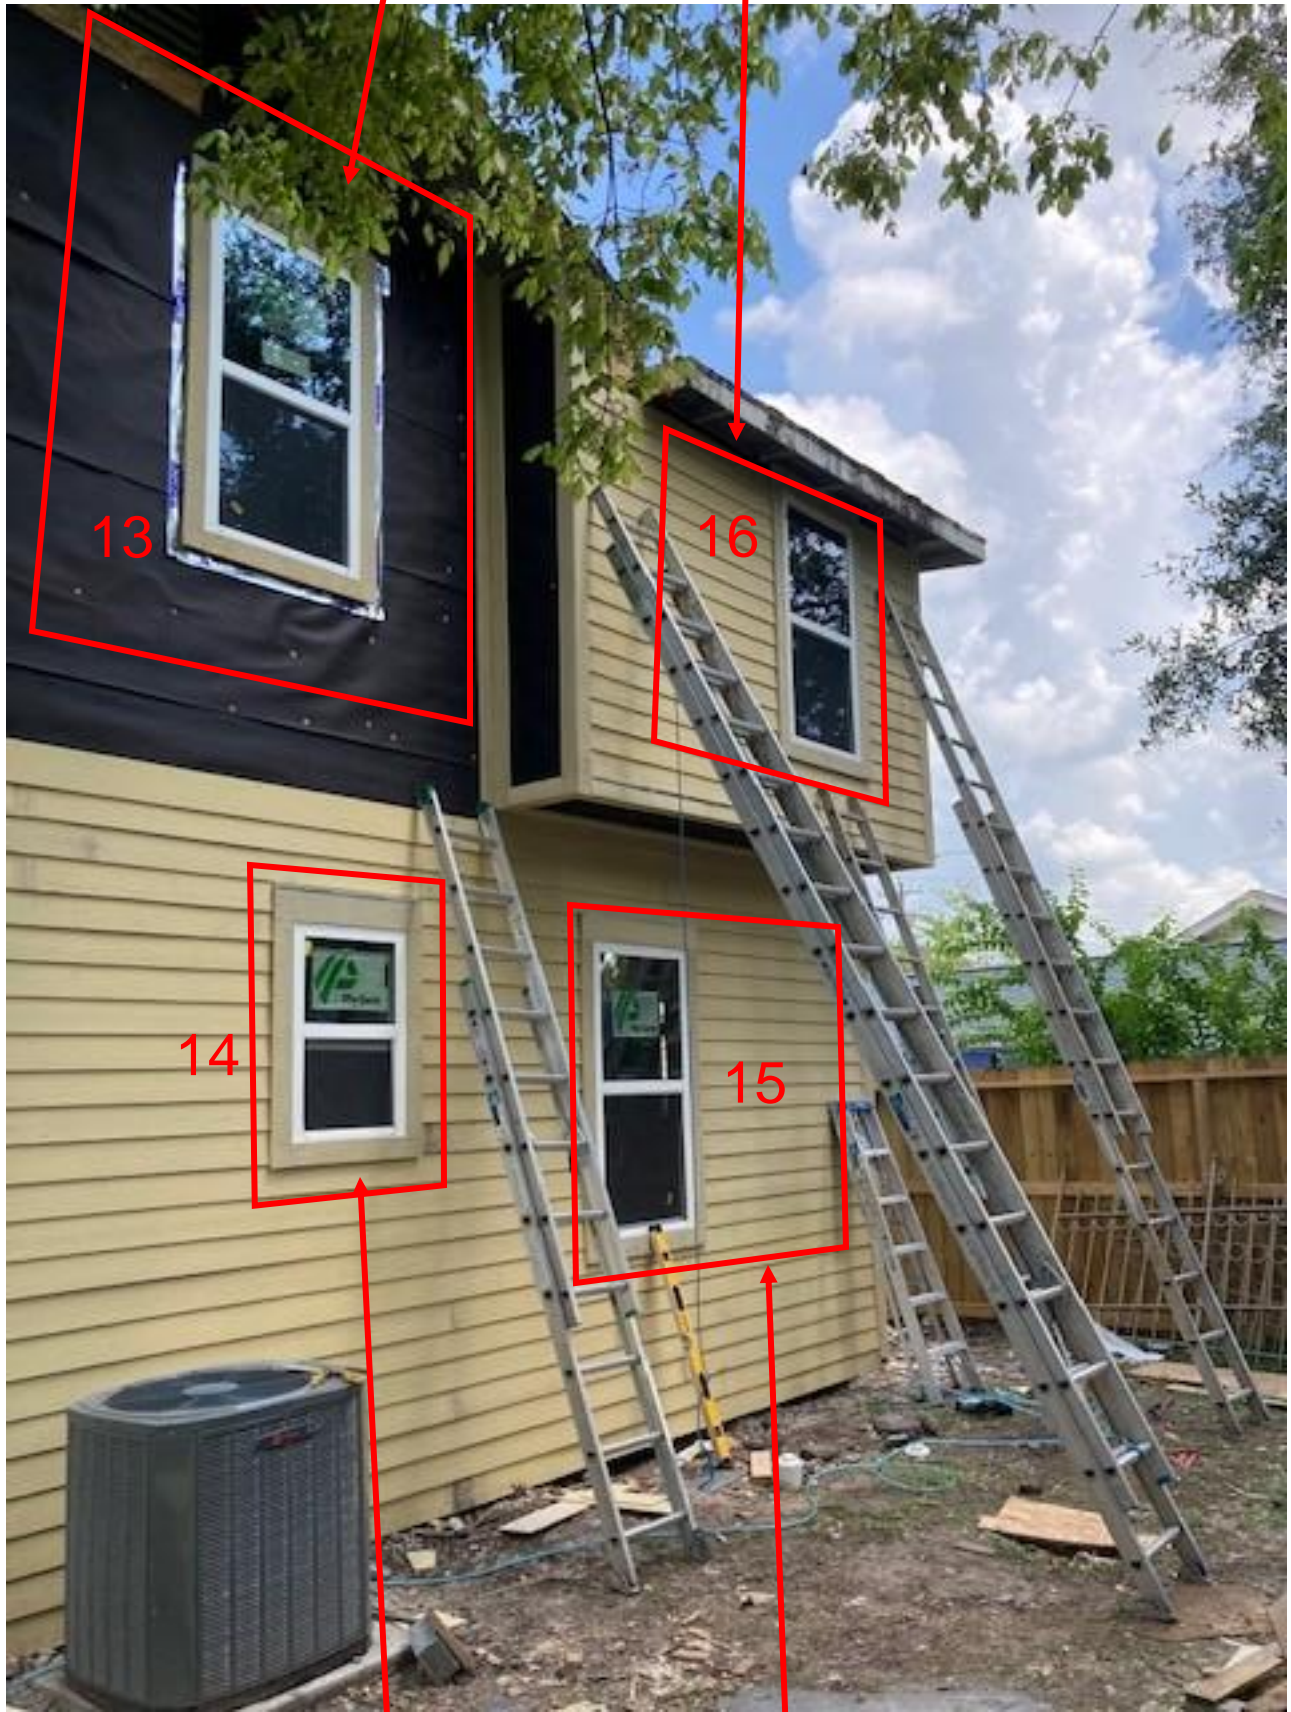
Upper-floor side-by-side windows altered to one window. Upper vent removed.

Lower-floor window reduced in size and side-by-side windows altered to one window.
