CERTIFICATE OF APPROPRIATENESS

ITEM D20
HPO File #: HP2026_0057

525 Teetshorn
Woodland Heights

Proposal: Alteration – Siding and Windows

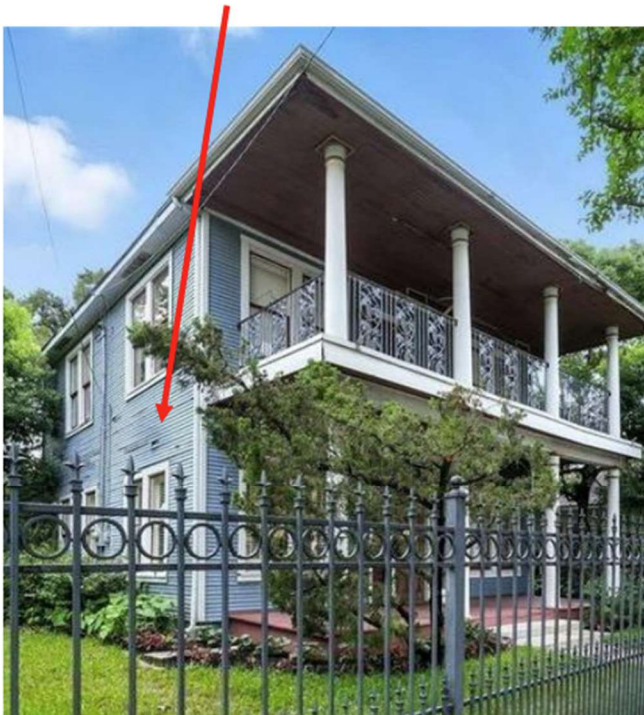
Siding Repair:

- Multiple areas on West facing side of home; some areas on East facing side as well
- Only material in damaged condition to be replaced
- Material in good condition will be left in place
- Anticipate ~30-40% of surface area repairs on east and west facing sides of home

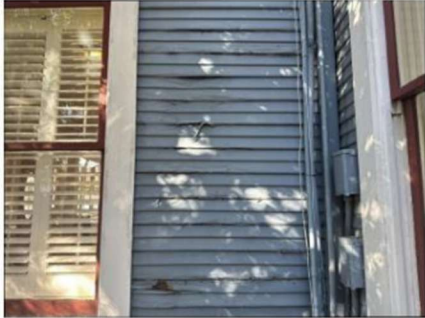
Large amount of wood rot observed around exterior of house

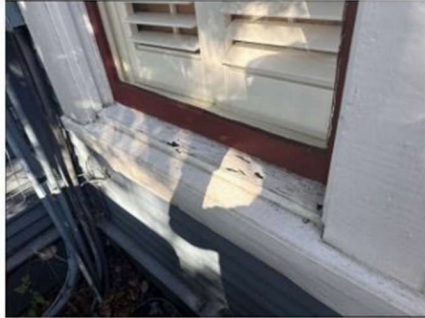
Large amount of wood rot observed around exterior of house

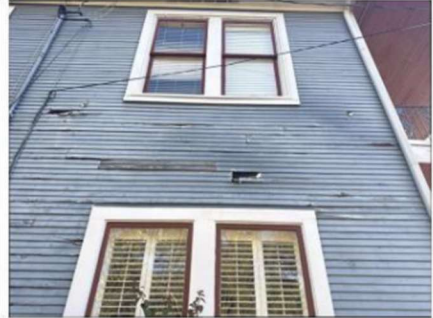
Large amount of wood rot observed around exterior of house

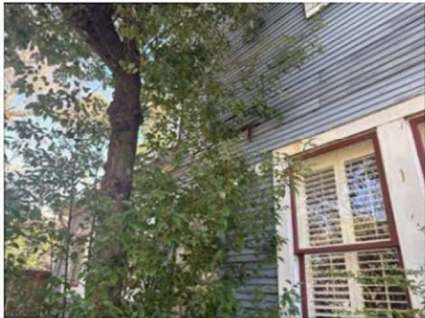
Heavy foliage touches the house

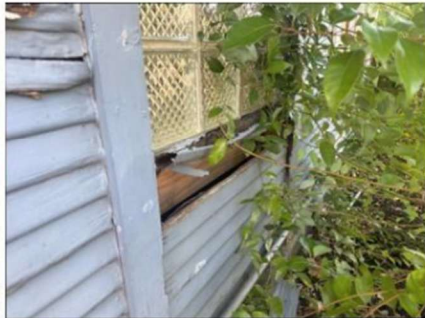
Damaged/missing siding

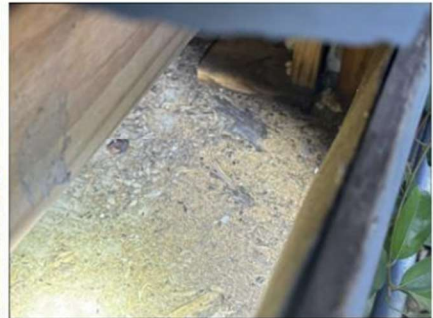
Evidence of Drywood termite activity below glass block window/stair landing

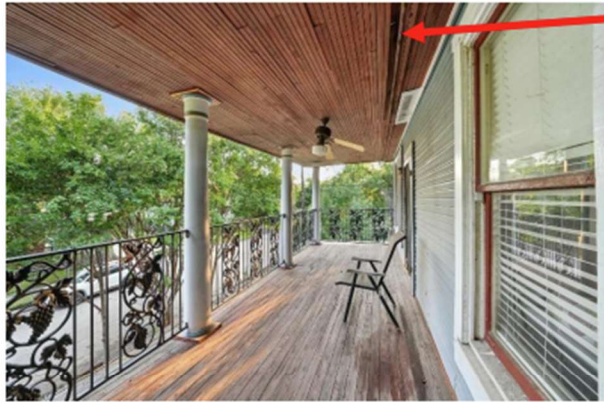
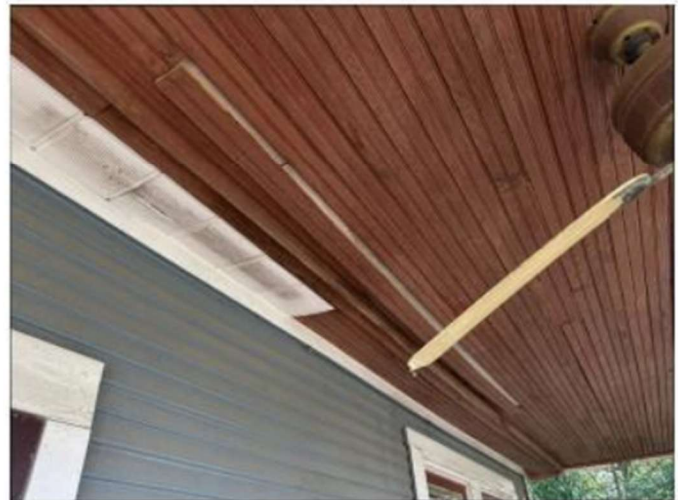
Loose ceiling material observed on the balcony

- Front porch repairs to relevel and reconstruct locations with damage due to wood rot, moisture and termite activity
- Replacement of cylinder pillar covers to square/rectangular pillars, consistent with architecture seen around the neighborhood.

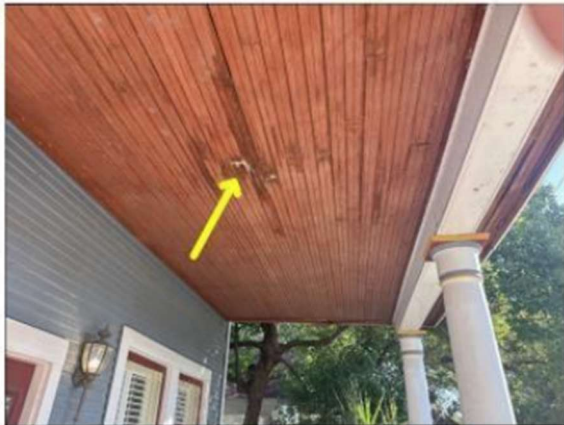
Water stains, observed below balcony

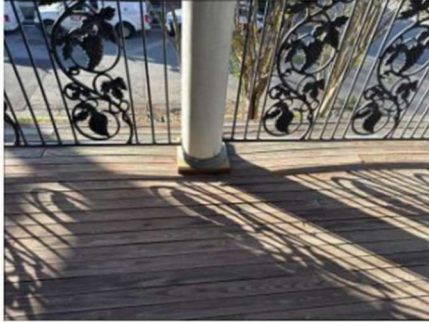
Balcony decking material is dilapidated

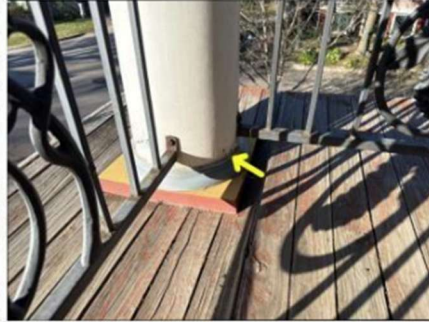
Base of column/post is deteriorated

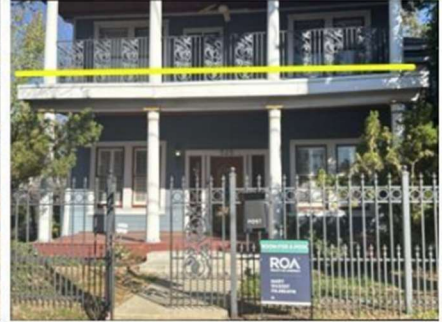
Balcony has significant sagging recommend further investigation/repair as needed
