# CERTIFICATE OF APPROPRIATENESS

**Property:** 3605 Del Monte Drive, Lot 9, Block 76, River Oaks Section 9 Subdivision. The property includes a historic 4,593 square foot, two-story wood frame single-family residence and attached garage situated on a 19,980 square foot (120' x 180') interior lot., Outside Historic District

**Proposal:** Alteration – Replace Windows

Certificate of Appropriateness Application: Window Replacement

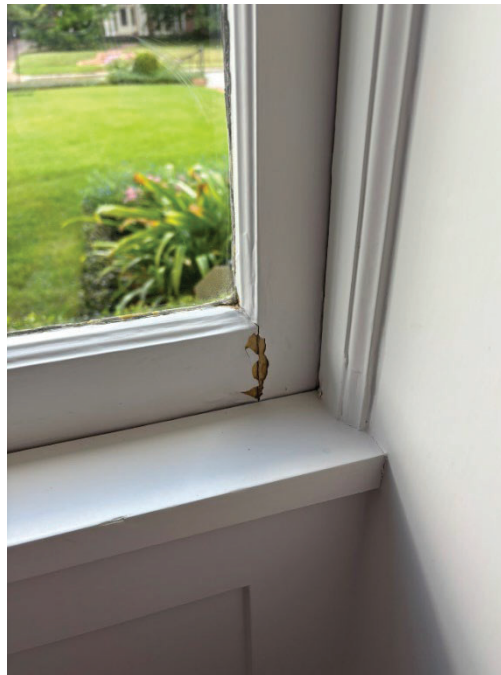
*Living Room window (EX02) – moisture damage at interior sash*

EX01	Moisture damage at interior sash, rot at exterior panel bottom
EX02	Moisture damage at interior sash, rot at exterior panel bottom
EX03	Rot at exterior panel bottom
EX04	Rot at exterior panel bottom

The owners would like to replace the existing windows on the front and side elevations with new windows to match the original sizes, lite configurations, profiles, and muntin patterns. The proposed new windows are custom units produced locally by MRJ (see the attached proposal for specifications); these will be painted wood and will visually match the original windows. The new windows will have insulated glass to address the long-term maintenance and moisture concerns.

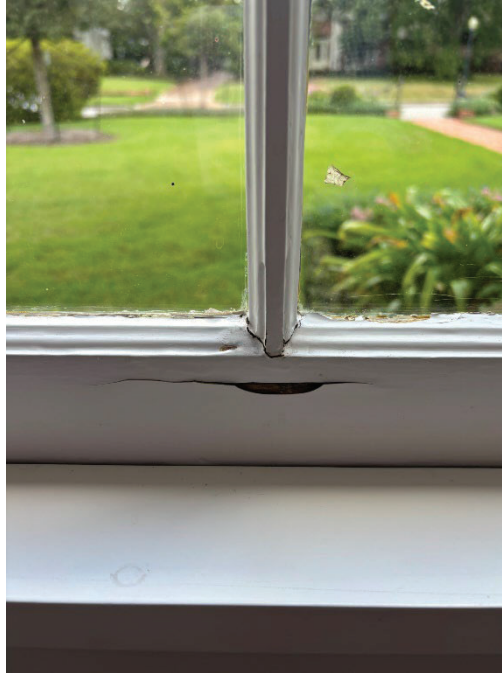
*Living Room window (EX02) – moisture damage at interior sash*

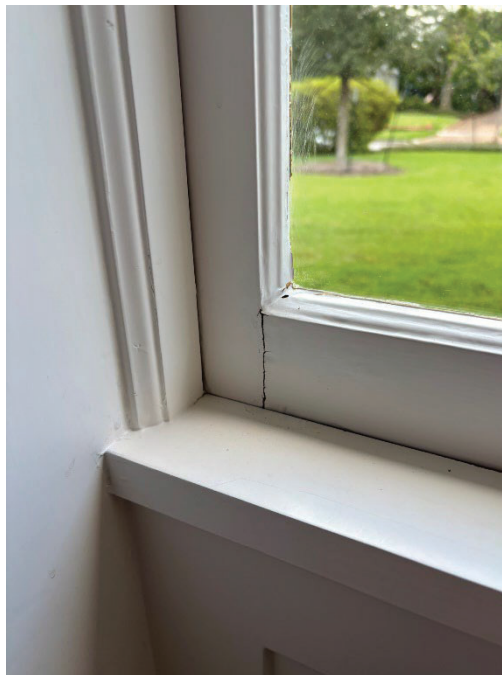
*Living Room window (EX01) – moisture damage at interior sash*

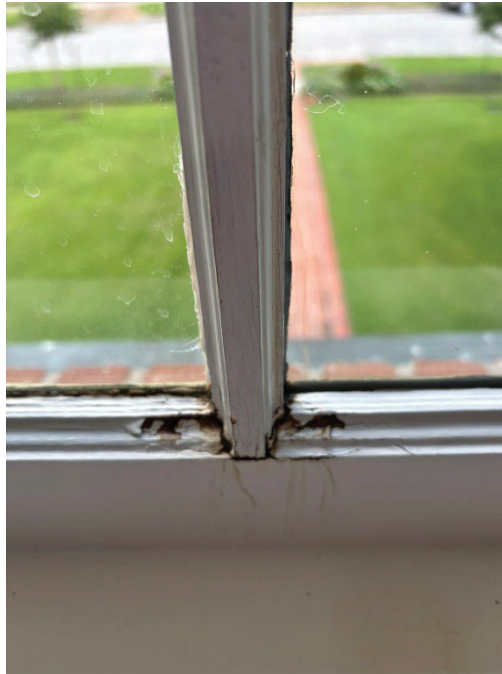
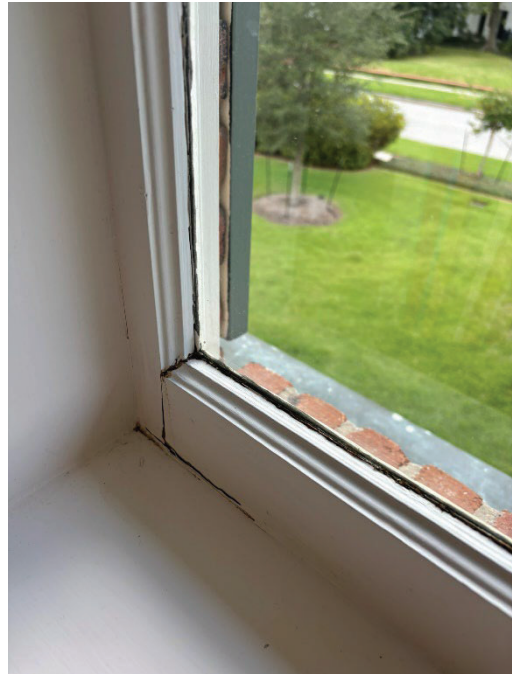
*Laundry window (EX20) – moisture damage and wood rot from leaking at interior sash*

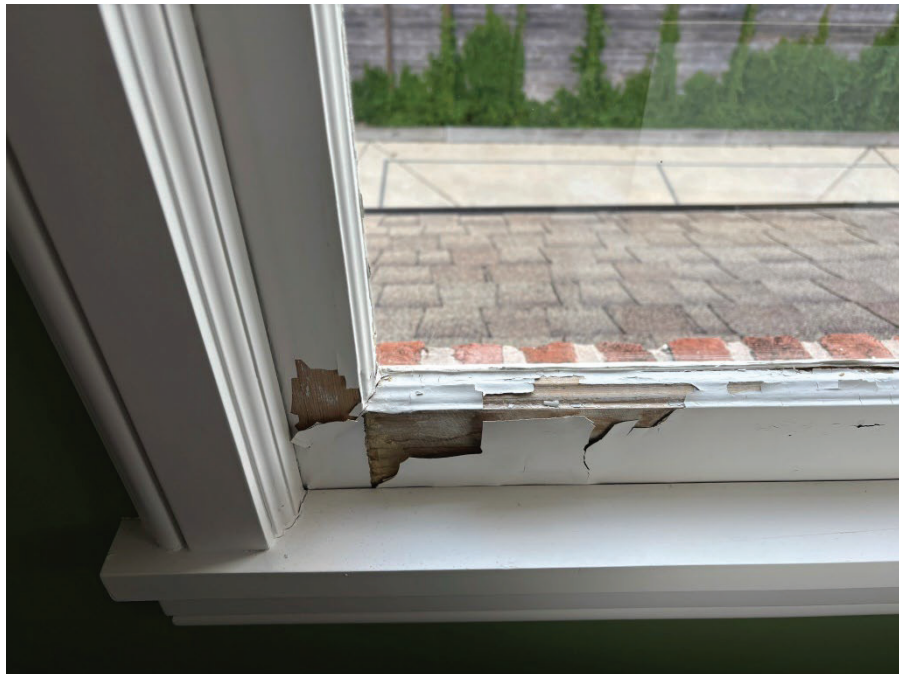
*Bedroom window (EX23) – moisture damage from leaking at interior sash*

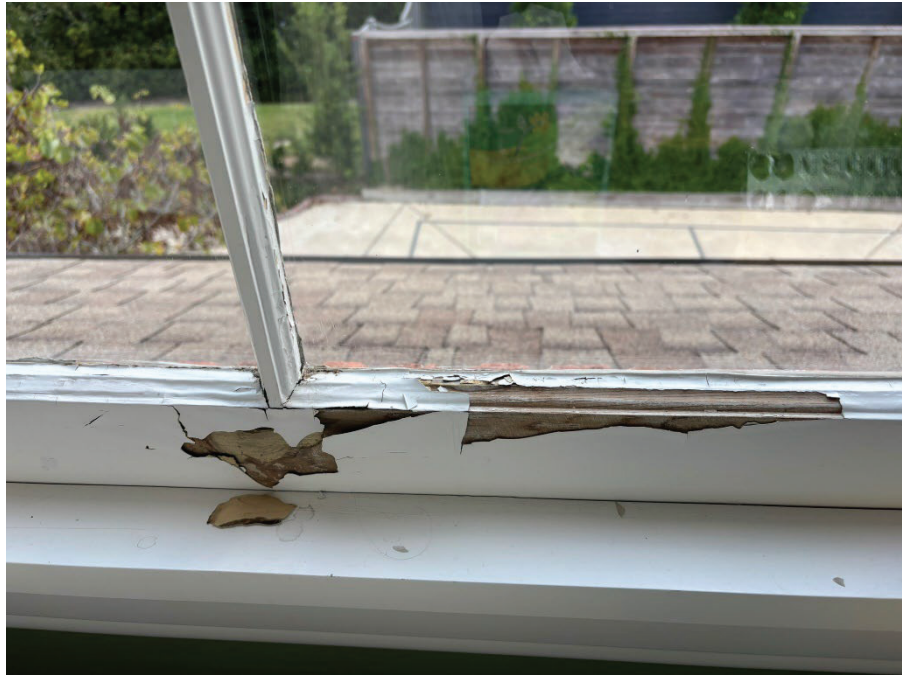
*Bedroom window (EX23) – moisture damage from leaking at interior sash*

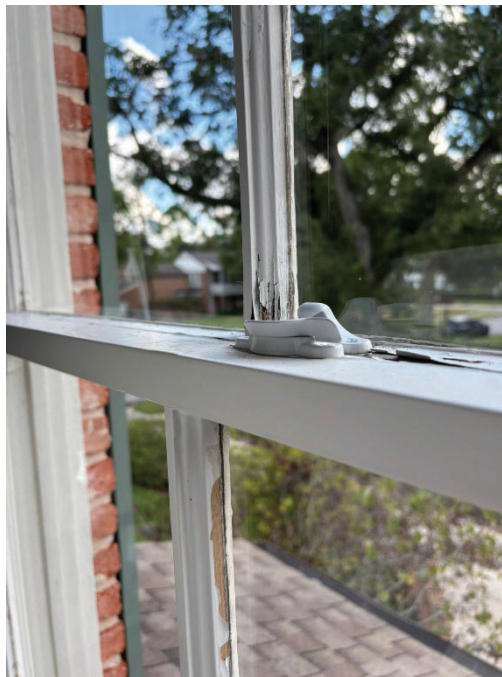
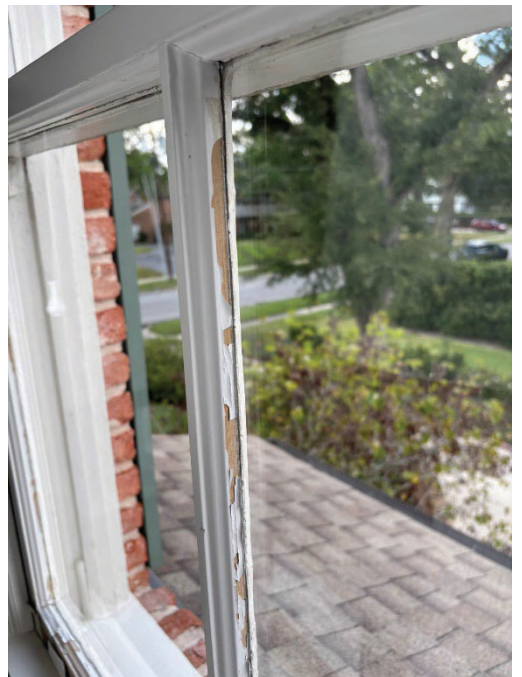
*Bedroom window (EX23) – moisture damage from leaking at interior sash*

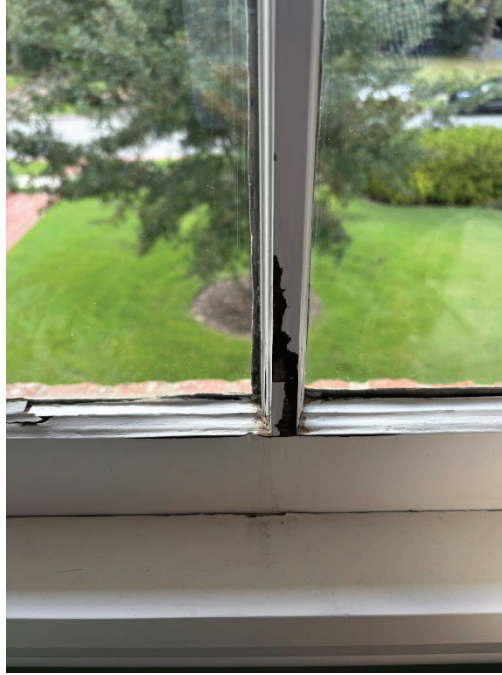
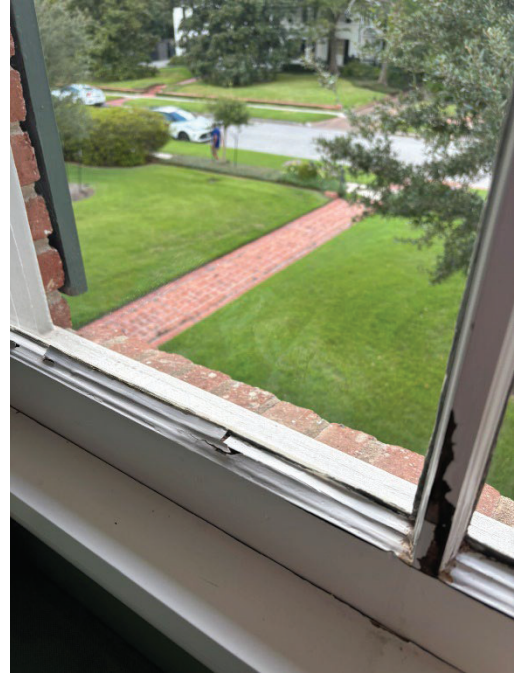
*Bedroom window (EX22) – moisture damage and wood rot at interior sash*
