**CERTIFICATE OF APPROPRIATENESS**

**Property:** 212 Bayland St, Tracts 14A & 15A, Block 3. Woodland Heights Subdivision. The property includes a two-story wood frame approximately 2,905 square foot single-family residence situated on a 6,500 sq. ft. corner lot.

**Significance:** Contributing Prairie house, constructed circa 1924, located in the Woodland Heights Historic District.

**Proposal:** Alteration- Addition, Doors, Windows

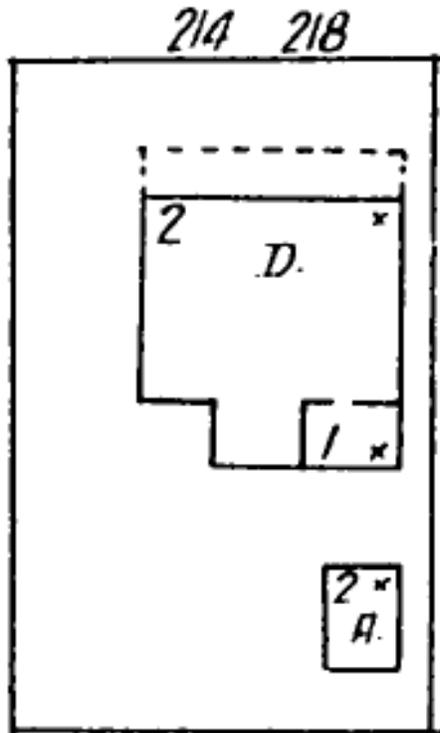
**SANBORN (1924-1950)**

On this Sanborn, the structure is labeled as 214/218, but it is the structure currently at 212. On the full view, it shows that it is the corner lot at Bayland and Beachamp.

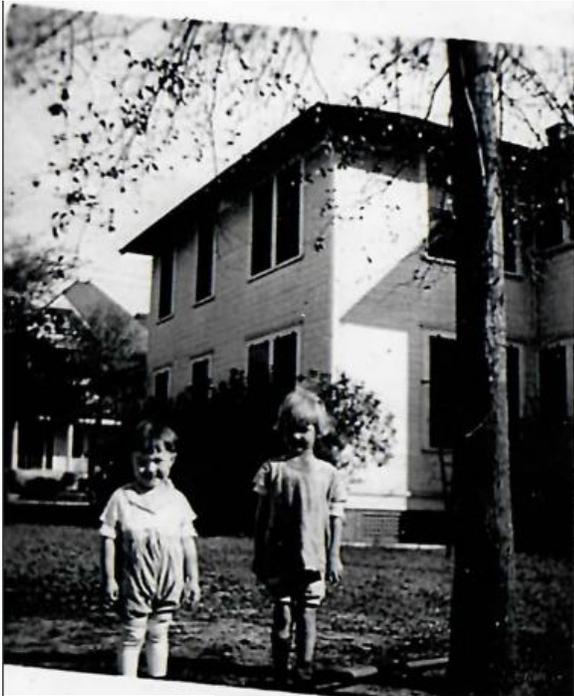
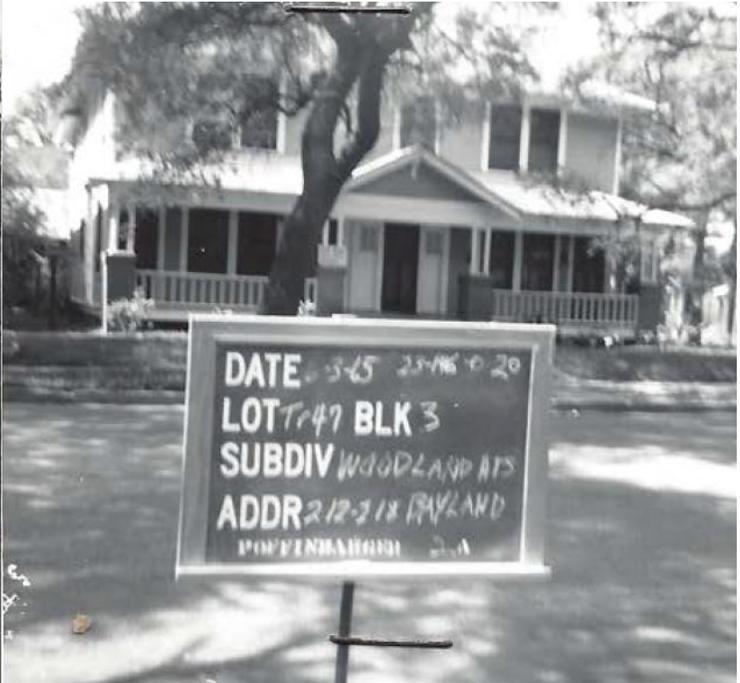
## HISTORIC IMAGES

The top left image is from the 1920s, provided by the applicant. This is the west elevation taken from the rear of the home that demonstrates that there was a later addition to fill in that corner as confirmed by the sanborn. The proposed added windows lie almost entirely in the non-original addition.

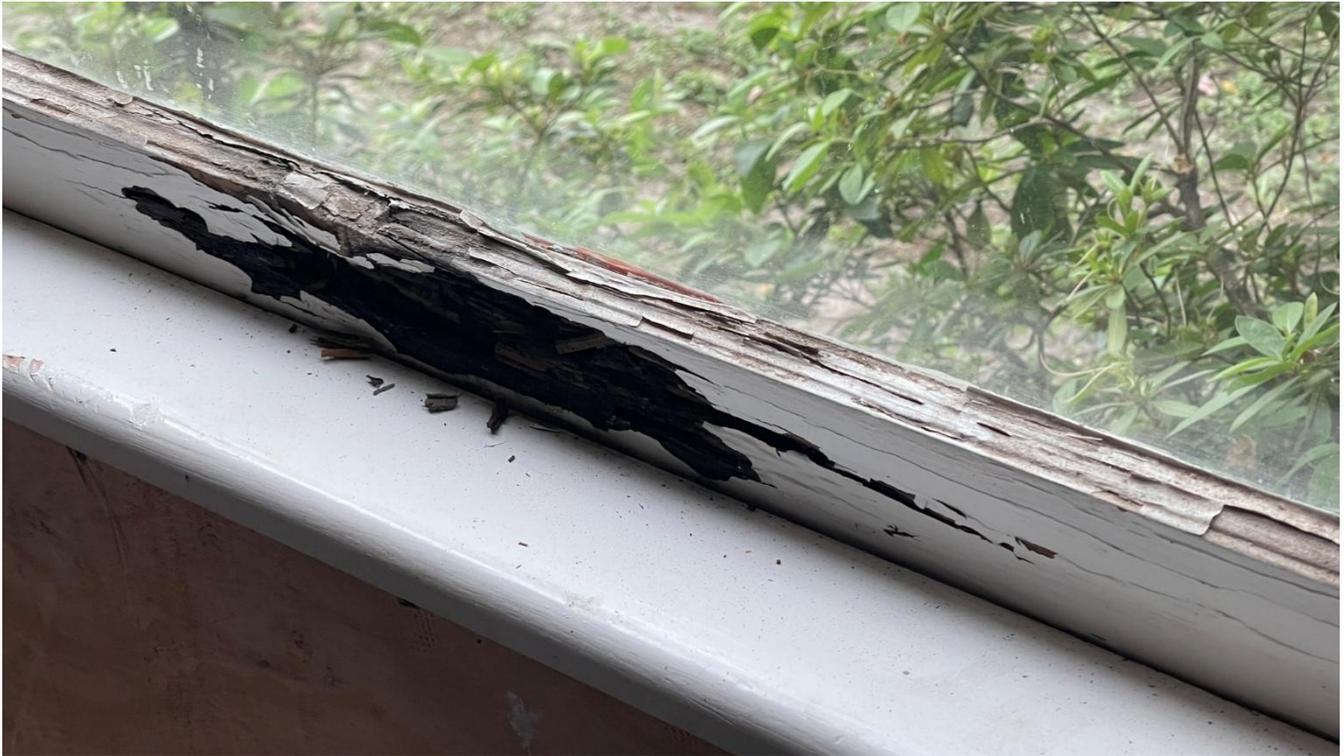
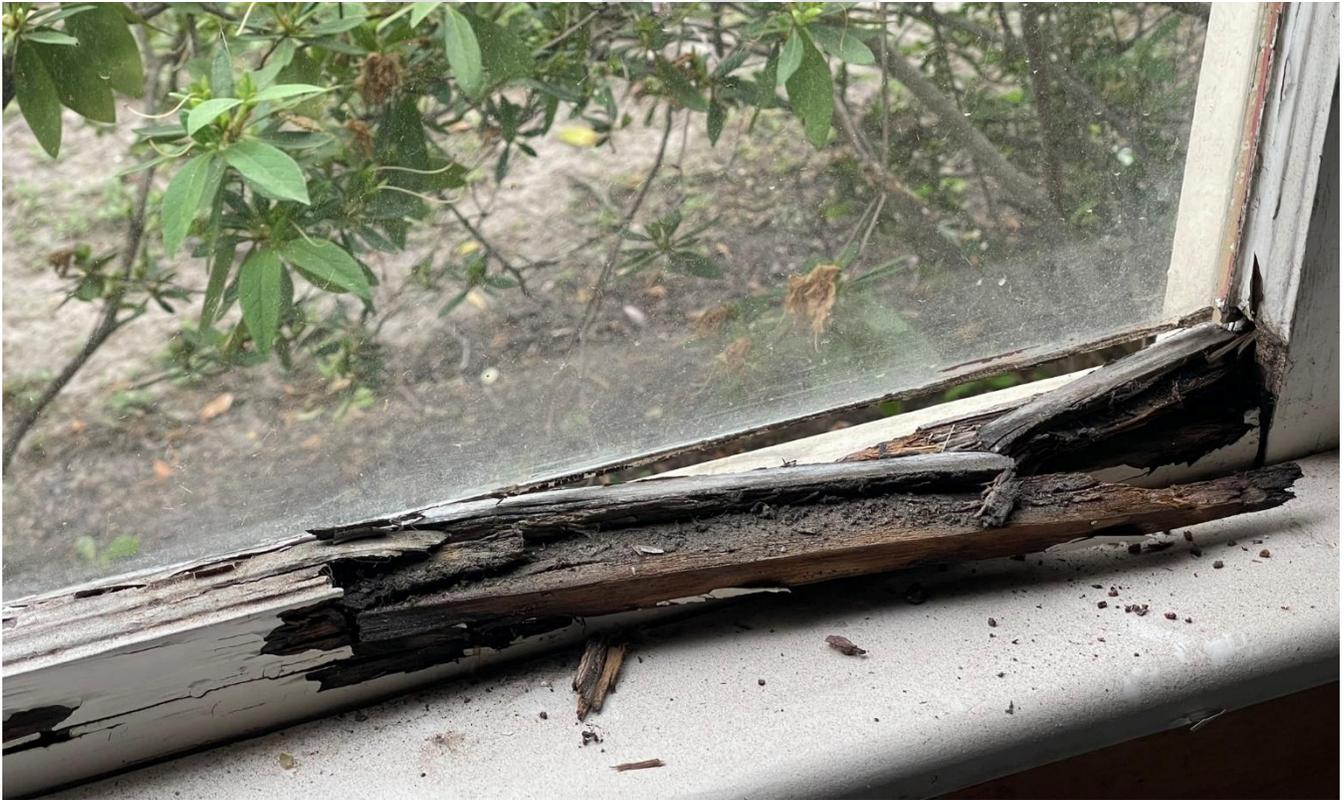
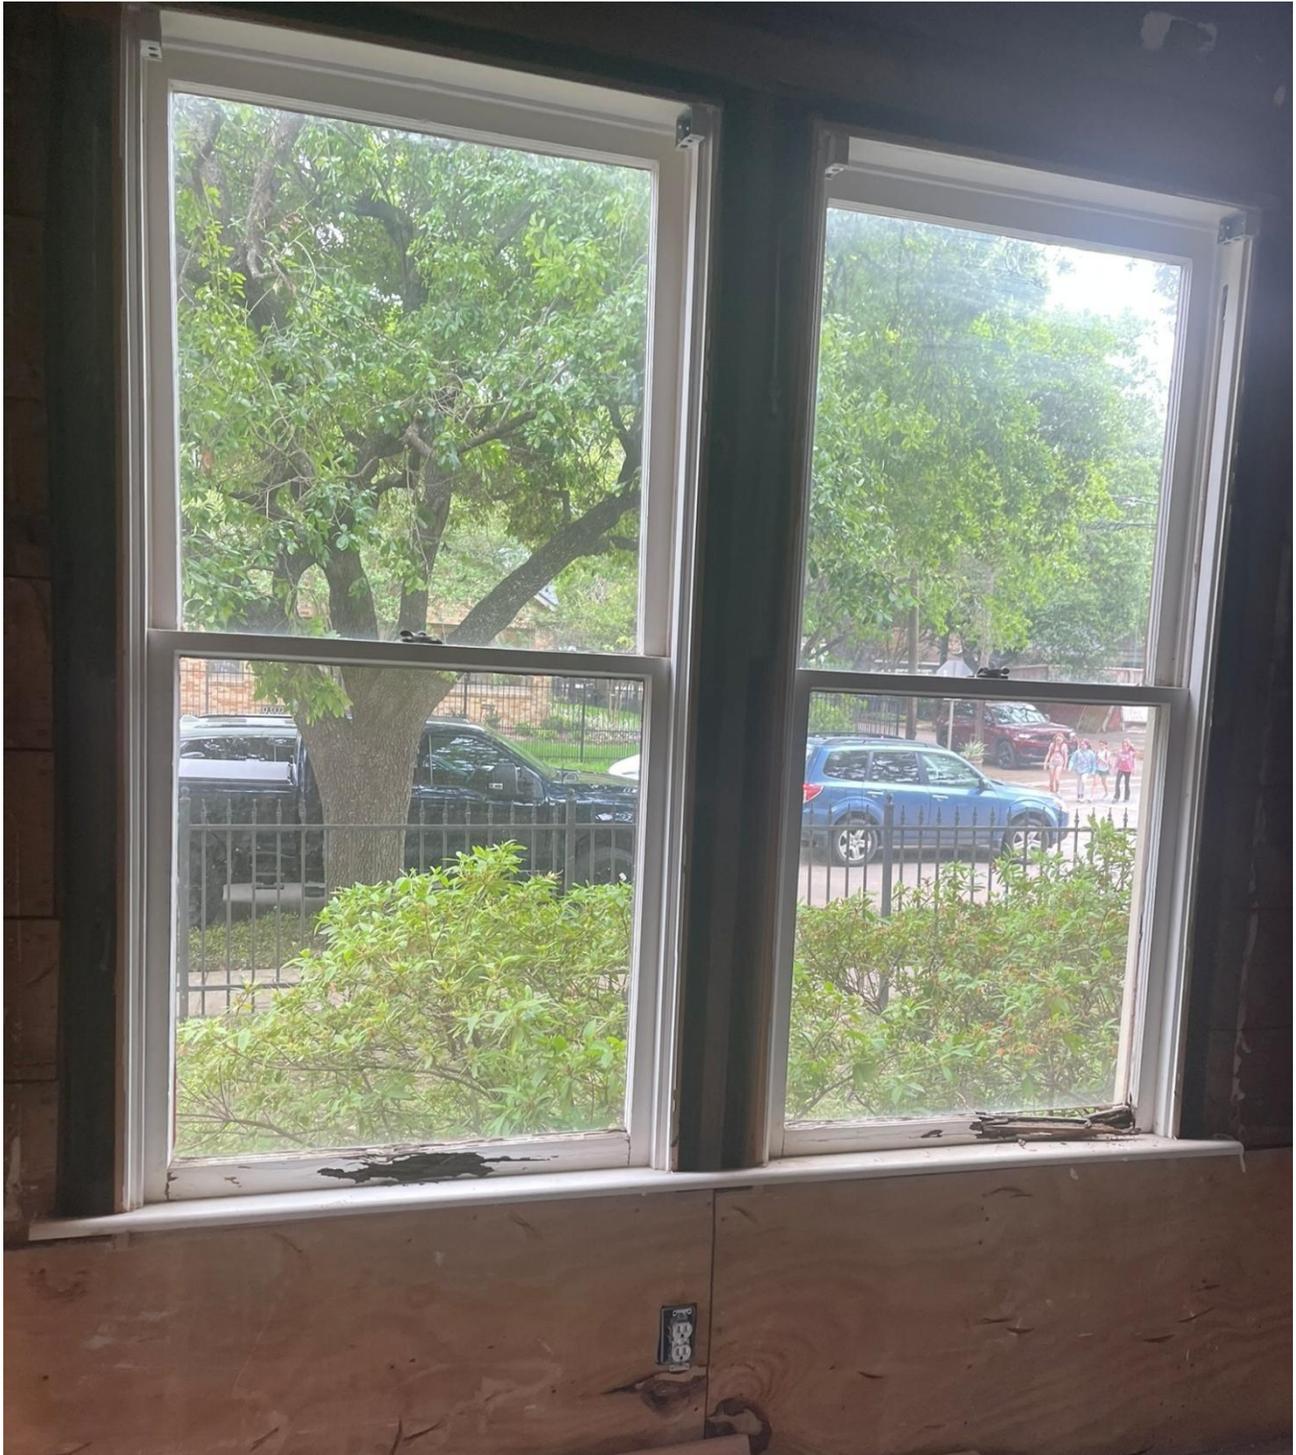
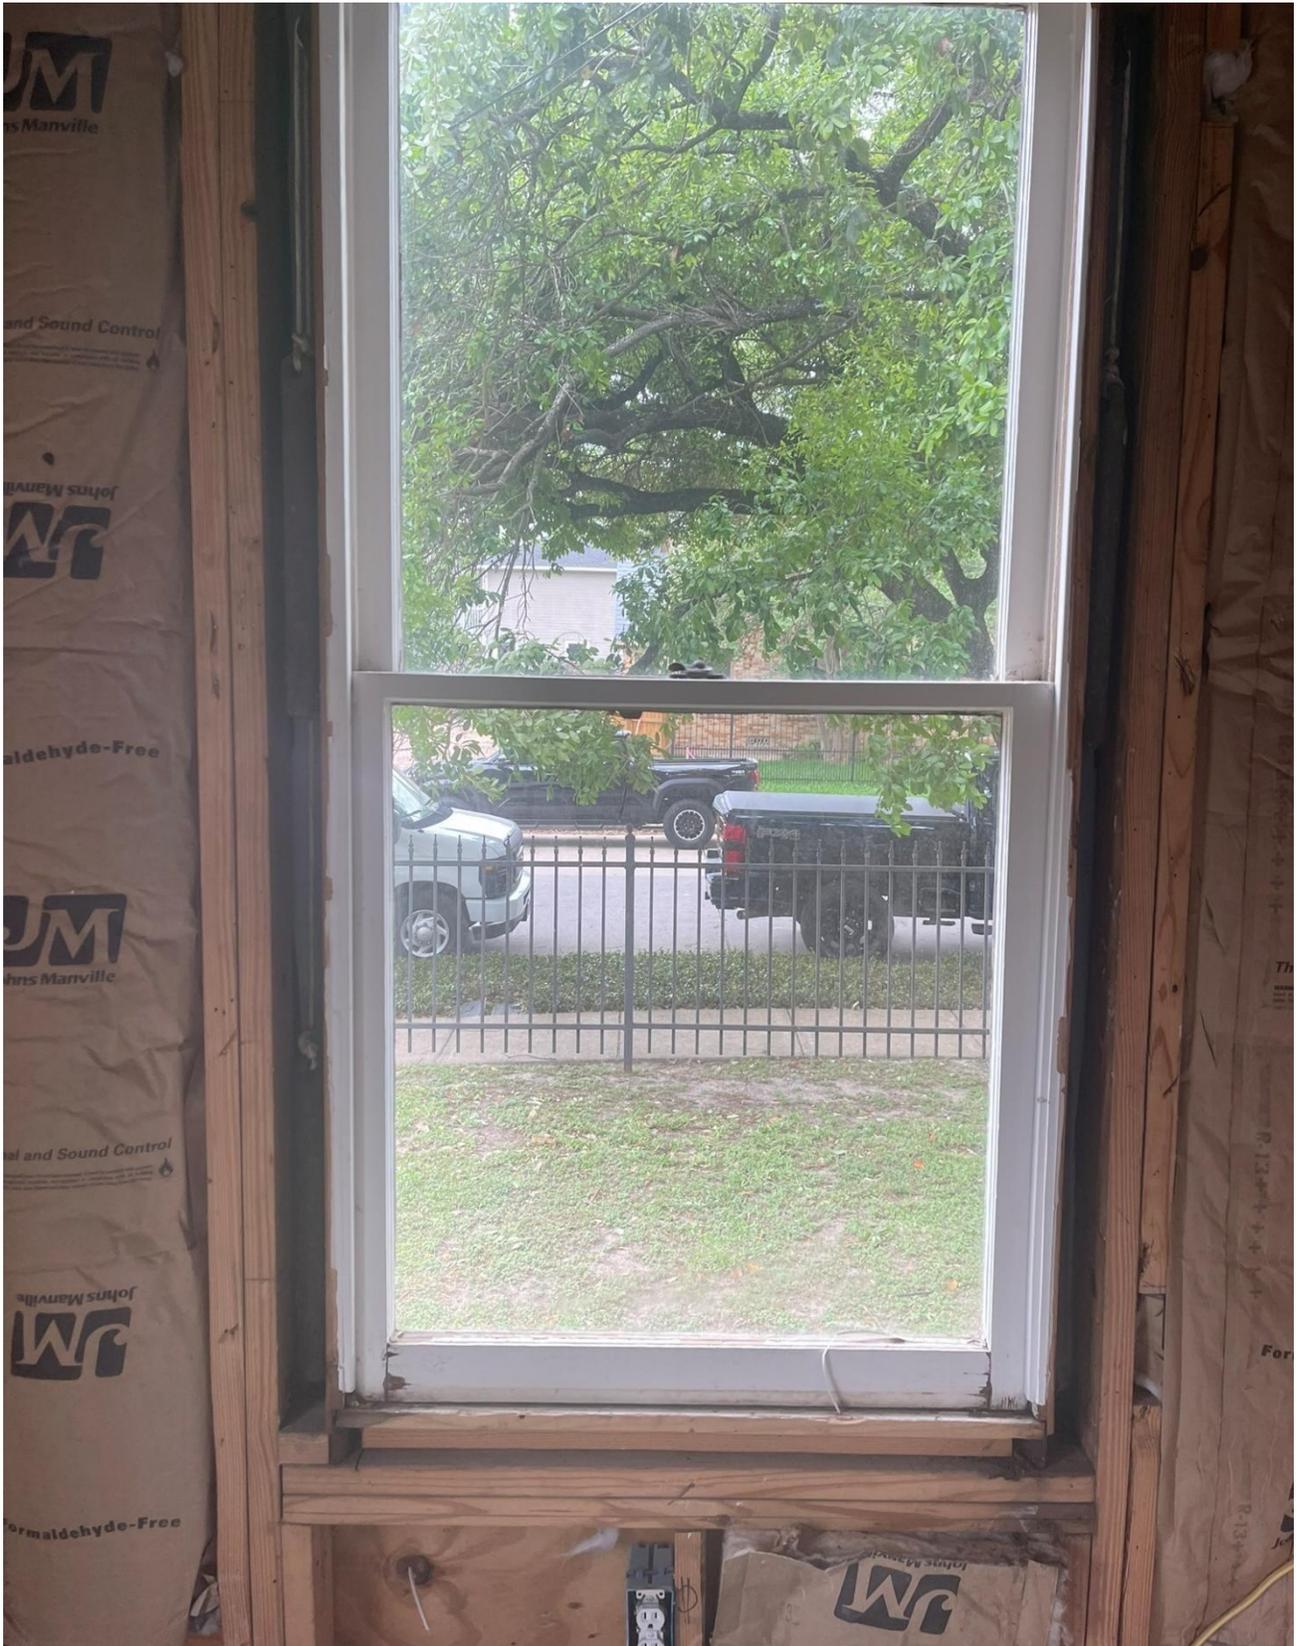
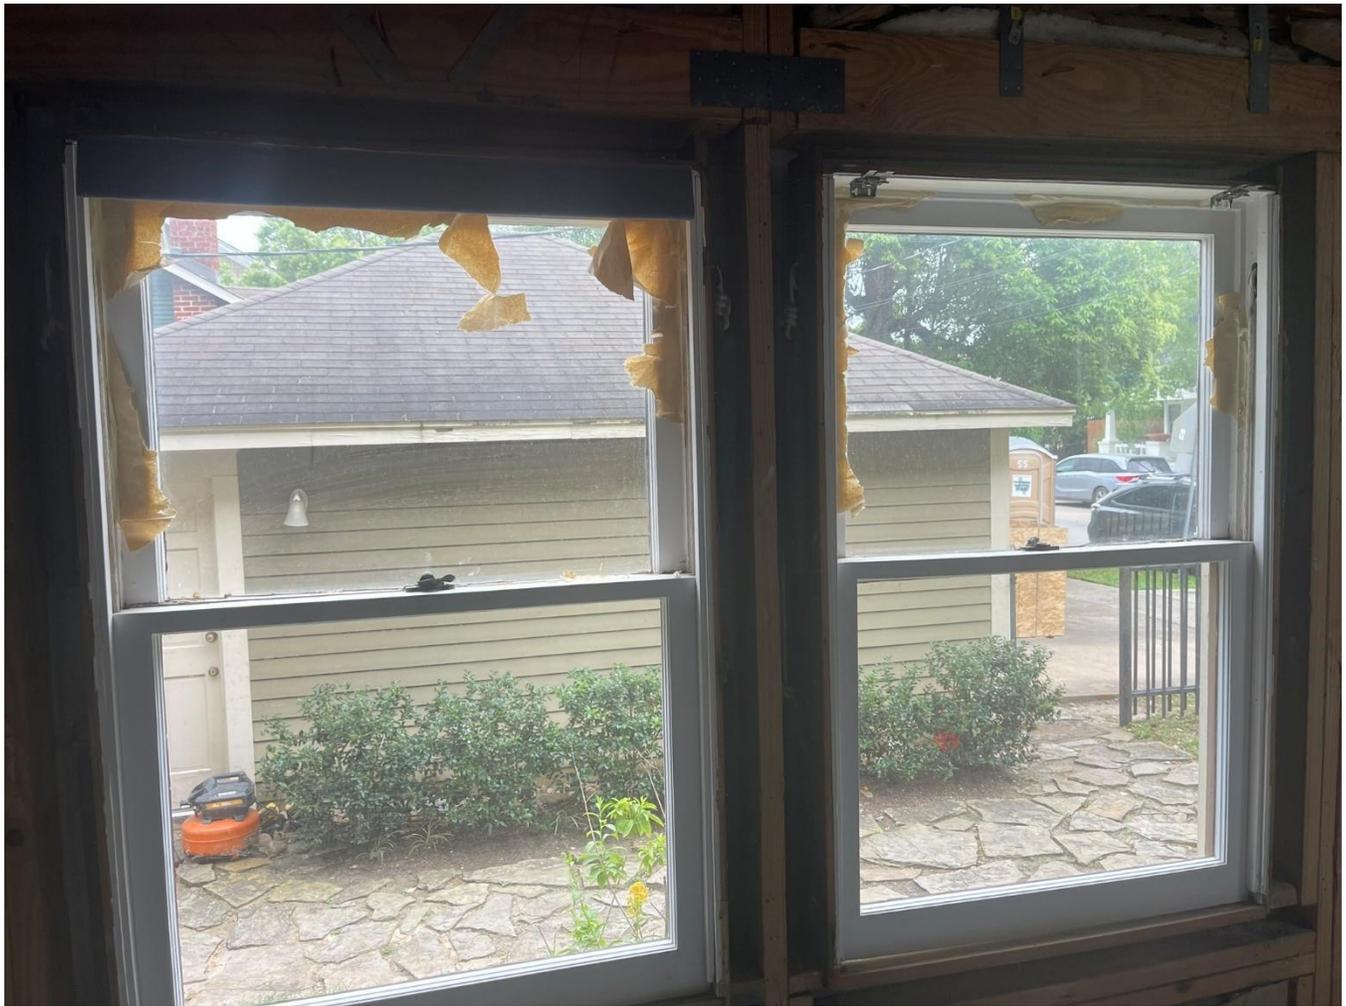
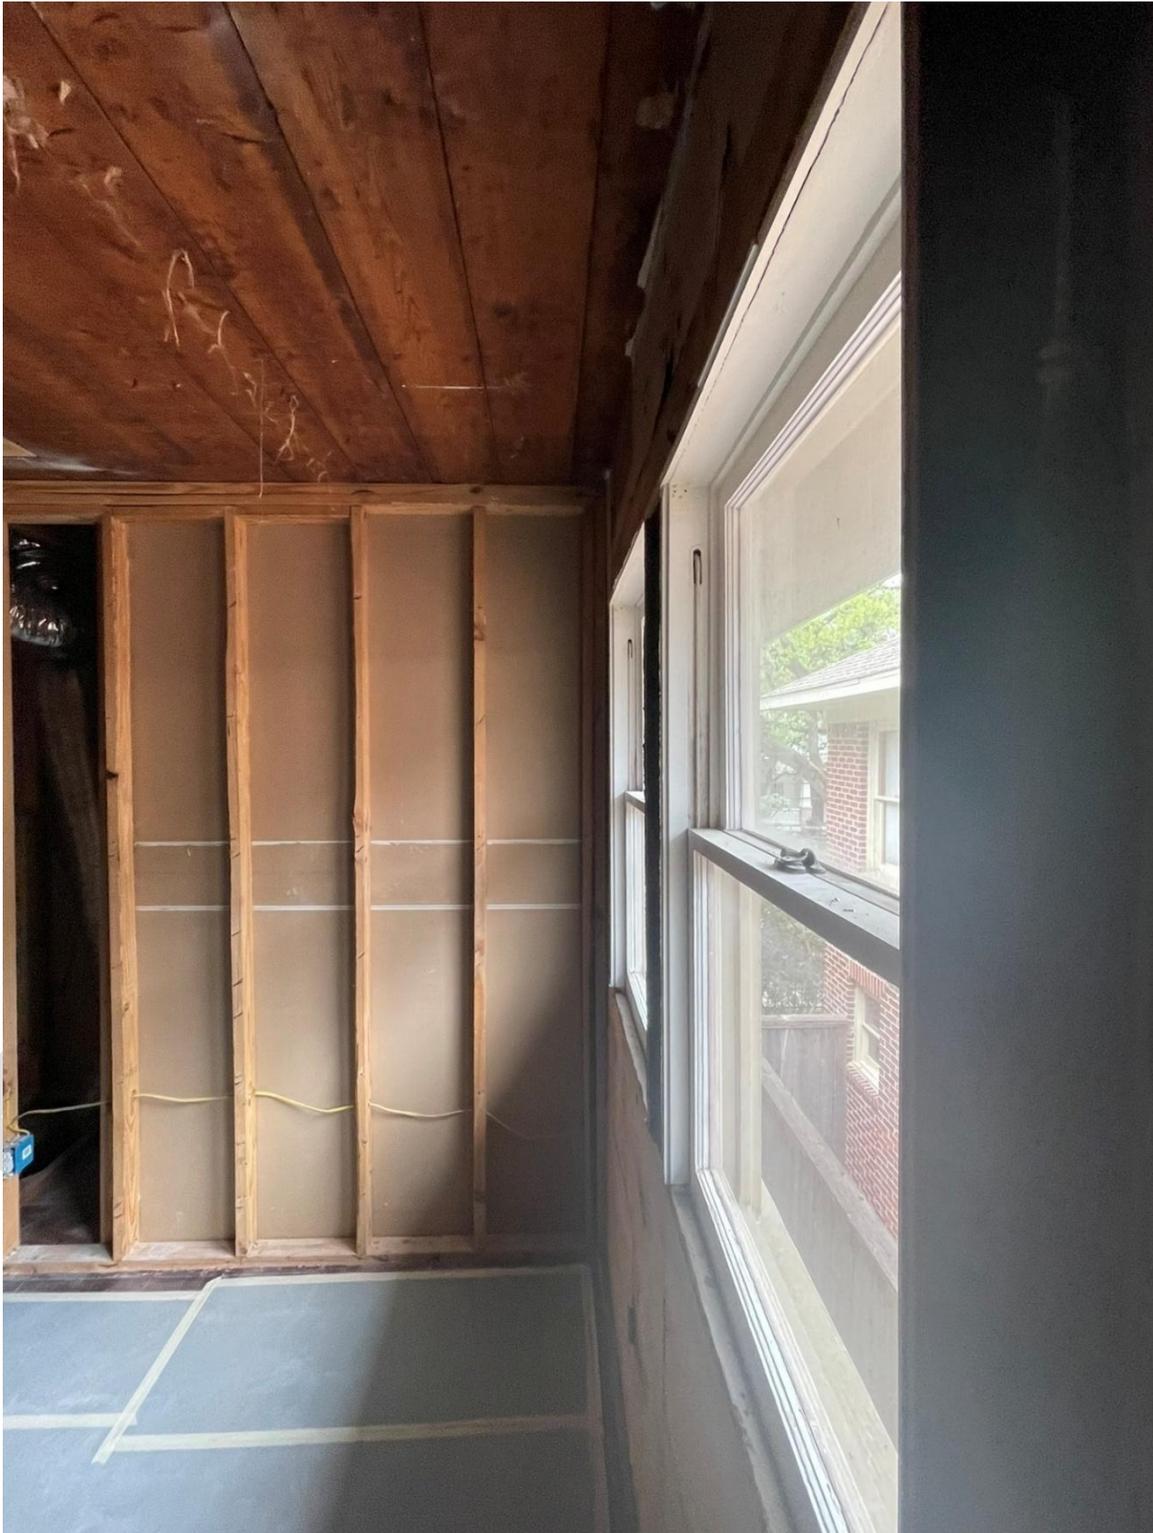
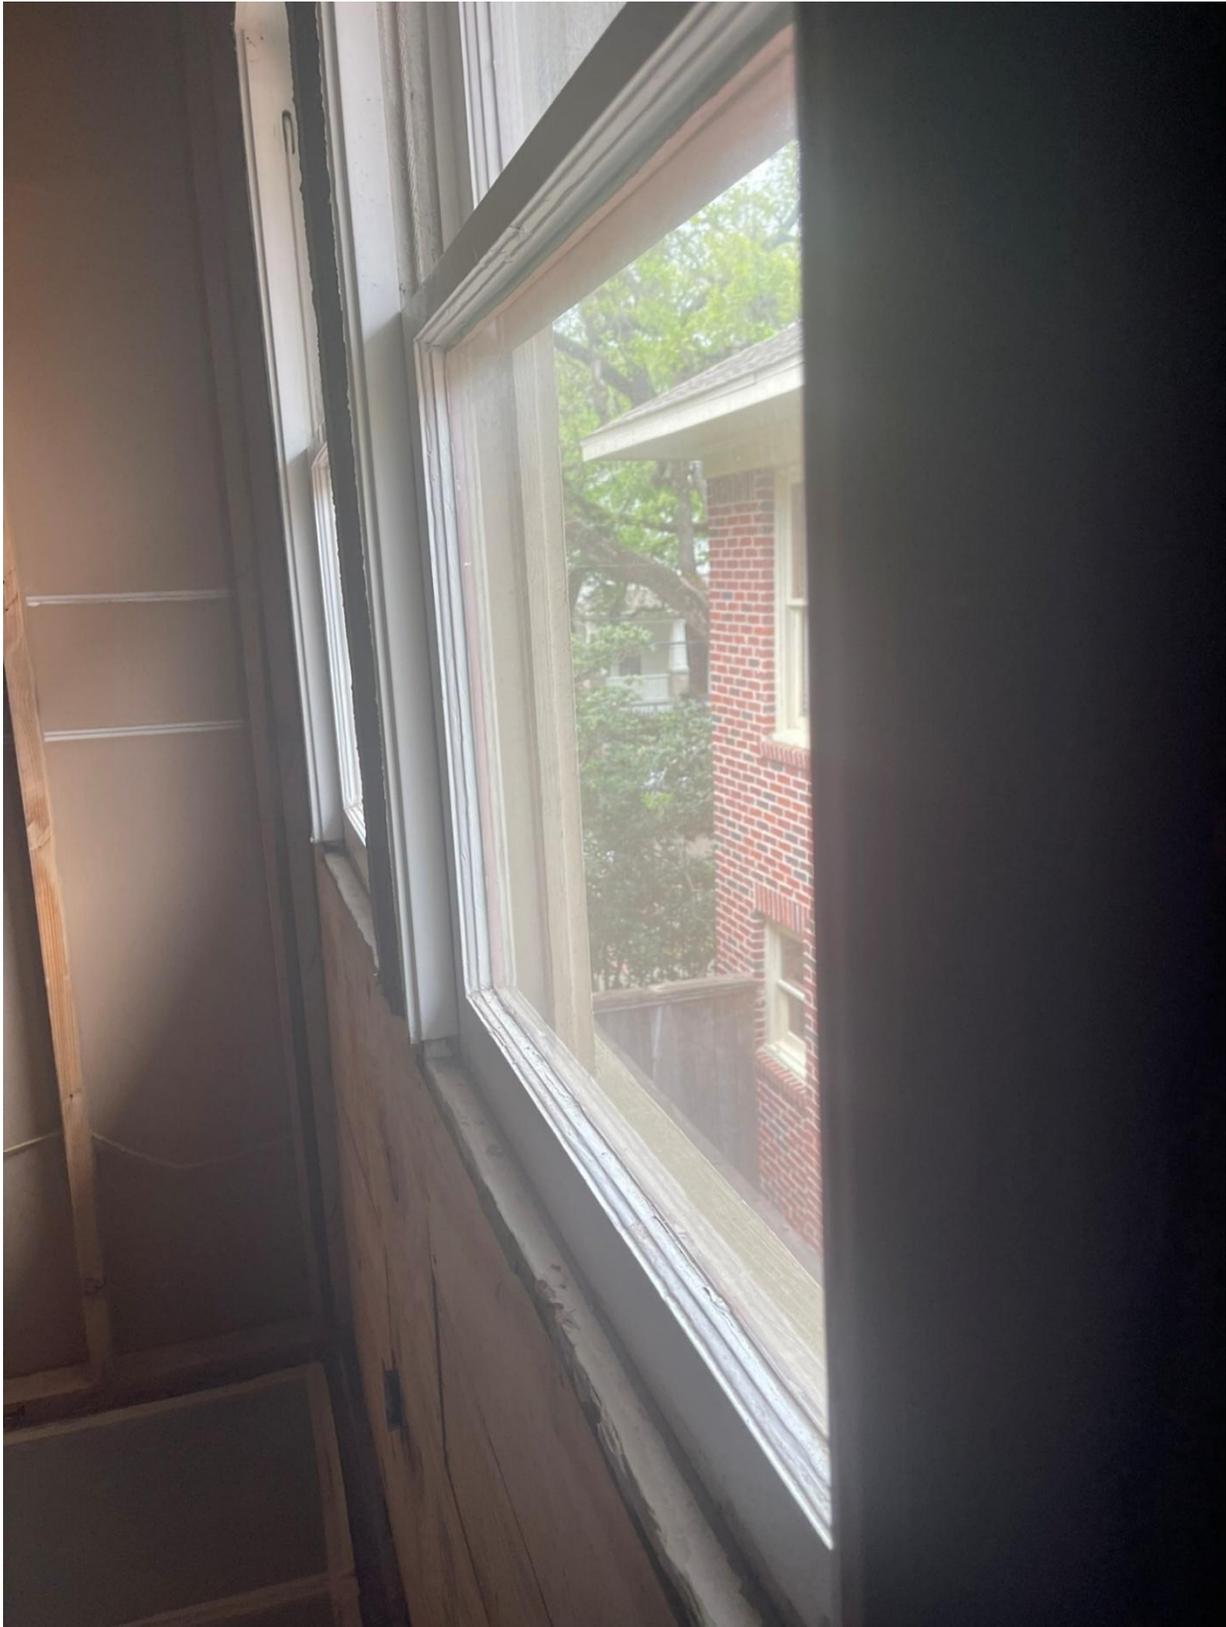
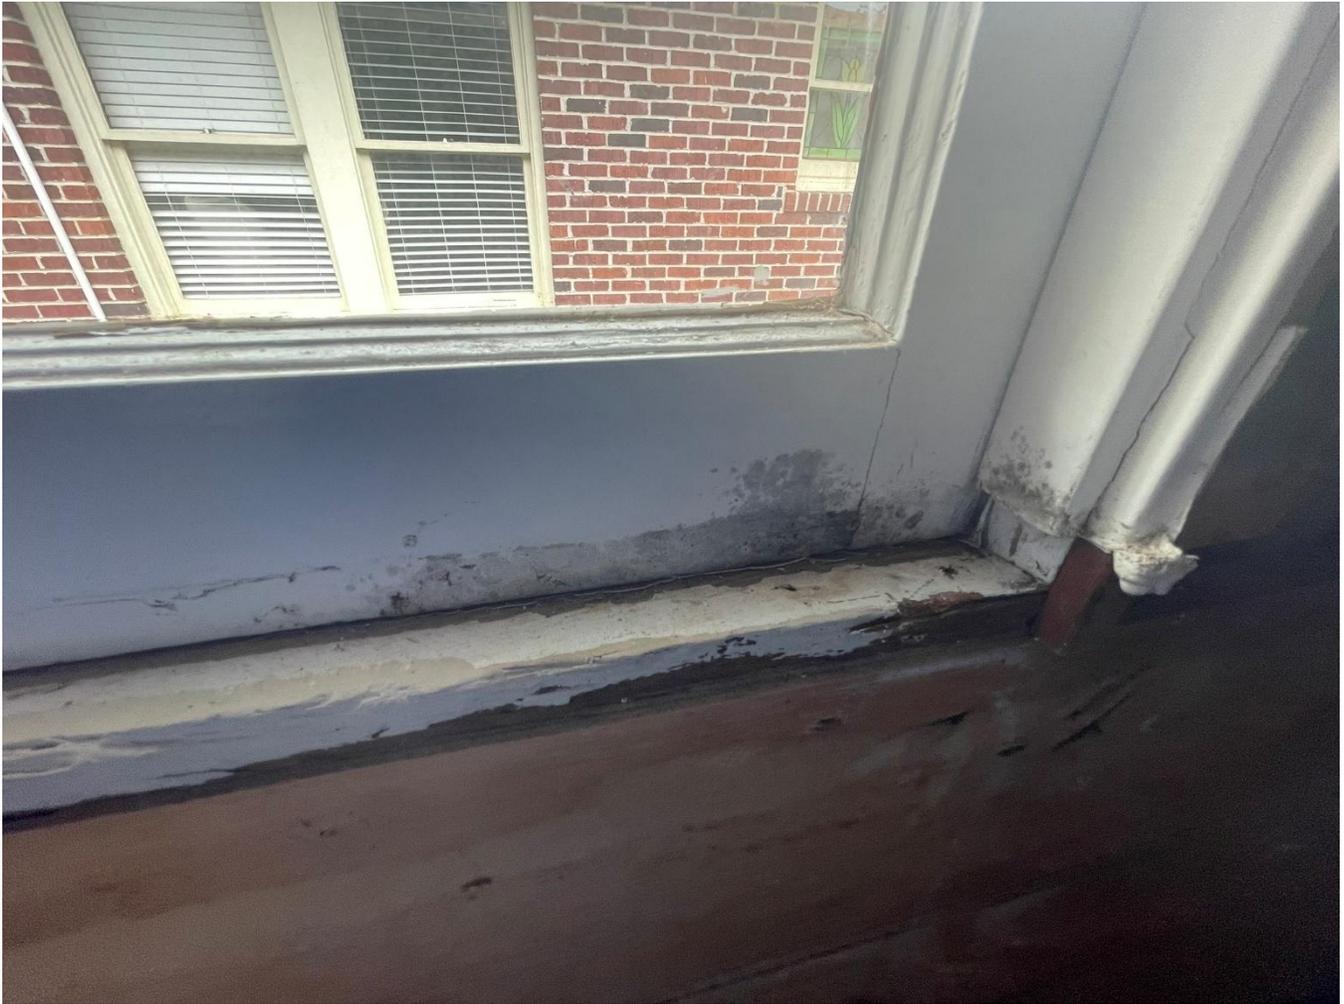
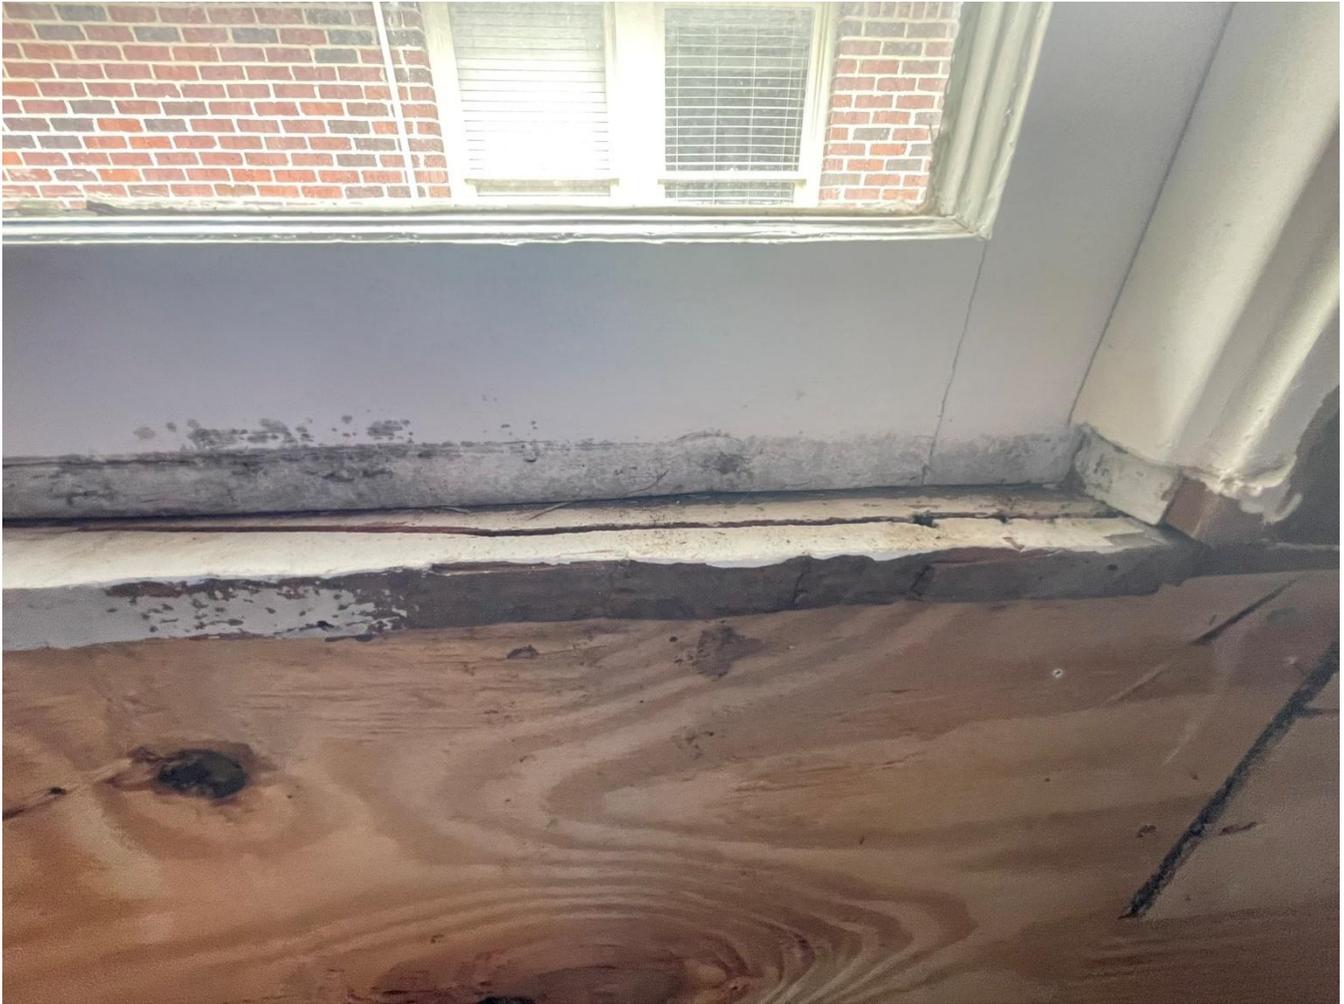
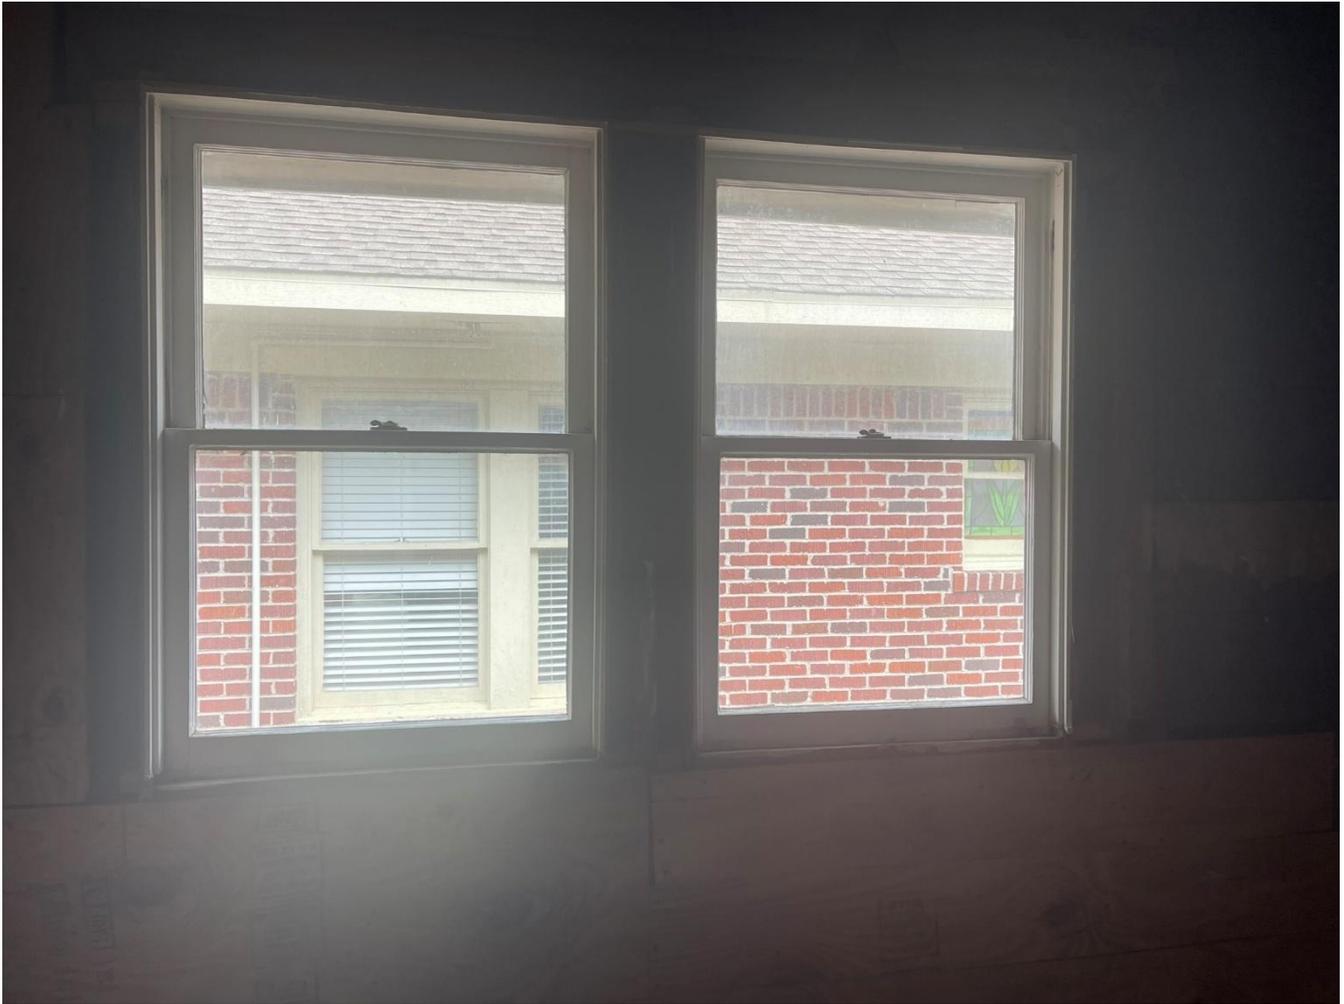
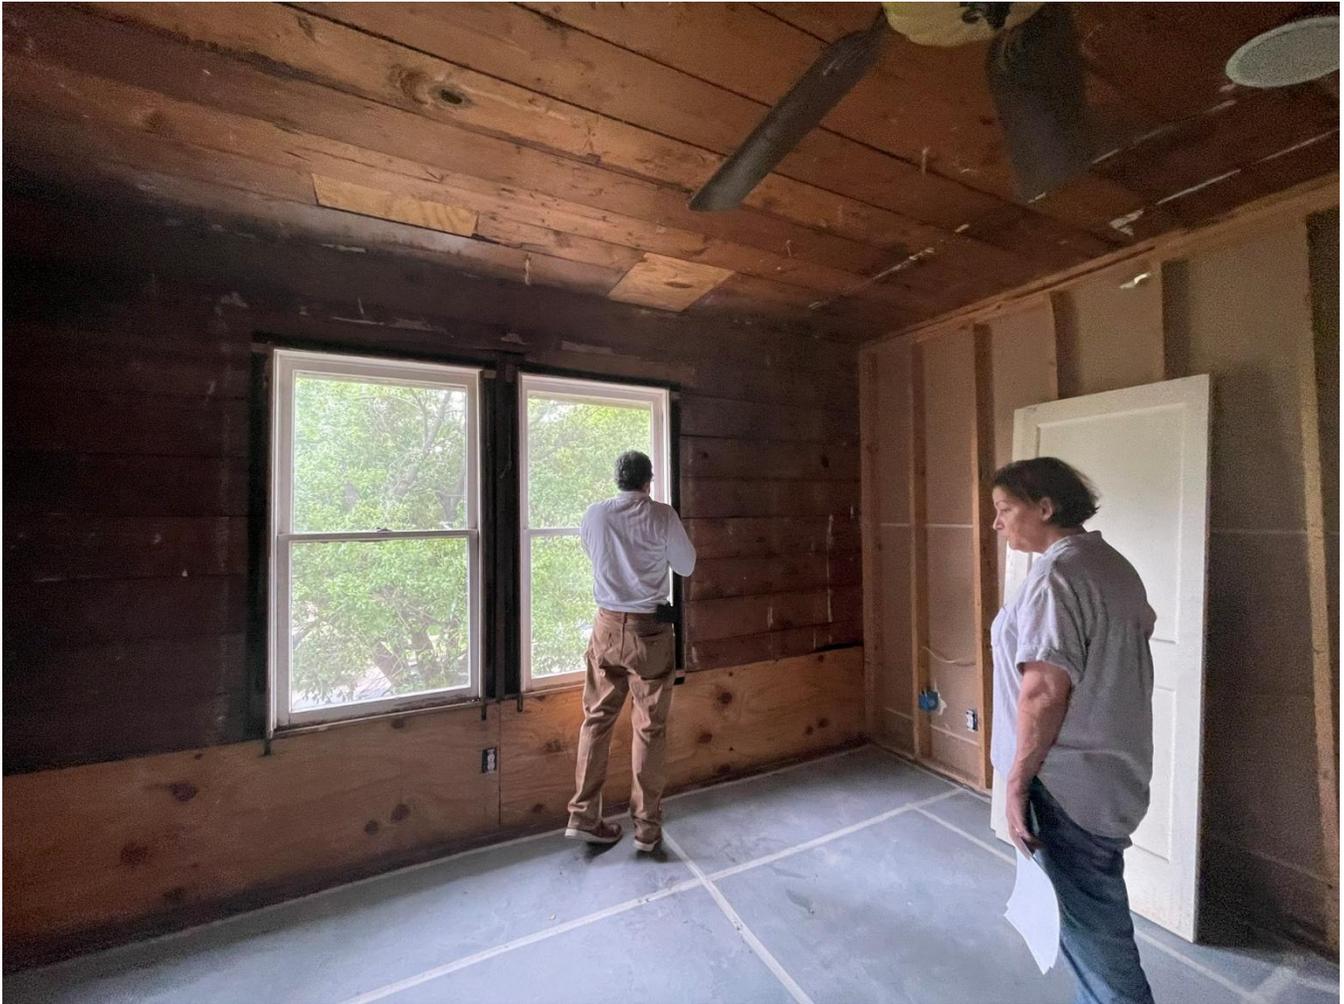
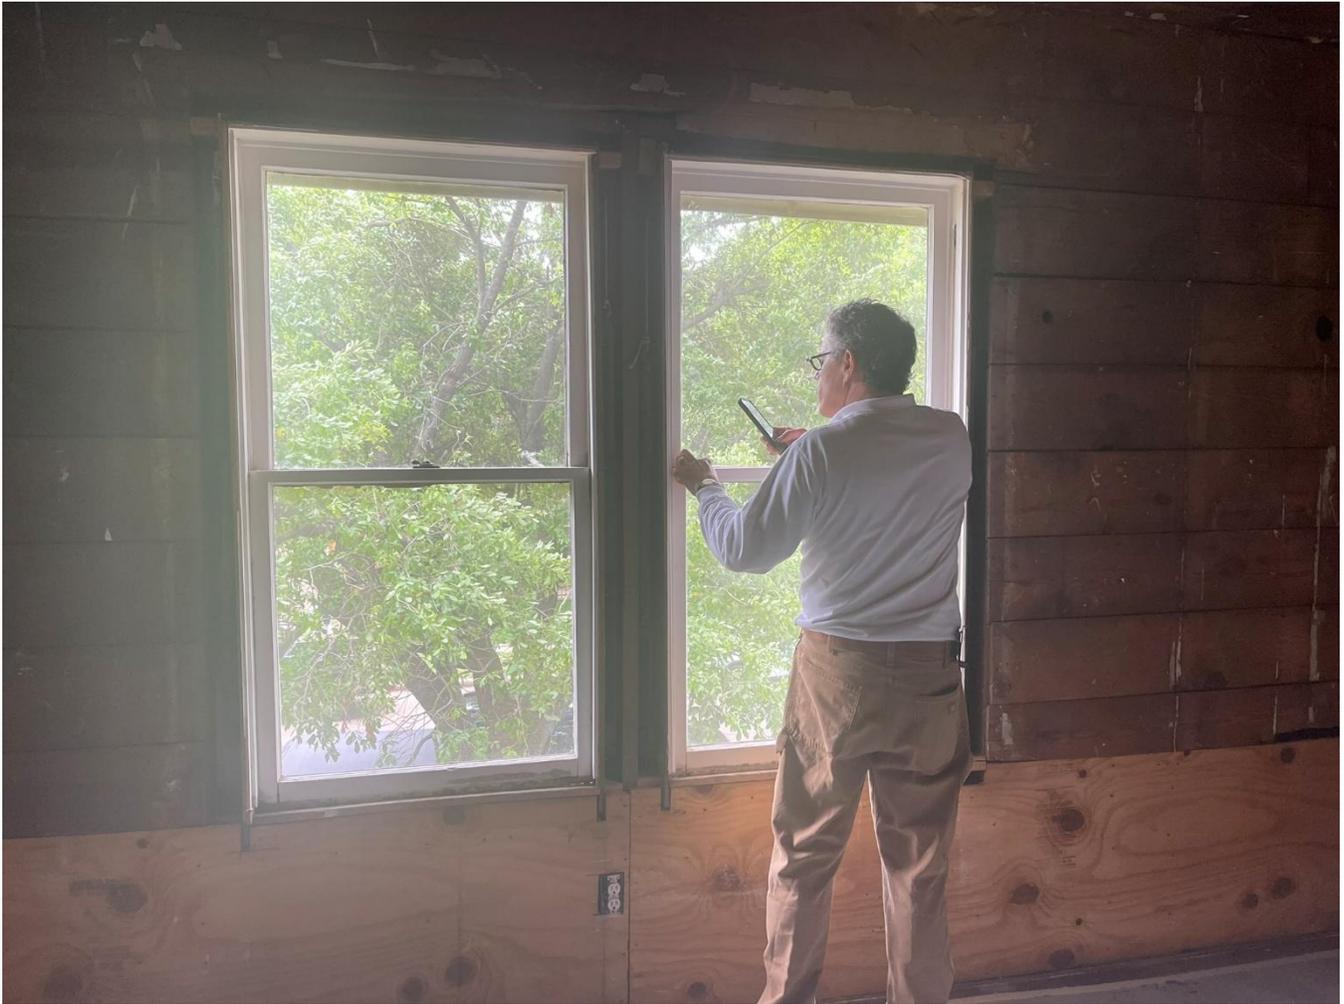
**WINDOW INSPECTION FINDINGS (Site Visit 4/4/2025)**

| <input checked="" type="checkbox"/> | <input type="checkbox"/> | <input type="checkbox"/> | (1) The proposed activity must retain and preserve the historical character of the property;<br><i>Window inspection revealed interior and exterior wood rot, mold and mildew on window, plus bowing, loose joints, non-original glass. All windows that are thought to be original locations are deemed beyond reasonable repair. In addition, current owner has paid to restore quite a few windows, which now three years later are rotted and falling apart.</i> |

1. Many of the windows have been previously approved for replacement in previous COA applications.
2. Staff performed in-depth Window Inspection on April 4, 2025.
  - Staff inspected all the windows in detail, both inside and out.
  - Staff found at least 50% of wood in windows to have deteriorated and need replacement.
  - Staff determined that none of the window glass is original.
  - After inspection, staff determined that wood has been replaced in some of the windows.
3. Staff concludes existing windows are beyond reasonable repair and that all windows may be replaced with windows of similar profile.

- East elevation, remove 2<sup>nd</sup> story set of two windows on back half of house with single window. This proposed area is obscured from view by the existing house and not readily visible from street.
- Staff has determined windows are all beyond reasonable repair, needing 50% or more of wood replaced, none of the glass is original.
- Windows are exhibiting decay, bowing, separation of joints, water intrusion, mildew and mold.
- Some of windows in poor condition were restored at great expense by owner in 2023.
- **All windows will be inset and recessed into the wall opening.**
