### CERTIFICATE OF APPROPRIATENESS

**Application Date:** 10/3/2025 **HPO File#:** HP2025\_0294 **ITEM#: B10**

Property: 219 Emerson Street, Block 3, Residential Single Family, 3,227 sq. ft., Lot size

## 219 EMERSON STREET -

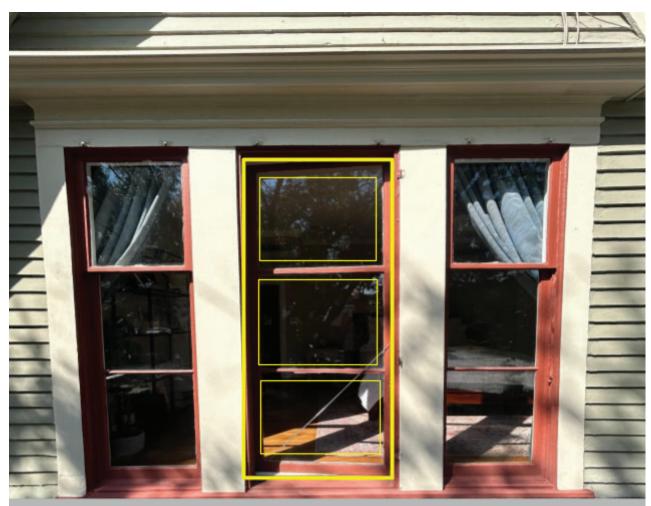
Door Refabrication -Stability & safety Improvement to old door detail

- Existing old door in middle was originally fabricated for use as a window sash but was altered to act as a door at an early date. To keep this old detail of a middle door while giving it the stability and safety it needs, rails and stiles will increase in proportion by 2\* (in yellow). Interior profile is exact replica to existing. Existing mortise and tenon joinery is exact replica with the addition of making tenons haunched for extra stability (a traditional door detail invisible on exterior or interior). Existing exterior bevel at glass is replicated Existing exterior bevel at glass is replicated Fabricated of vertical grain douglas Fir. Glass will be replaced with tempered actual replica wavy glass from Artisan Glass Works to keep vintage glass quality while increasing safety. Existing hardware re-used/restored

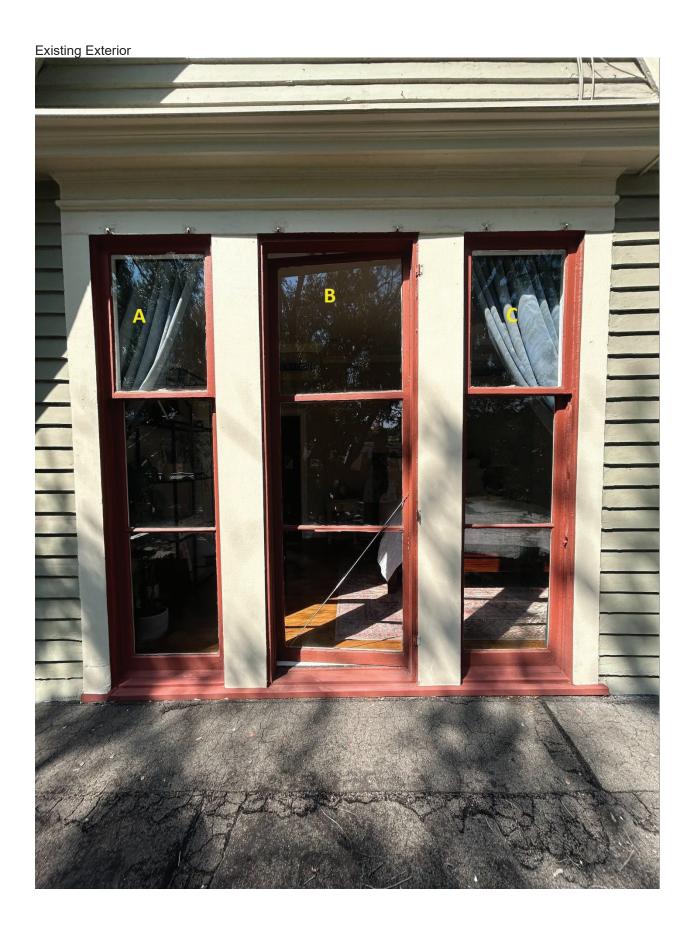
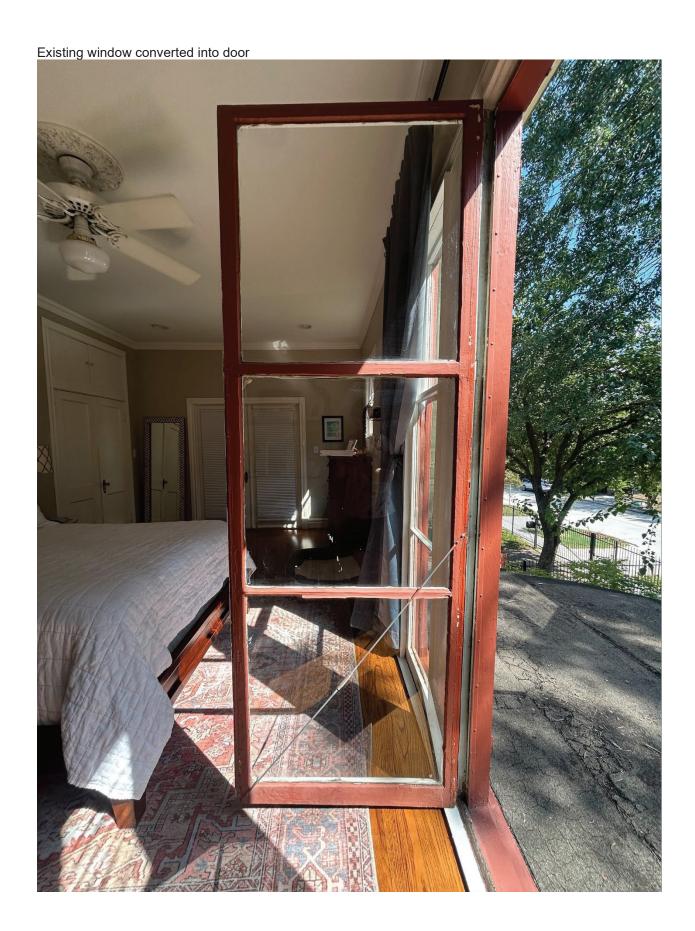
Existing Structural inadequacy – Joinery is separating due to inadequate structure, door sags, cannot be opened without significant care not to break glass/glazing/etc. due to flex in structure.

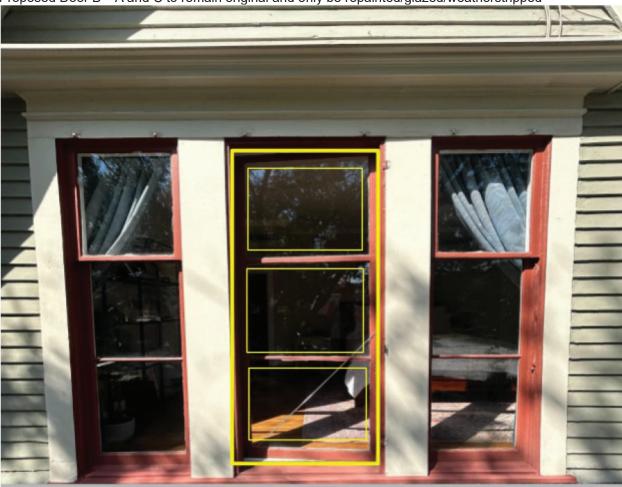
Existing old door in middle was originally fabricated for use as a window sash - but was altered to act as a door at an early date. To keep this old detail of a middle door while giving it the stability and safety it needs, rails and stiles will increase in proportion by 2" (in yellow). Interior profile is exact replica to existing.

Existing mortise and tenon joinery is exact replica with the addition of making tenons haunched for extra stability (a traditional door detail invisible on exterior or interior). Existing exterior bevel at glass is replicated Fabricated of vertical grain douglas Fir. Glass will be replaced with tempered actual replica wavy glass from Artisan Glass Works to keep vintage glass quality while increasing safety. Existing hardware re-used/restored 1.
