CERTIFICATE OF APPROPRIATENESS

Property: 7603 Glen Vista St, lot 10, block 66 in the Glenbrook Valley Subdivision. The property includes a historic 2,602 square-foot, one-story wood-frame single-family residence, situated on a 5,000 square foot (50' x 100') interior lot.

Proposal: Alteration – Windows:

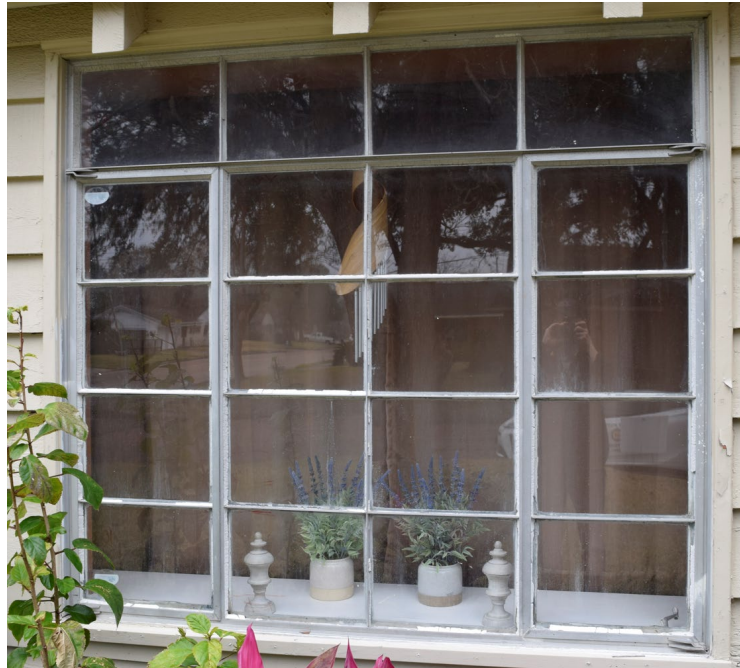
Window	Describe Damage
101	Broken glass and condensation with rot/air leaks
102	Condensation with air leaks
103	Broken glass / condensation with sill rot
104	Broken glass / condensation and air leaks
105	Air leaks / condensation
106	Air leaks / condensation

Window	Material	Lite Pattern	Style	Dimensions	Recessed/Inset	Brand/ Vendor	Other
101	Fiberex	1:1	DG	50X49	Recessed	Renewal by Andersen	
102	Fiberex	1:1	DG	34X36	Recessed	"	"
103	Fiberex		PW	67 x 15	Recessed	"	"
104	Fiberex		PW	67 x 46	Recessed	"	"
105	Fiberex	1:1	GL	67 x 48	Recessed	"	"
106	Fiberex	1:1	DG	51 x 48	Recessed	"	"

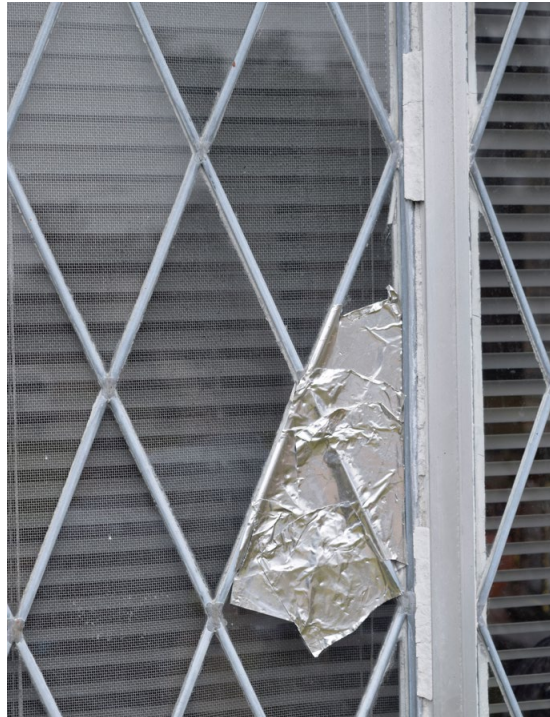
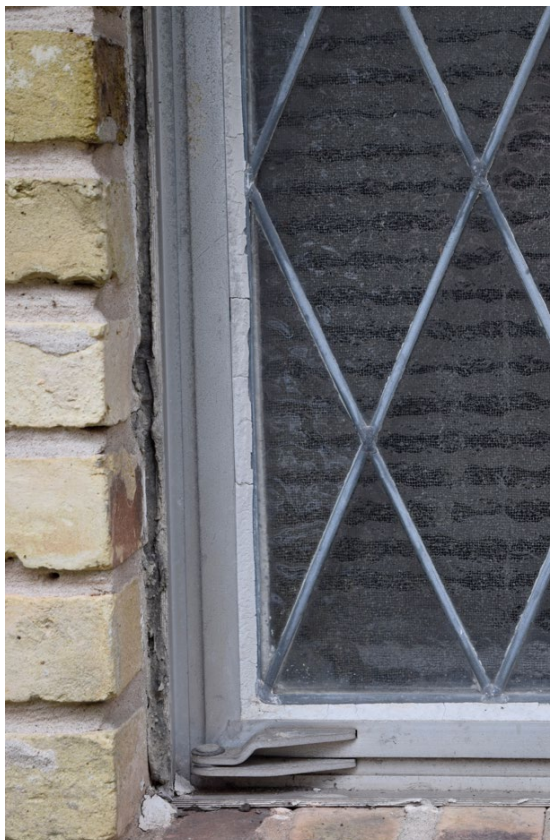
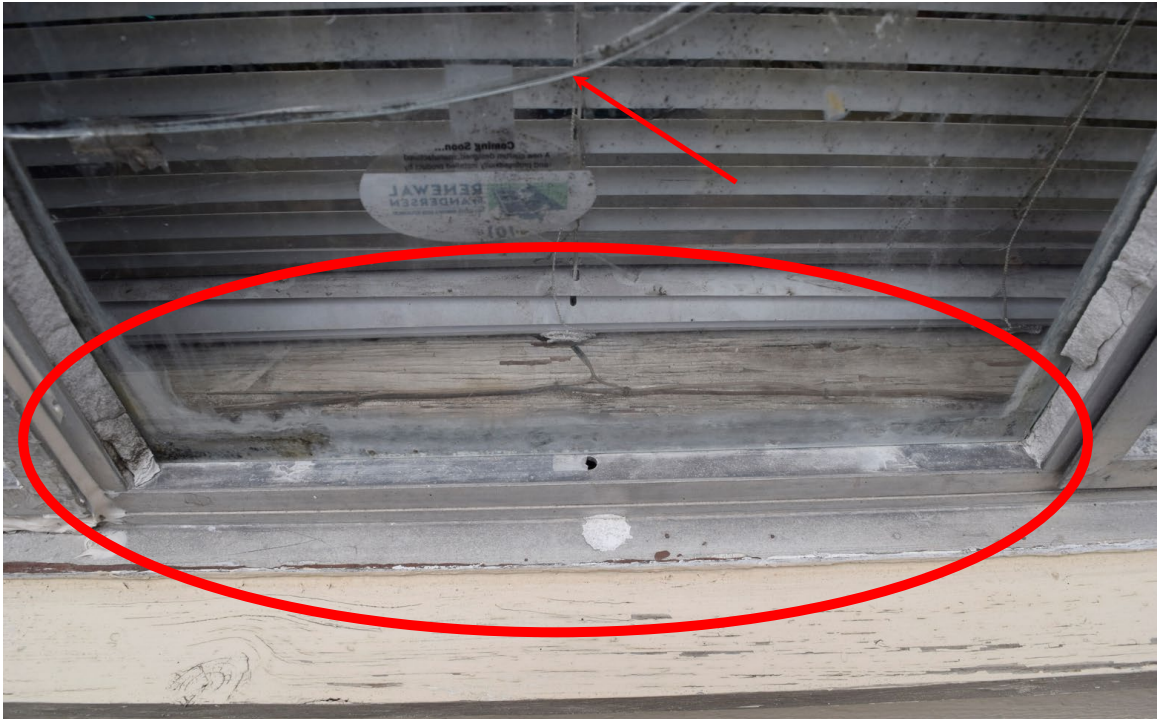
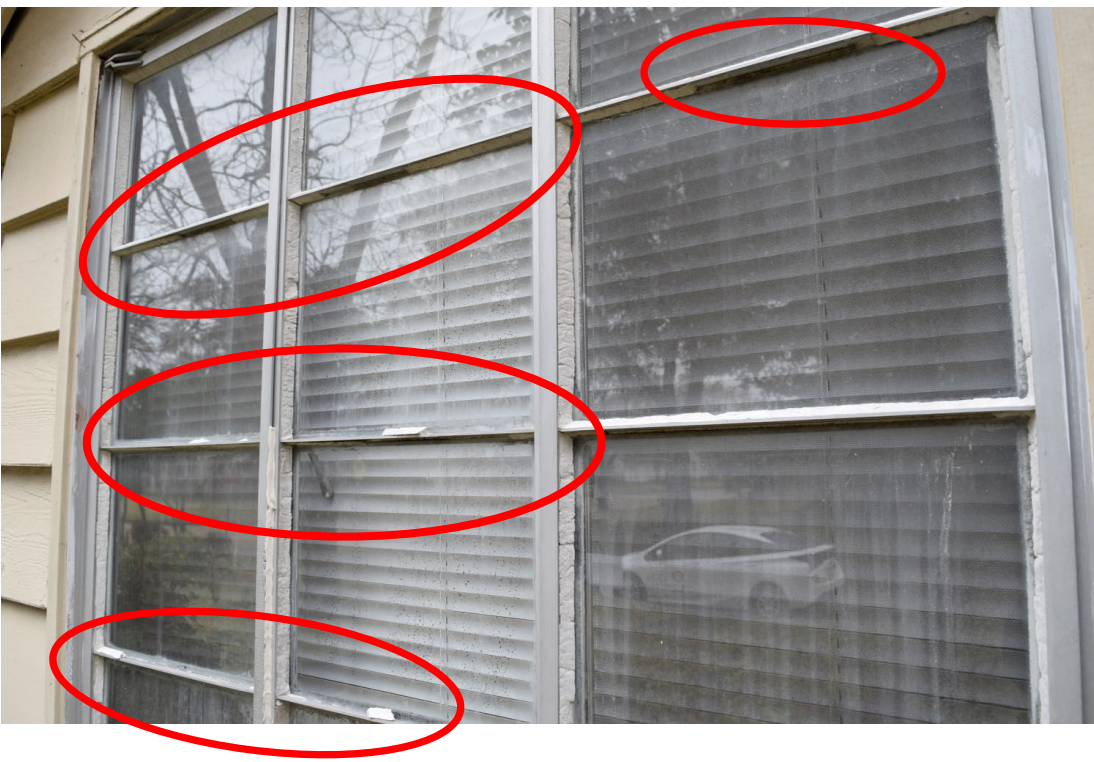
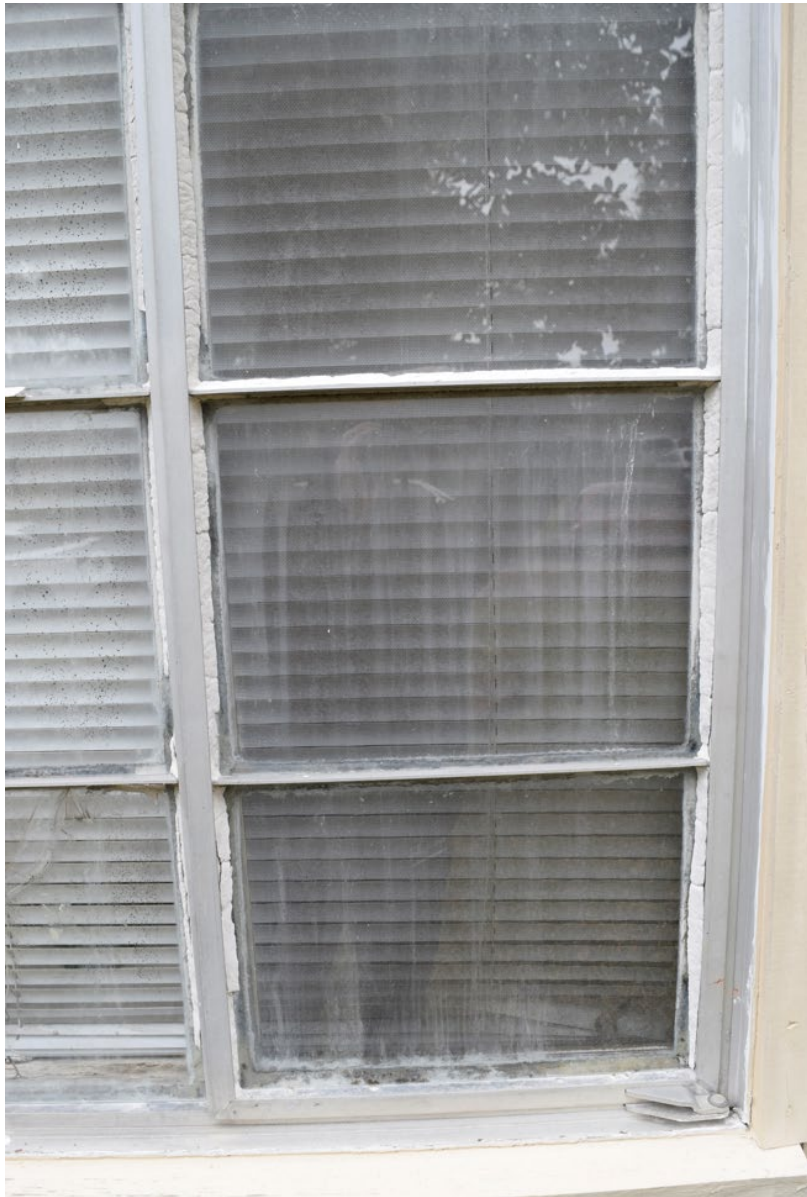
CLOSE-UP PHOTOS

- Removal of existing original windows (at the front of home)
- Installation of Renewal by Andersen fibrex windows
- Proposed windows will be double hung consisting of sliding and picture windows
- The windows will be sandstone in color
- The existing windows currently have broken glass, air leakage, condensation, and sill rot
