**CERTIFICATE OF APPROPRIATENESS**

**Property:** 7734 Glen Vista Street, Lot 9, Block 35, Glenbrook Valley. The property includes a 1,578 SF one-story wood frame single-family residence with an attached garage on an 8,625 SF interior lot.

**Significance:** Non-Contributing American Ranch style residence, constructed circa 1957

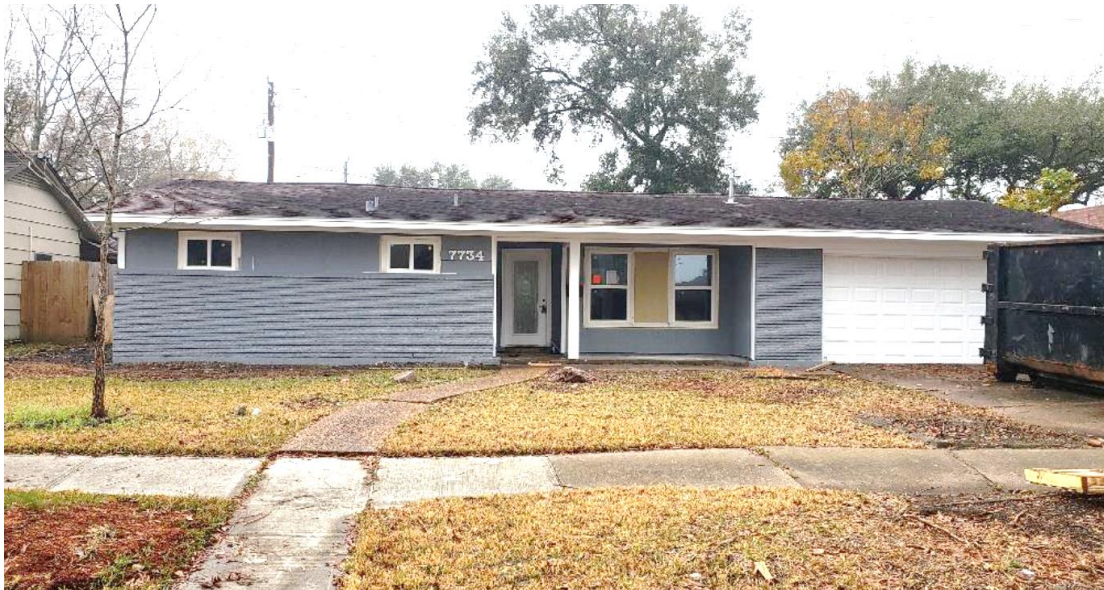
(b) The proposed activity must match the architectural features, materials, and character of either the existing noncontributing structure or the contributing structures within the context area.  
*The work done does not do either of these. Original, mill finish, windows were removed and replaced with white vinyl windows that do not match the original opening sizes. On the front porch, 3 windows were replaced with 2. The original unpainted brick veneer on the front and sides of the house were painted.*

*Figure 2 - Feb. 2022 - from Code Enforcement*

- Install aluminum windows with matching light patterns to the original windows in the original locations and patterns. This is to replace the white vinyl windows that were installed and do not match original opening sizes.
- Leave the house painted. The original unpainted masonry was painted by the applicants.
- Replace the front door with an appropriate front door approved by staff.

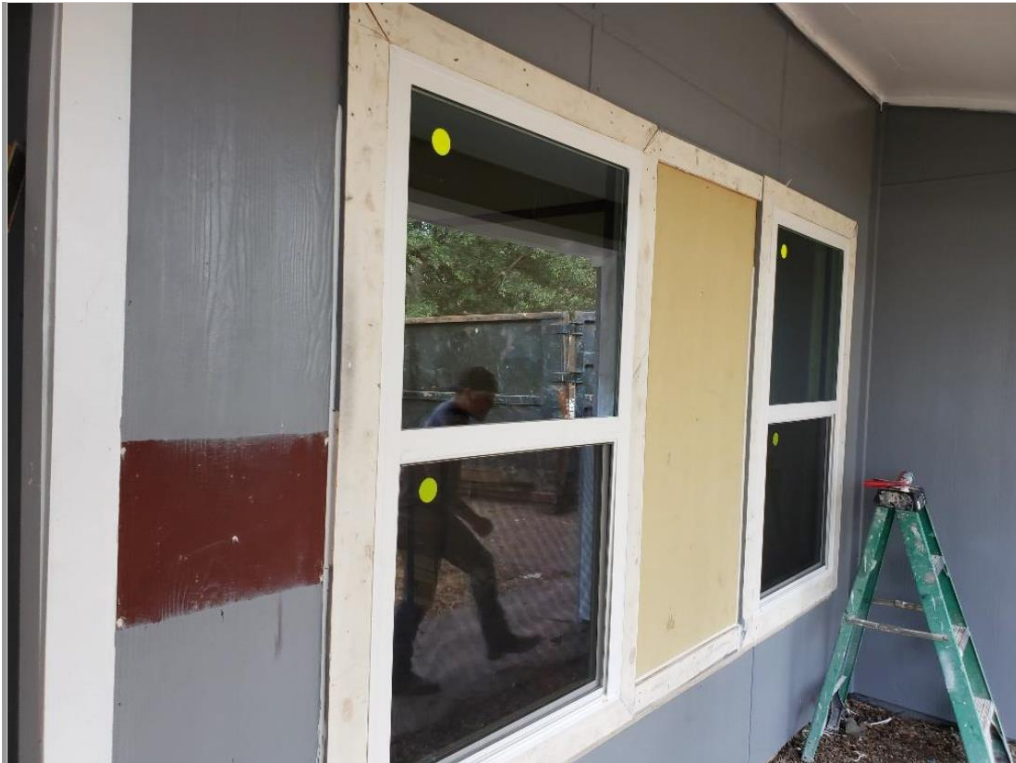
Figure 5 - Original Location of 3 Aluminum Windows

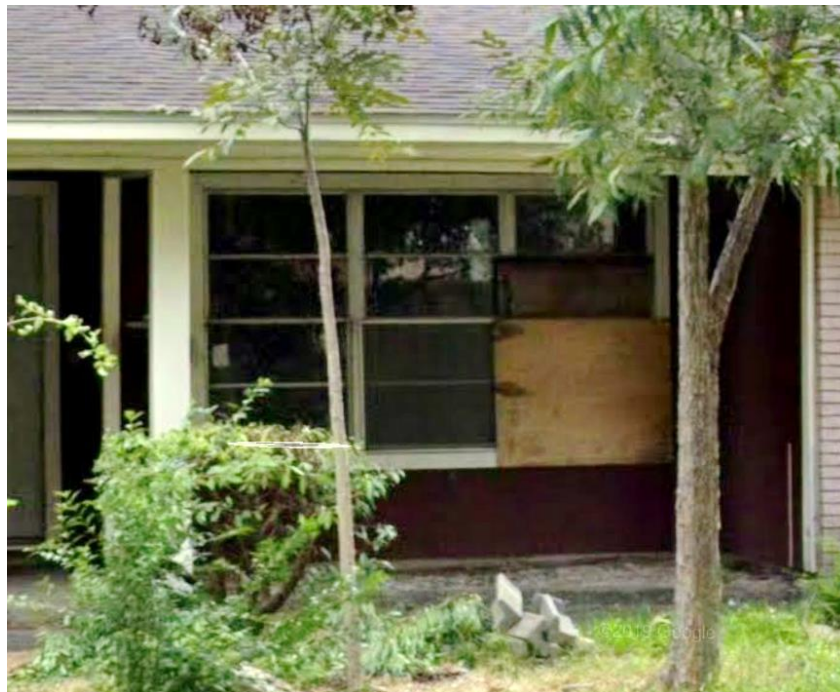
Figure 6 - Original Porch Windows
