CERTIFICATE OF APPROPRIATENESS

Property: 7746 Wilmerdean St, lot 10, Block 49, Glenbrook Valley Subdivision. The property includes a historic 1,922 square-foot, one-story wood-frame single-family residence, situated on a 8,553 square foot (75' x 110') corner lot.

Proposal: Alteration – Garage/Siding and Trim

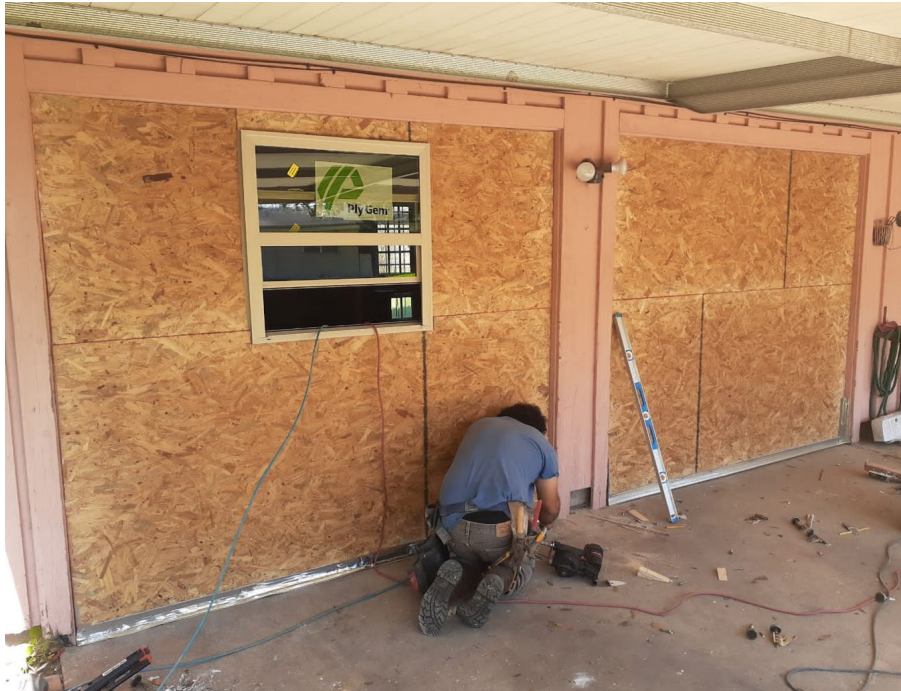
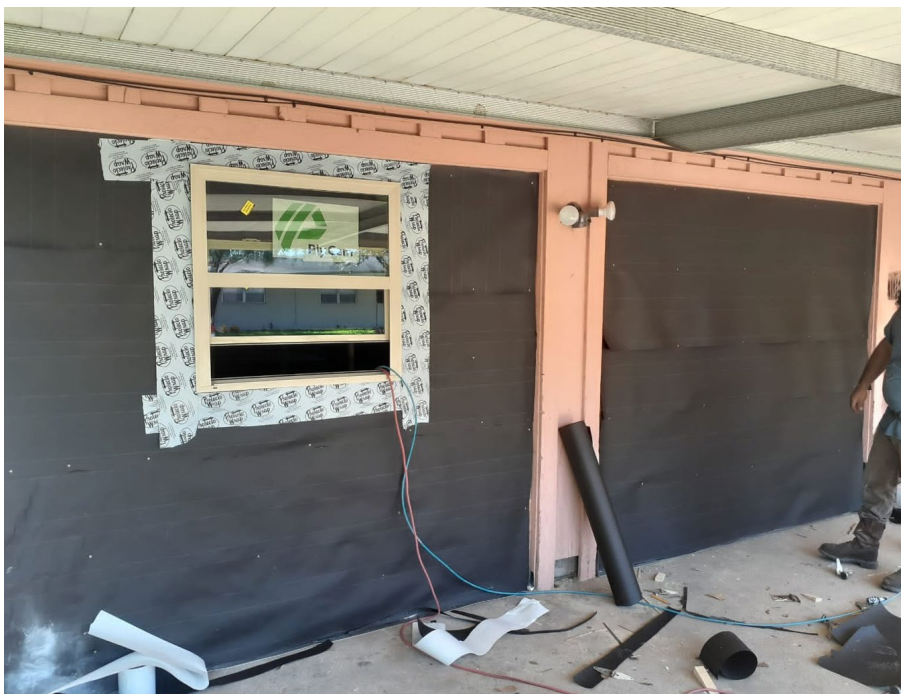
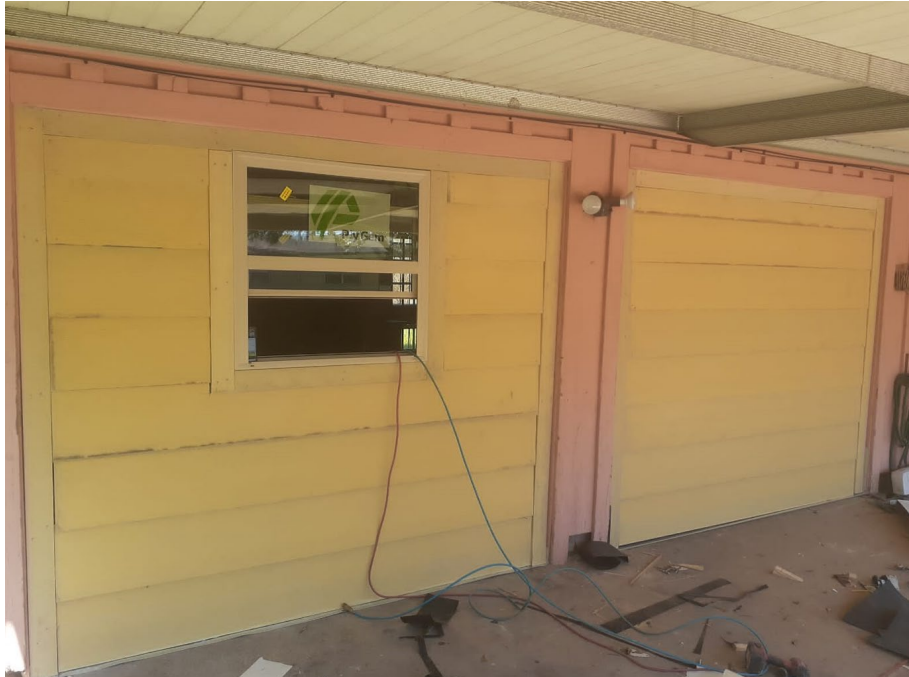
PHOTOS
PROPOSED

- The applicant stopped work upon receiving a 3-1-1 notice.
- The applicant is also replacing the siding on the home.
- The wall will be constructed of wood studs, sheathing, water-proofing (felt), cementitious, siding, as well as install a new window.
