7947 Rockhill Street Glenbrook Valley

CERTIFICATE OF APPROPRIATENESS

Proposal: Alteration – Windows

December 11, 2025 HPO File No. 2025_0317

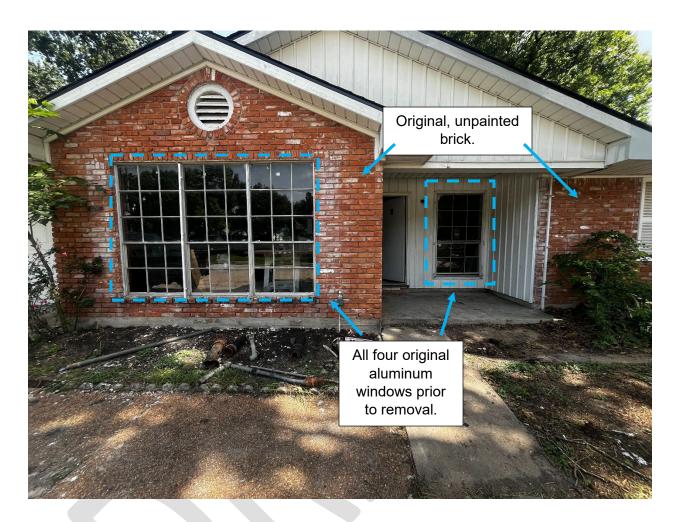
FRONT ELEVATION - BEFORE

The applicant completed work without a permit for change of four original front elevation windows and for painting on unpainted masonry. The original windows were changed from aluminum to vinyl.

S	ט	NA		S - satisfies D - does not satisfy NA - not applicable
			(1)	The proposed activity must retain and preserve the historical character of the property; Aluminum windows are a defining architectural feature of the home. Vinyl windows create a later appearance of the structure and violate the 1-1 Window Replacement (HOP) internal policy.

Recommendation: Denial - does not satisfy criteria 1, 3, 4, 9, and 10, and issuance of COR requiring removal

of paint from brick, removal of replaced vinyl windows, and reversion of inset aluminum

windows.

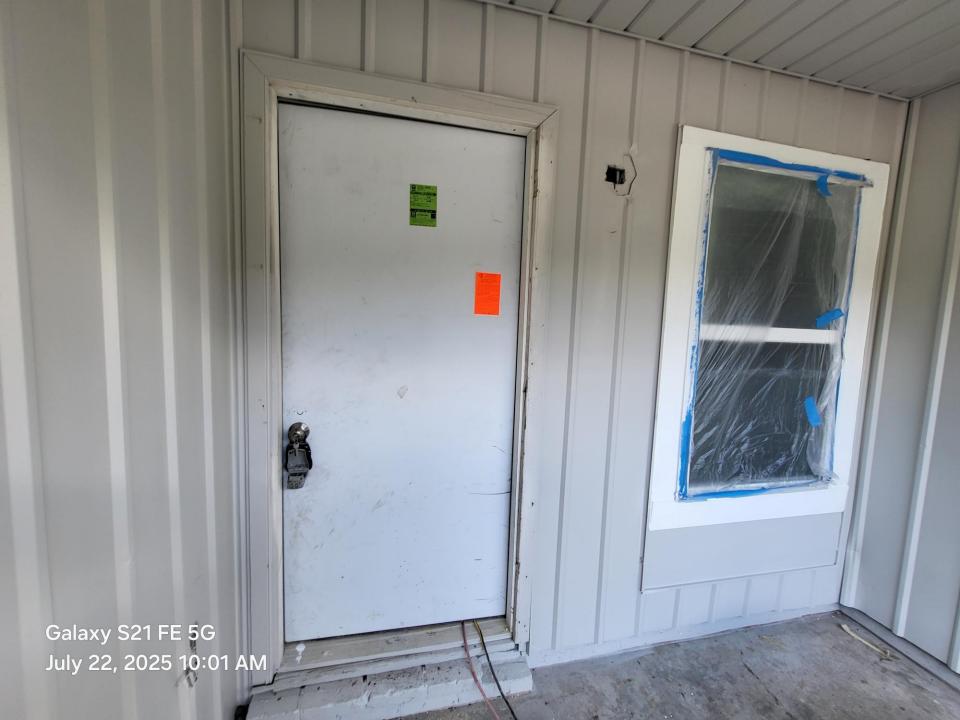
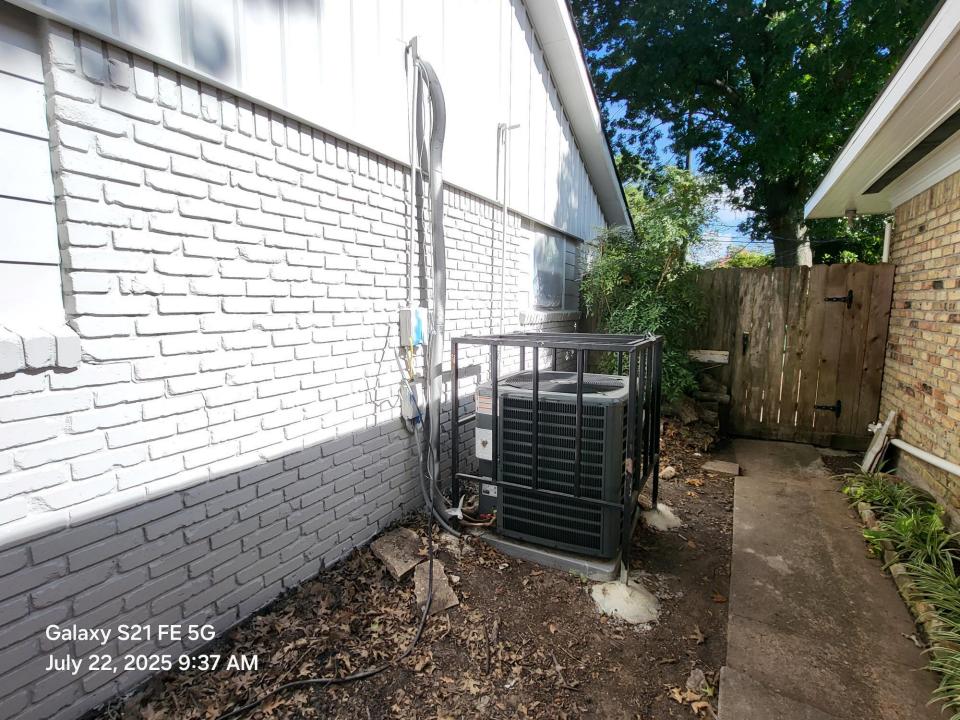
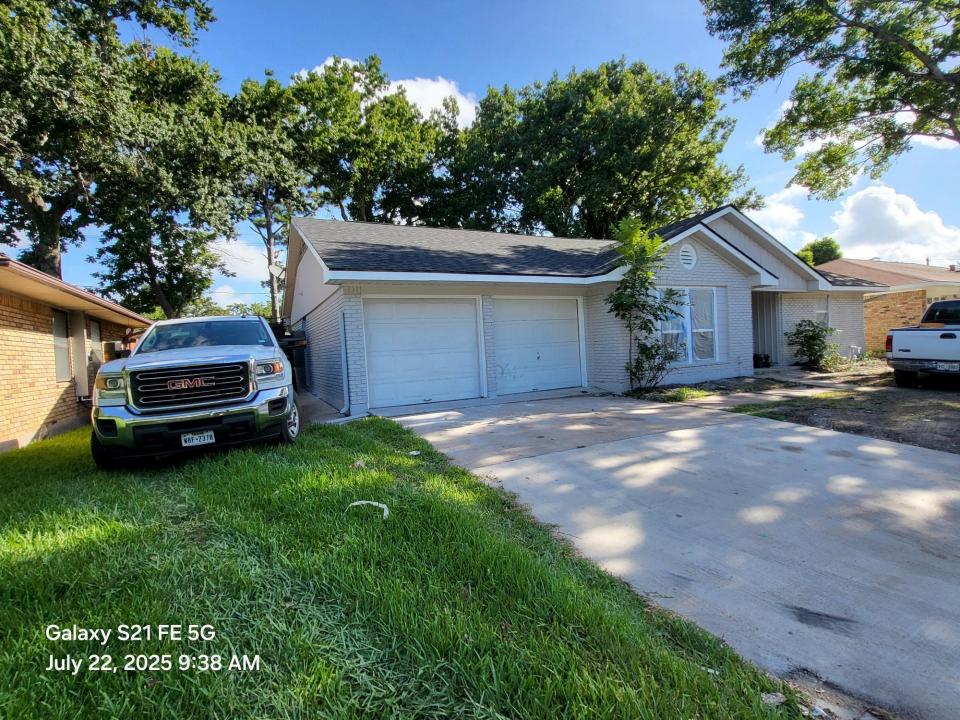
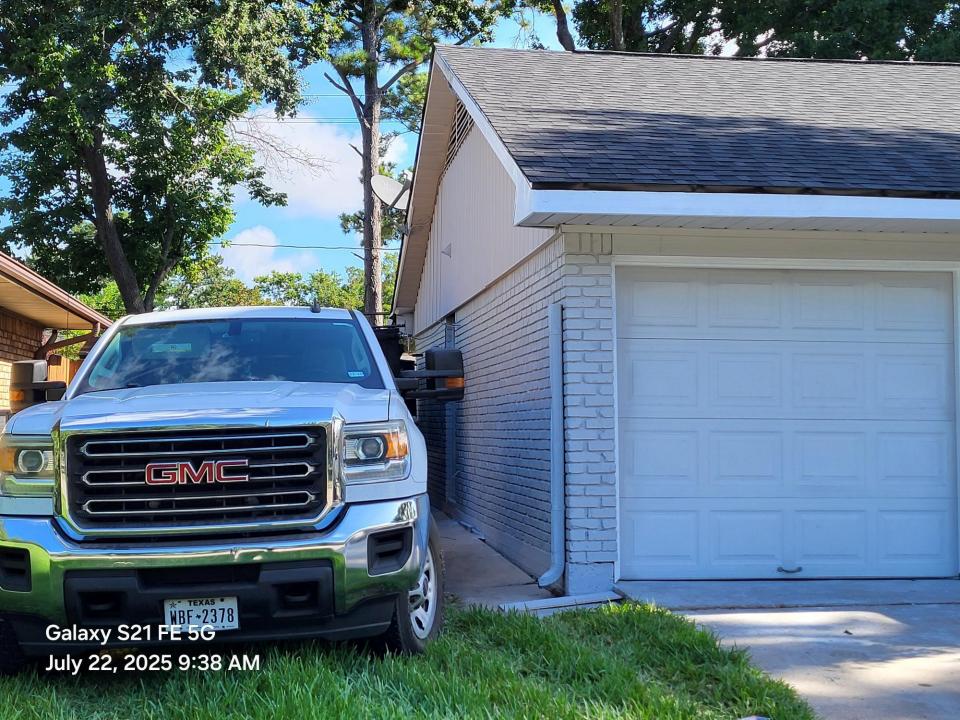
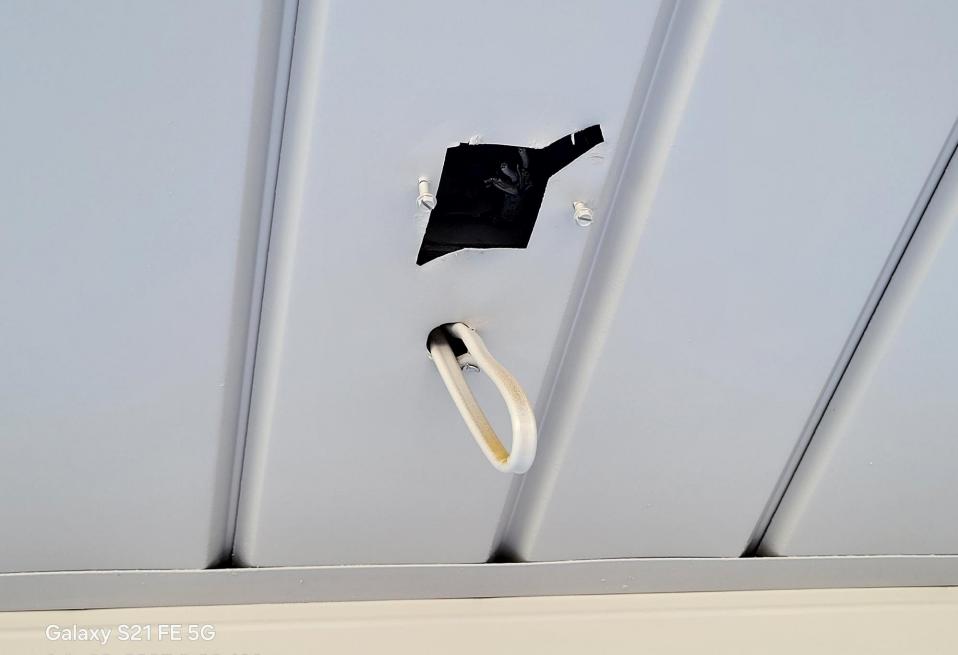
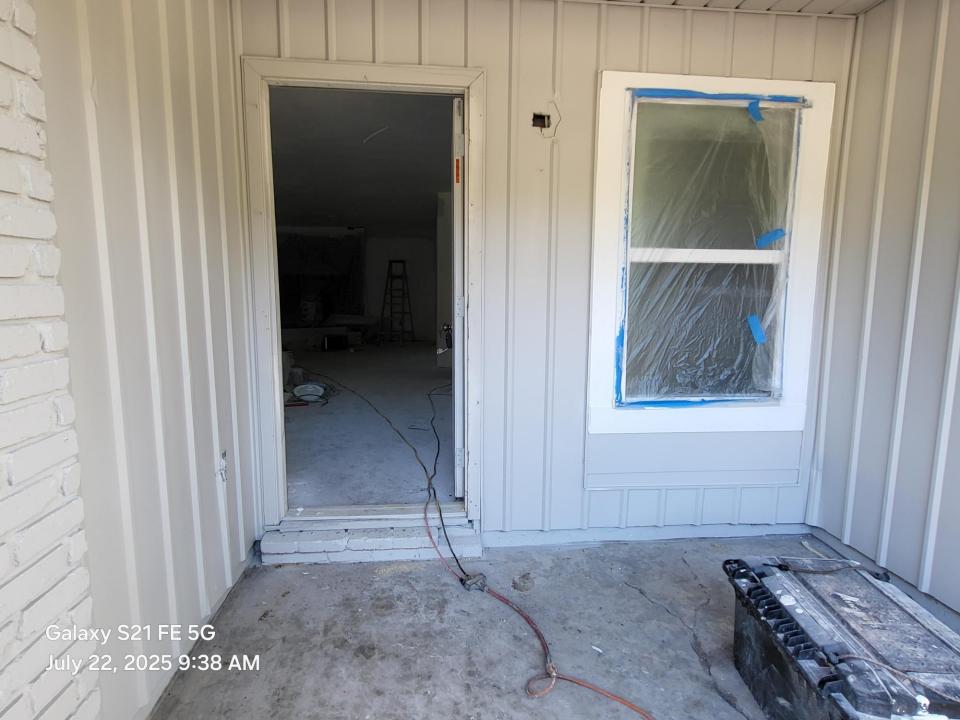
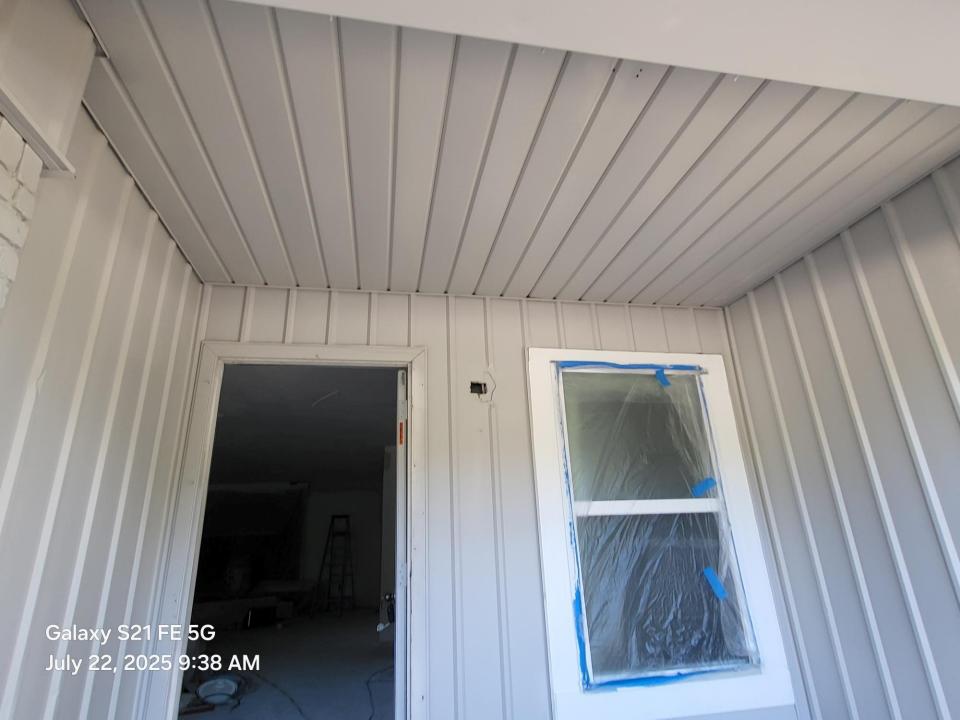
SITE VISIT – 1st NOTICE 7947 ROCKHILL ST PROJECT #25067949 I35 07/22/25

- 311 complaint and building inspector at site, 7/22/2025
 - Unpermitted work for windows and plumbing
 - o Red tag issued
 - See Attachment B for Inspector report.
- Windows: Vinyl
- Paint color: BEHR Silver City
- No other work was done to the exterior that is visible from the street.
- All windows to be inset and recessed. See Attachment A for details.
 - Minimum 1¾ inch inset depth from exterior casing to the face of the window unit (Upper Sash) Windows must be 1-over-1 if single or double-hung and equally horizontally divided. 1¾ inch minimum inset for Fixed Window.
