CERTIFICATE OF APPROPRIATENESS

Property: 1819 Oxford Street, Lot 9, Block 108, Houston Heights Neighborhood Subdivision. The property includes a historic 1,952 square foot, two-story wood single-family residence and detached garage situated on a 6,600 square foot interior lot.

Proposal: Alteration – Siding, Doors, Windows, Porch, Canopy, Garage, Pergola

Recommendation: Approval with conditions: First floor east (front) elevation fenestration alteration to be reviewed and approved by staff; if after the removal of synthetic siding determines a previous door opening existed at the proposed central location, then the proposed door and window relocation will be approved. If there is no evidence of a previous opening, the existing door is to remain as is.

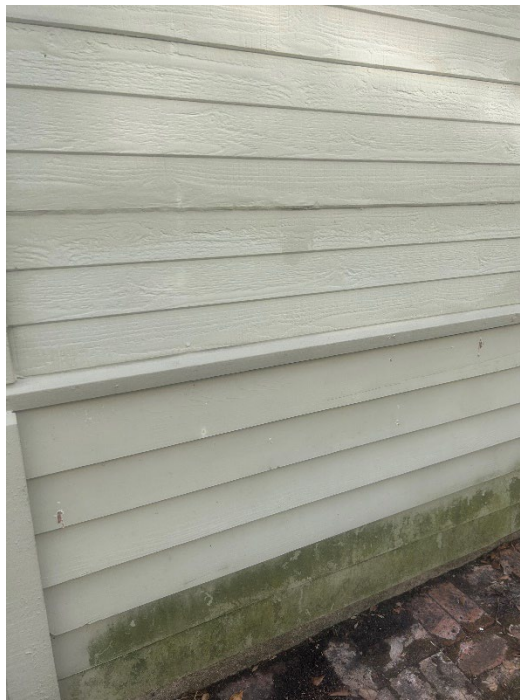
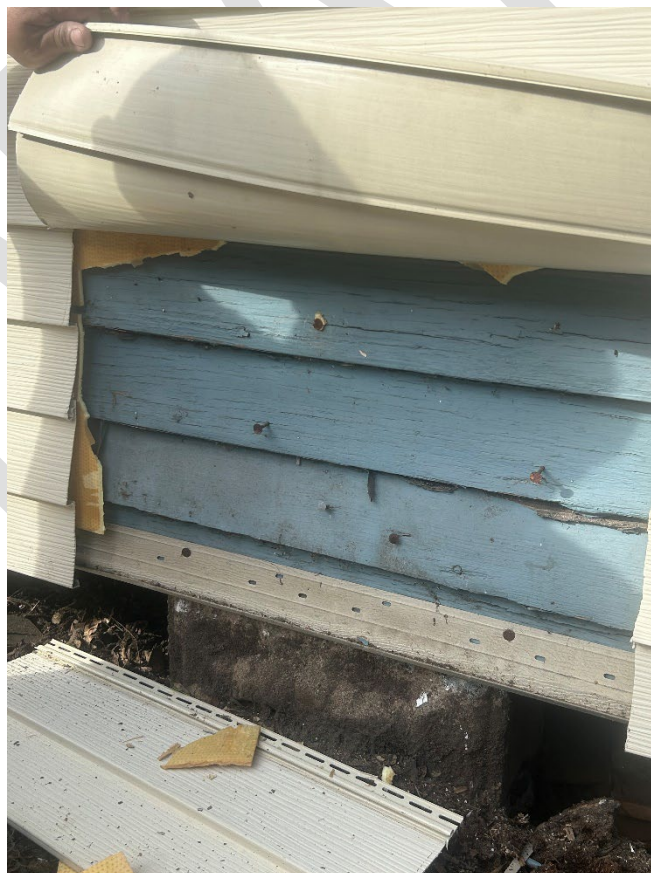
SOUTH (LEFT) ELEVATION – SIDING

The existing siding is all vinyl. Once all this synthetic material has been removed, the condition of the original wood siding below will be determined in order to prescribe the most appropriate repair and replacement strategy. Any repair section will be replaced with 117 wood siding.
