1932 Albans Road Landmark: Joseph and Annie Ludwig

#### CERTIFICATE OF APPROPRIATENESS

**Proposal:** Alteration – Addition, Windows, Porch or Balcony

The applicant is proposing to repair brick, build an attached 605 SF rear two-car garage, and replace front porch steps and windows.

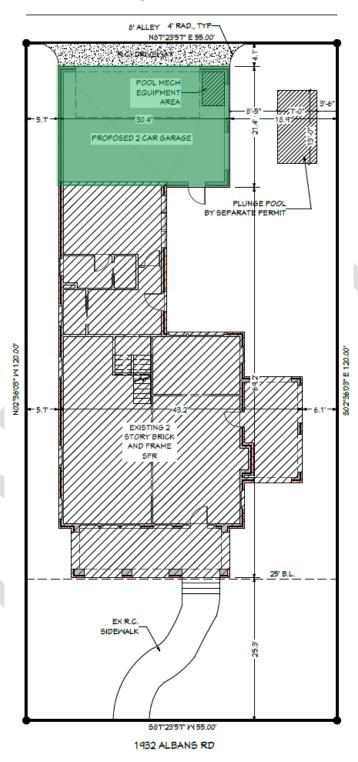
#### SITE PLAN

**PROPOSED**

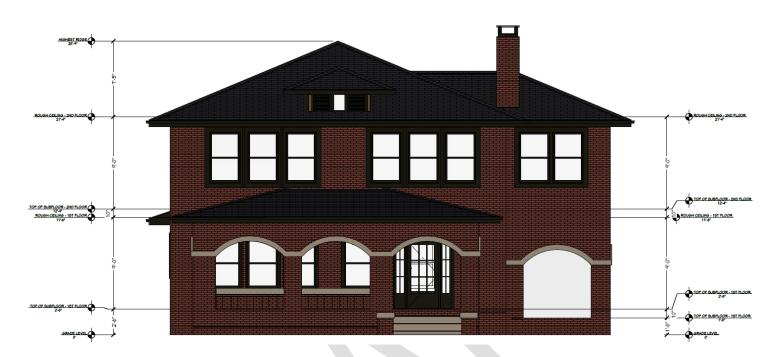
#### **FRONT ELEVATION**

**PROPOSED**

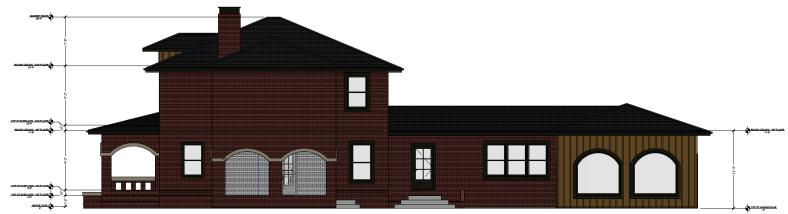
#### **RIGHT ELEVATION**

**PROPOSED**

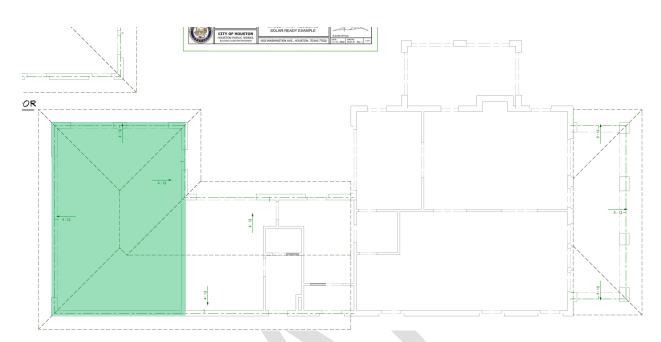
#### **ROOF PLAN**

FIRST FLOOR ROOF PLAN - PROPOSED

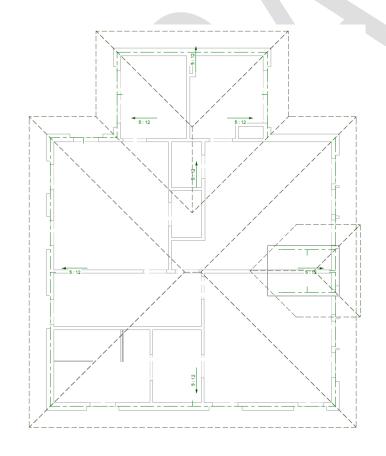
EXISTING SECOND FLOOR ROOF PLAN
