CERTIFICATE OF APPROPRIATENESS

Property: 4007 Oak Ridge Street, Lots 15 & 16, Block 127, North Norhill Neighborhood Subdivision. The property includes a historic 1,343 square foot, one-story wood frame single family residence and a 593 square foot detached garage situated on a 10,000 square foot interior lot. Lot 16 only is 4,994 square feet.

Significance: Contributing Bungalow, constructed circa 1923, and detached noncontributing garage, constructed circa 1980, located in the Norhill Historic District.

Proposal: Alteration –Addition, Windows, Porch, Siding

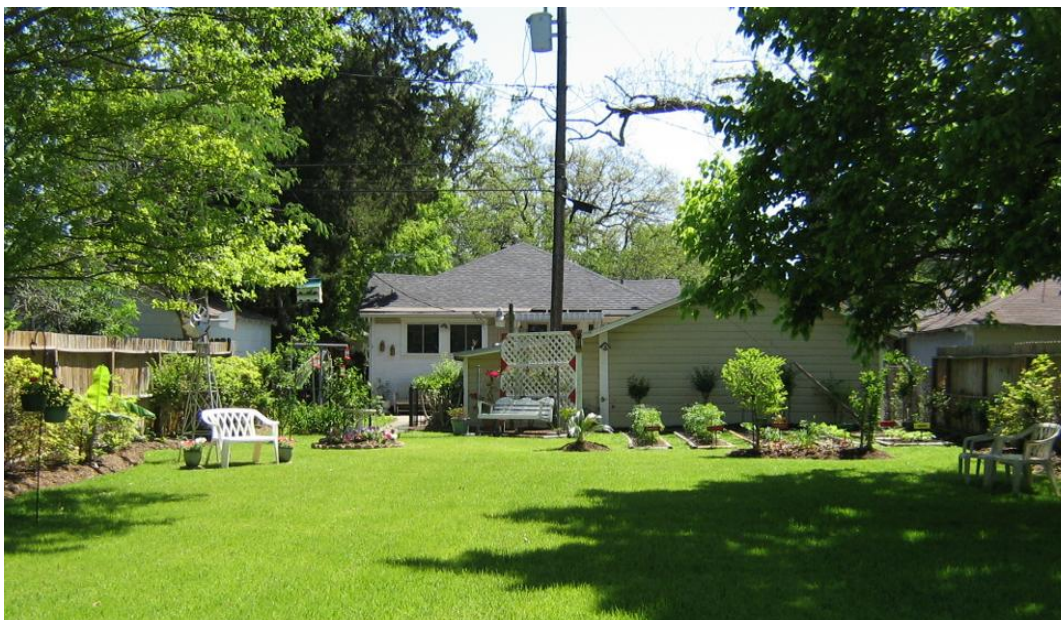
FACING EAST FROM REAR OF LOT TOWARDS REAR OF HOUSE

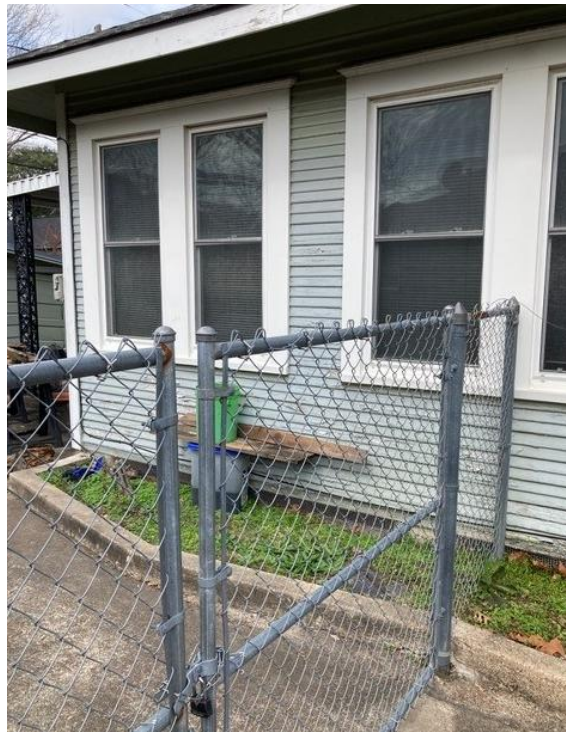
SOUTH (LEFT) ELEVATION WINDOWS TOWARDS REAR

***Site visit 12/30/25 confirmed proposed work had already begun. Proposed window removals have already taken place on the south and north towards the rear of the house. *** The applicant proposes a partial rear addition to extend the existing living quarters and includes a covered rear porch. The new porch will provide a covered breezeway to connect the rear porch to the detached garage. Details include:

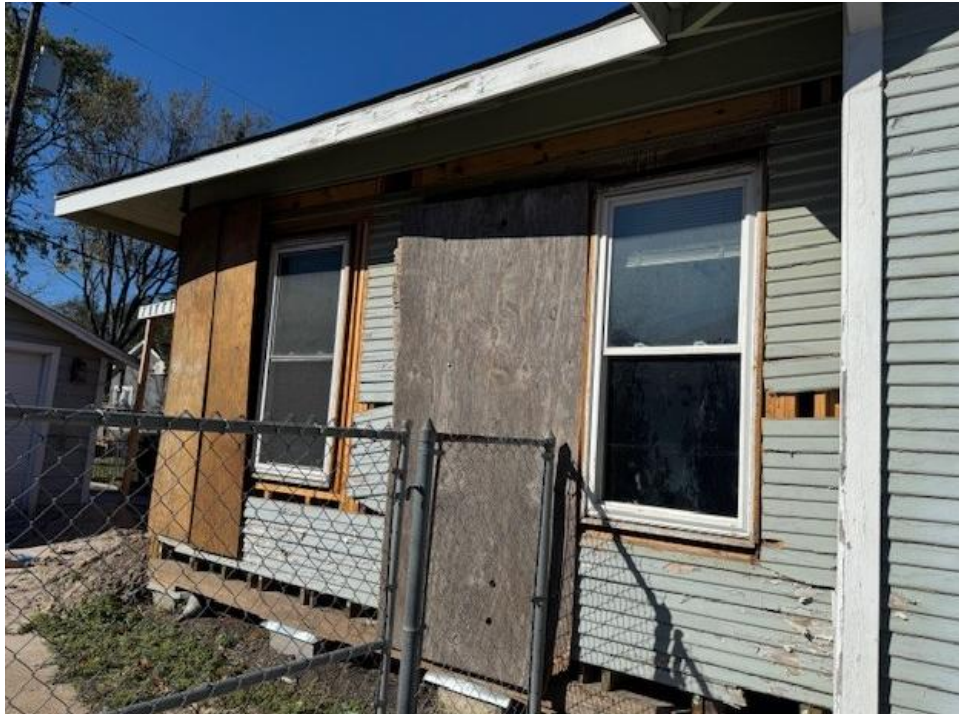
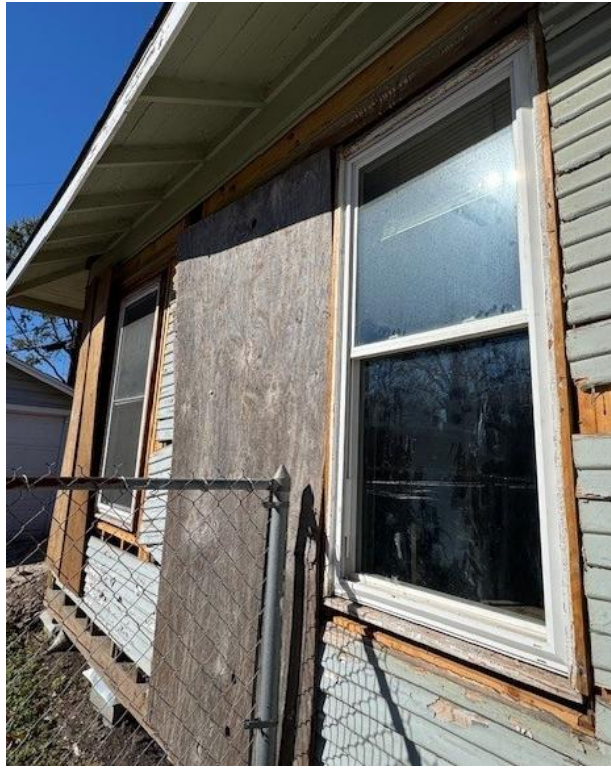
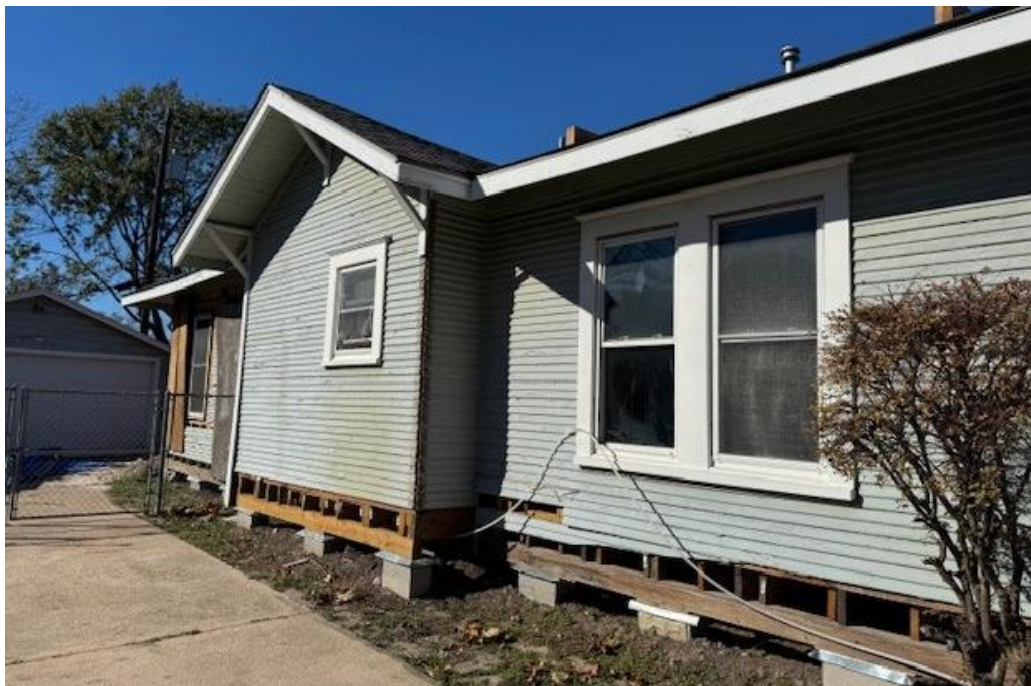
SOUTH (LEFT) ELEVATION TOWARDS REAR 12/30/2025 - HOP SITE VISIT

SOUTH (LEFT) ELEVATION - 12/30/2025 - HOP SITE VISIT

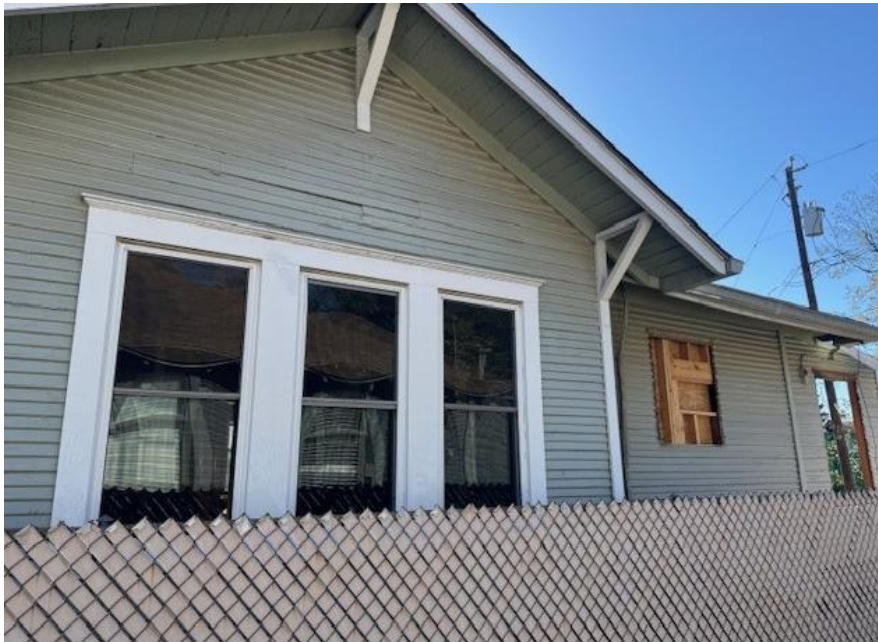
- Windows throughout the building have been replaced over the years with vinyl windows. Two window openings on the south (left) elevation towards the rear will be changed to single windows and one small window towards the center of the elevation will be added.
- Two window openings on the north (right) elevation towards the rear will be changed to two horizontal windows with privacy glass.

NORTH (RIGHT) ELEVATION WINDOWS - 12/30/2025 - HOP SITE VISIT
