CERTIFICATE OF APPROPRIATENESS

ITEM D18
HPO File #: HP2026_0019

528 Columbia
Houston Heights South

Proposal: Demolition – Siding and Windows

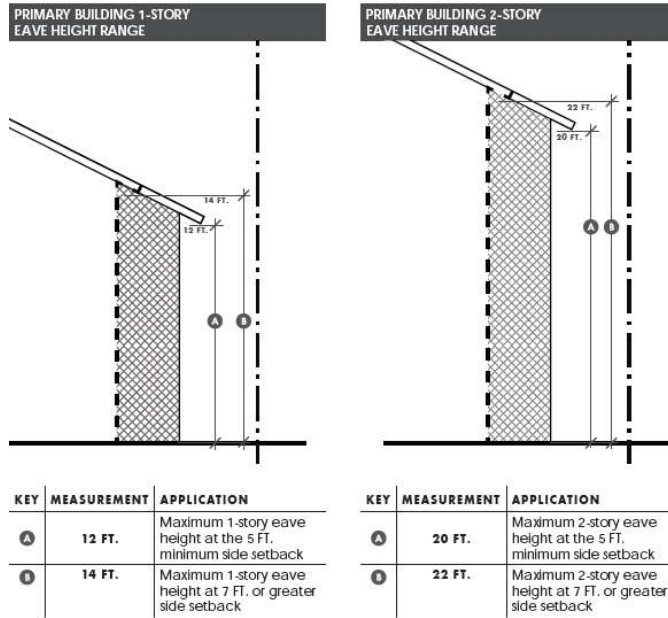
Eave Height (Addition and New Construction)

Proposed eave height: 22' at minimum 7'-2" side setback

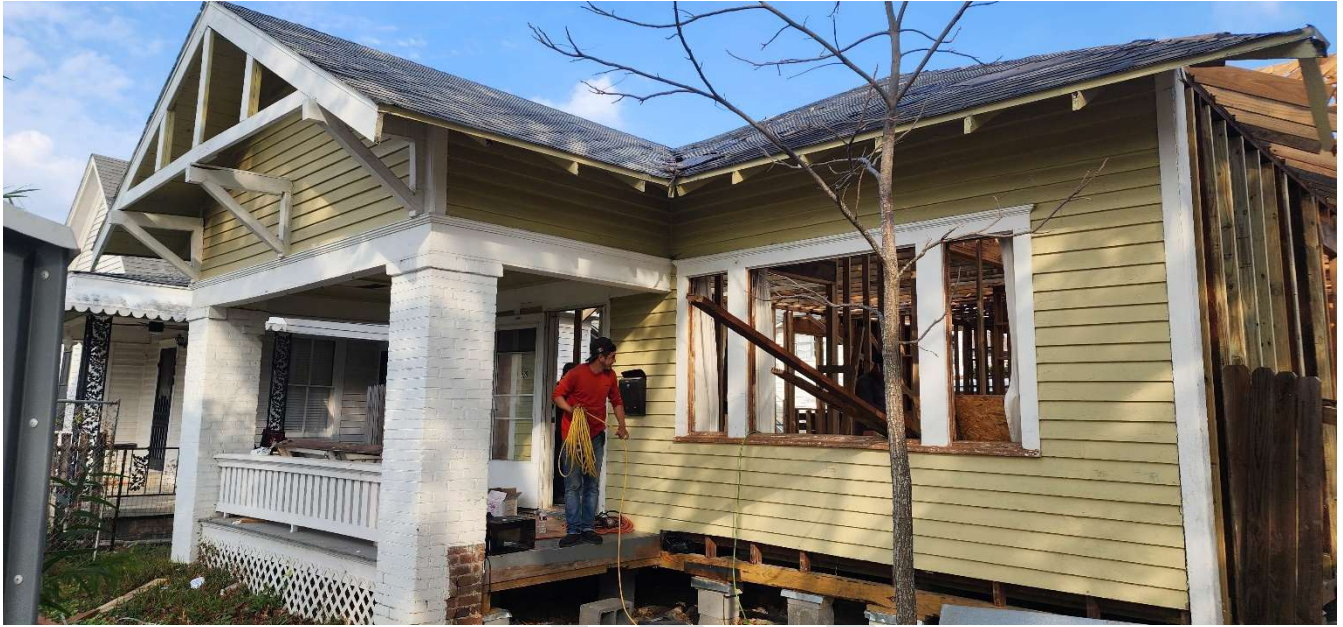
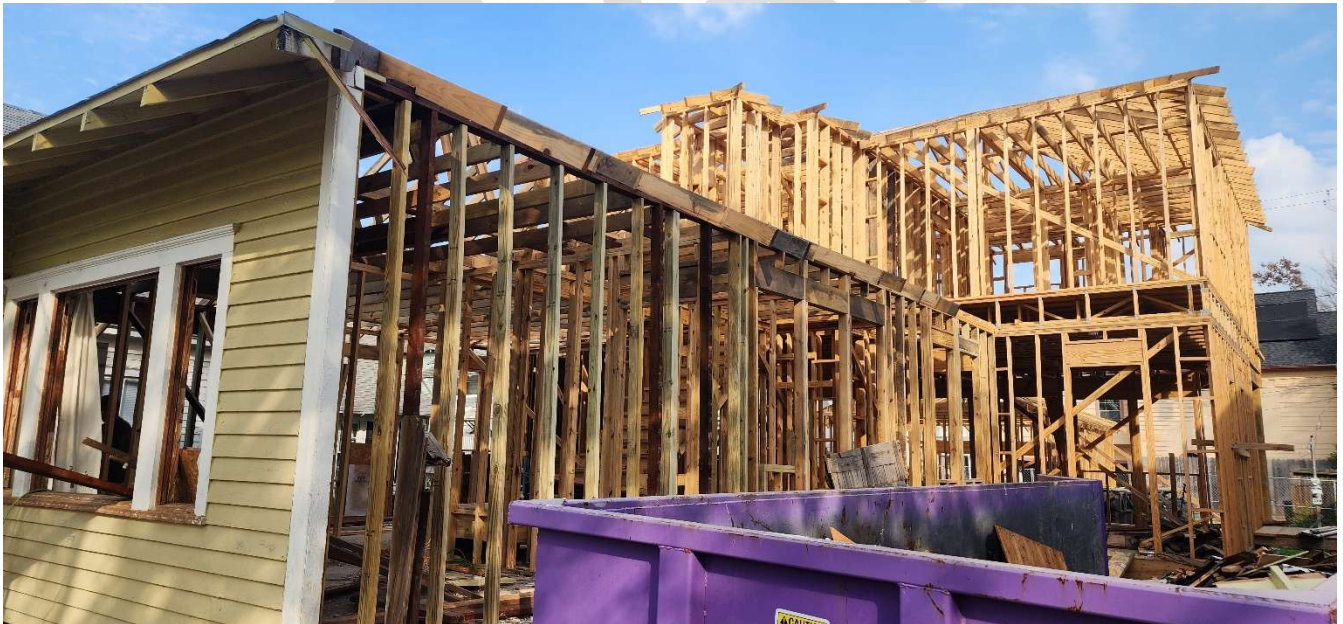
CURRENT PHOTO **(Violation of COA)**

During construction of the original COA (HP2023_0252) which was approved with conditions the applicant removed the following:

- The existing wood siding (only front façade remains).
- Original wood windows.
- The existing composition shingle roof.
- The front porch steps and brick pony wall.
- The existing shiplap from the contributing structure.

Issuance of a COR to install 3/4" plywood in place of removed shiplap, install wood bevel siding, front porch steps and brick pony wall on original structure, and restore existing windows with original light pattern.

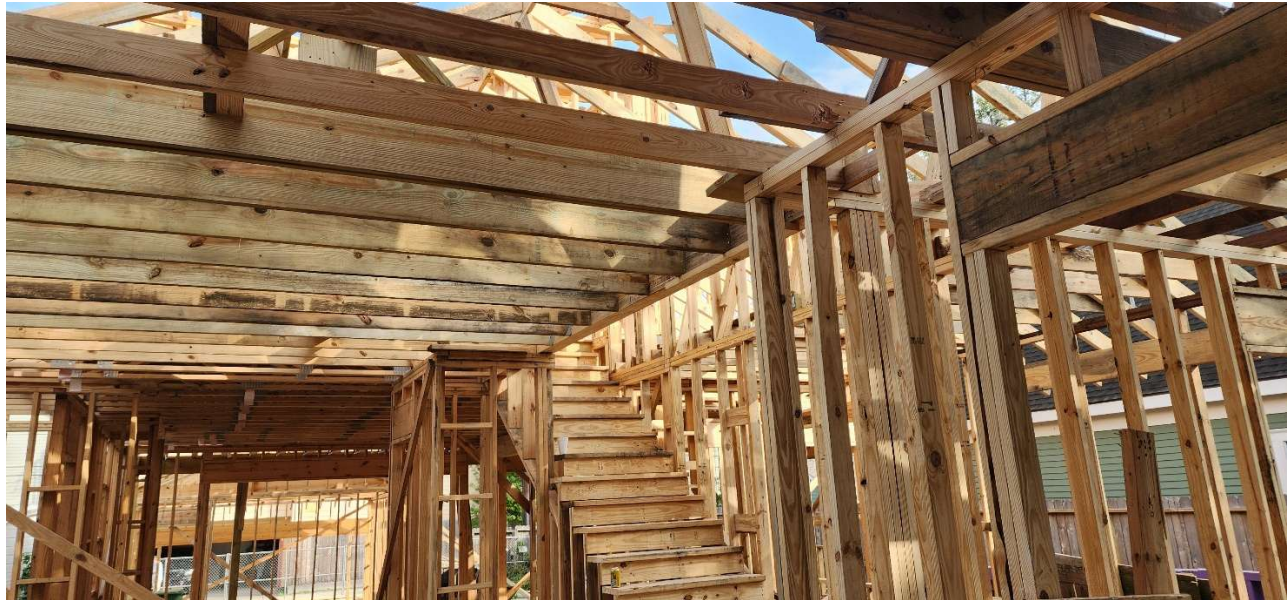
Inspection reveals the following items DO NOT comply with the City of Houston Building Code.

NO PILES JUST FOOTINGS
PROVIDE A FULL SET OF PLANS STAPLED TOGETHER.
REMOVE VEGETATION UNDER FOUNDATION REMOVE A FORM SURVEY

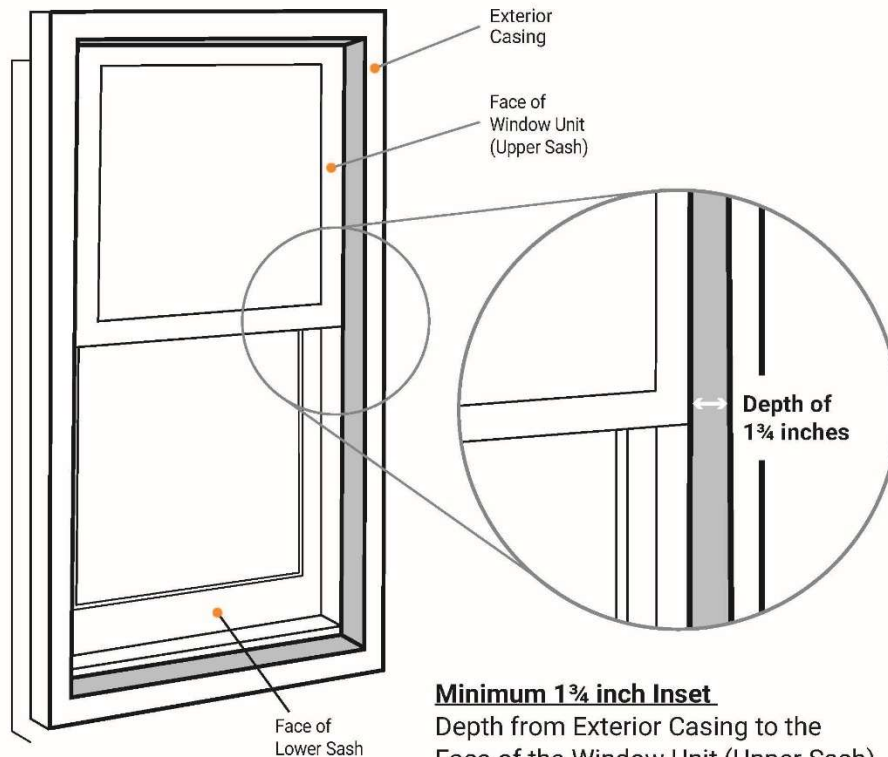
Historic Window Standard: New Construction & Replacement

Minimum 1 3/4 inch Inset
Depth from Exterior Casing to the Face of the Window Unit (Upper Sash)

Windows must be 1-over-1
(equally horizontally divided)

1 3/4 inch minimum inset for Fixed Window
