### CERTIFICATE OF APPROPRIATENESS

**Application Date:** 10/3/2025 **HPO File#:** HP2025\_0294 **ITEM#: B10**

Property: 219 Emerson Street, Block 3, Residential Single Family, 3,227 sq. ft., Lot size

## 219 EMERSON STREET -

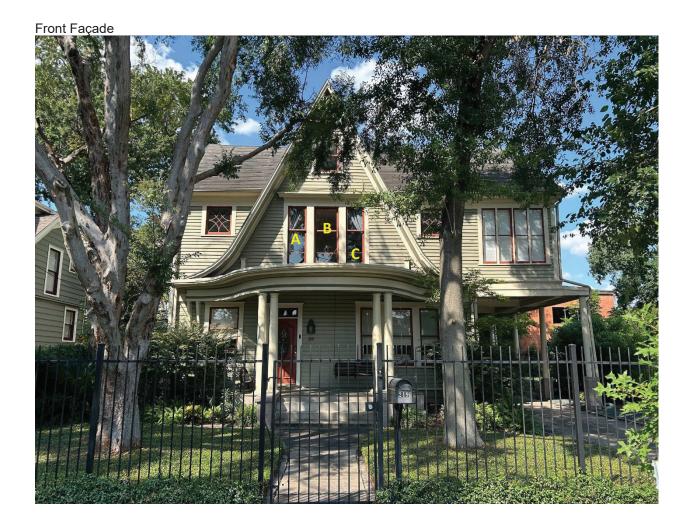
Existing Structural inadequacy – Joinery is separating due to inadequate structure, door sags, cannot be opened without significant care not to break glass/glazing/etc. due to flex in structure.

DAMAGE TO EXISTING WINDOWS										
Window Broken Painted		Inoperable/Cut	Rotten Rotten		Rotten/Broken	Other Damage/				
	Glass	Shut	Sash Cords/Weights	Rails/Stiles	Sill	Frame	Description			
Ex. A1	Y	Y	Y	N	Y	N	Missing Parts			
Α	N	Y	Y	N	N	N				
В	N	N	Y	N	N	Y	Unstable Broken Frame			
С	N	Υ	Y	N	N	N

Existing mortise and tenon joinery is exact replica with the addition of making tenons haunched for extra stability (a traditional door detail invisible on exterior or interior). Existing exterior bevel at glass is replicated Fabricated of vertical grain douglas Fir. Glass will be replaced with tempered actual replica wavy glass from Artisan Glass Works to keep vintage glass quality while increasing safety. Existing hardware re-used/restored 1.
