CERTIFICATE OF APPROPRIATENESS

Property: 915 Harvard, Lot 9, Tract B, Block 230, Houston Heights Subdivision. The property includes a 2,476 square foot one and a half story residence with non-historic detached garage situated on a 6,600 square foot interior lot.

Proposal: Alteration – Replace Front Door and windows on noncontributing garage

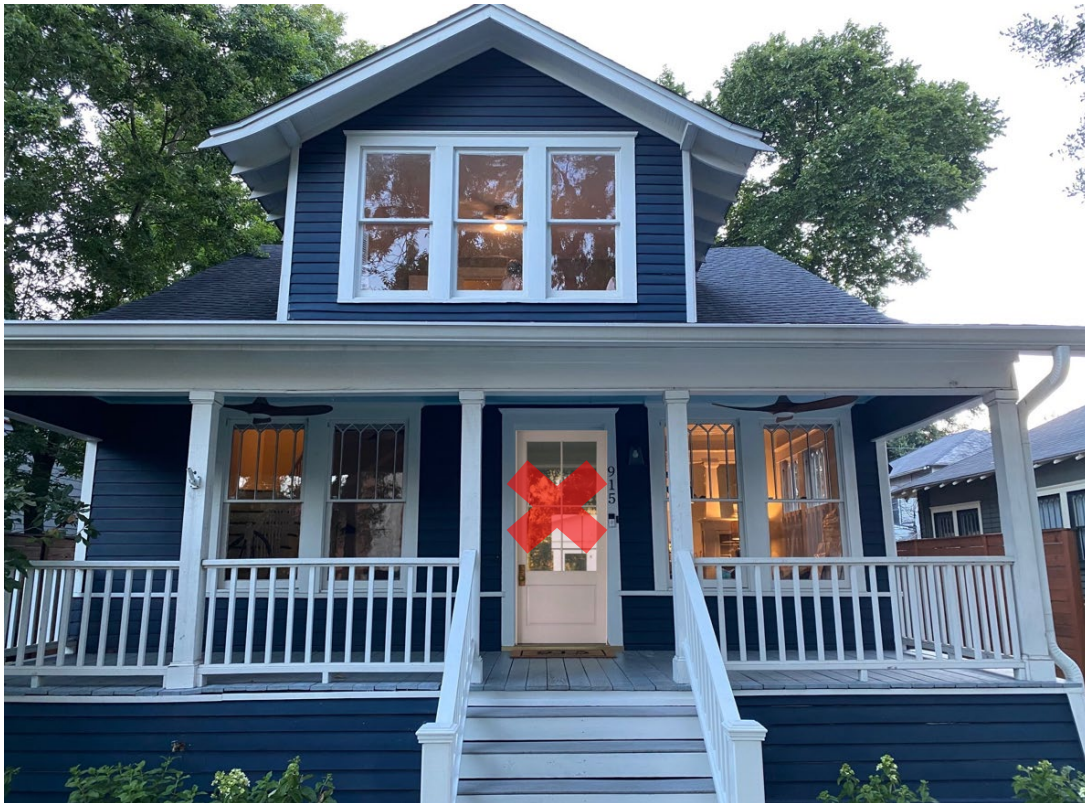
RENDERING OF PROPOSED DOOR REPLACEMENT *proposal revised 9/7/22

The proposed door is reflective of a craftsman style, appropriate for the era of this home.

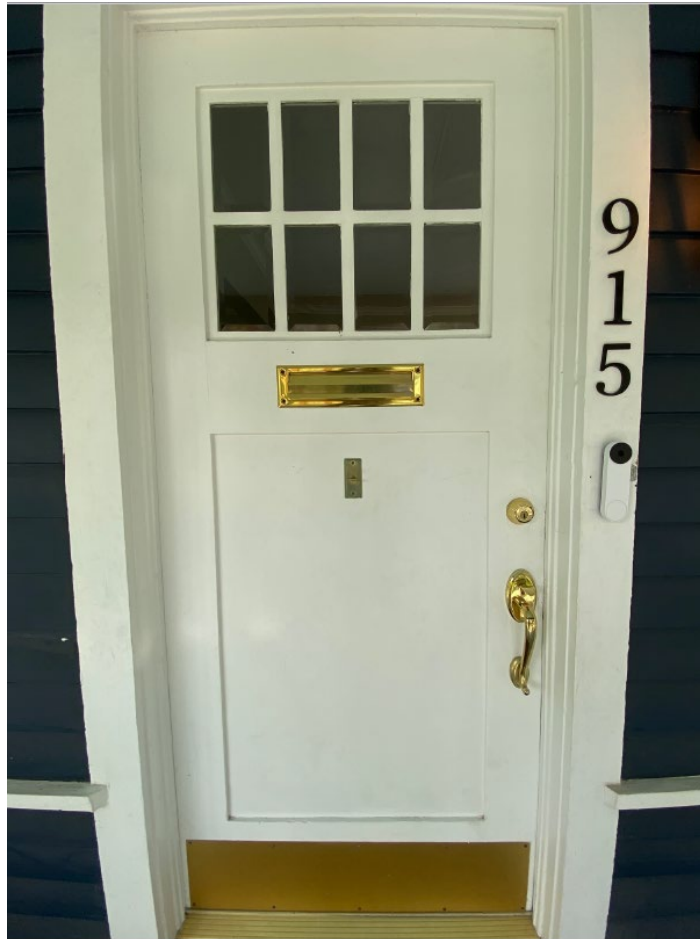
EXTERIOR

CURRENT FRONT DOOR (HISTORIC)

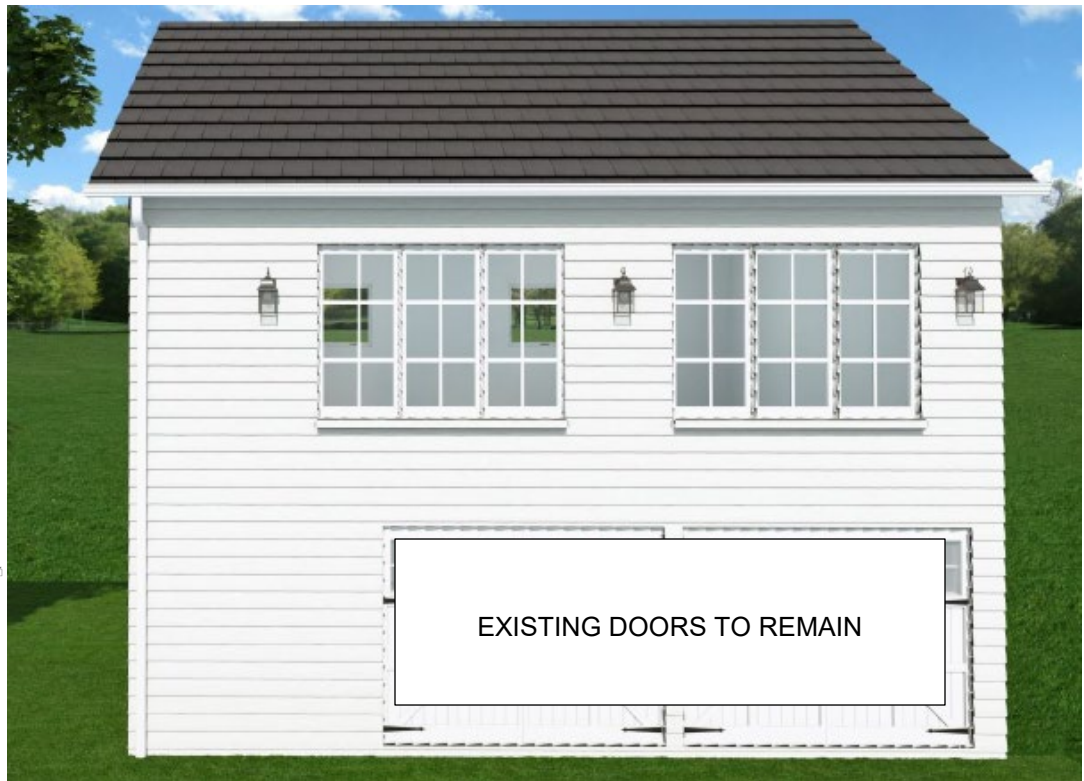
PROPOSED

- Replace existing early/historic front door with new, single lite mahogany craftsman style door (see historic reference).
- **Alterations to rear noncontributing garage (eligible for administrative approval, grouped in one COA for consolidation of reporting)**
 - Remove existing replacement windows with new wood windows, inset and recessed.
 - Alter, enlarge or remove openings – see renderings and window worksheet.

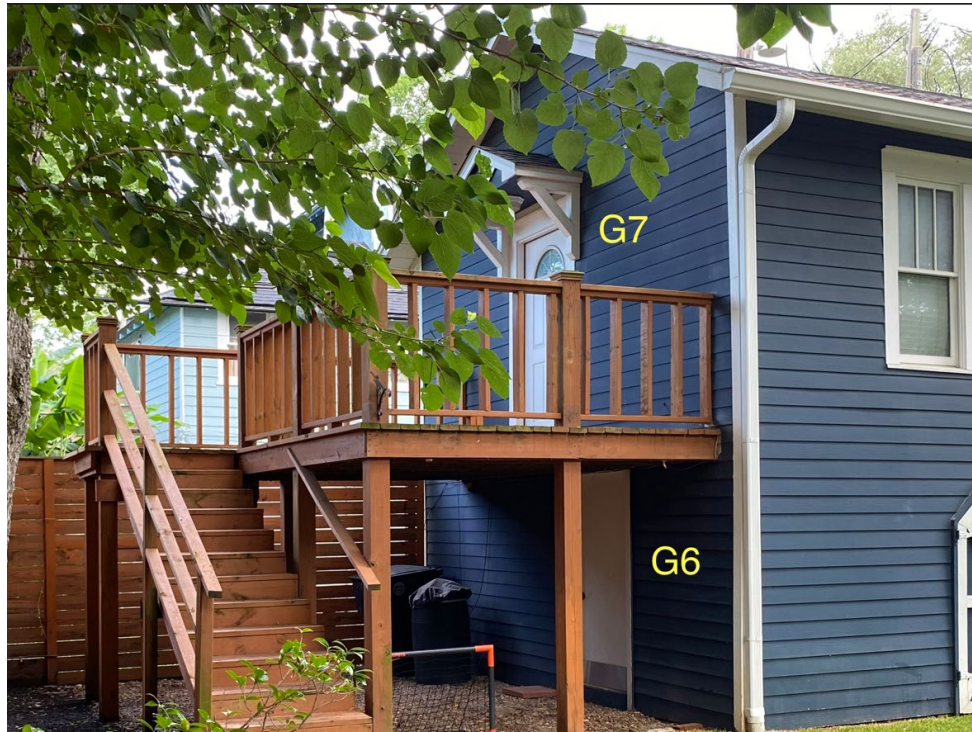
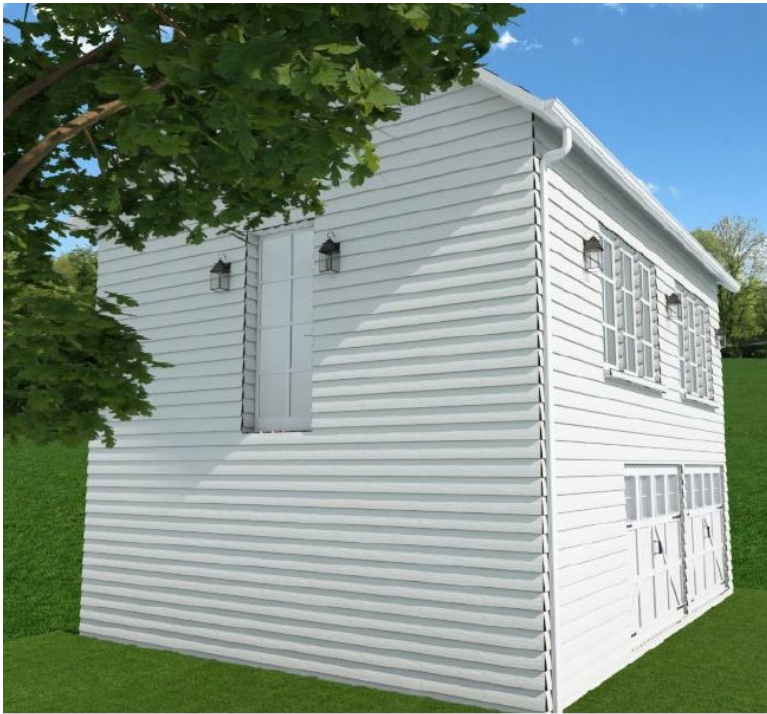
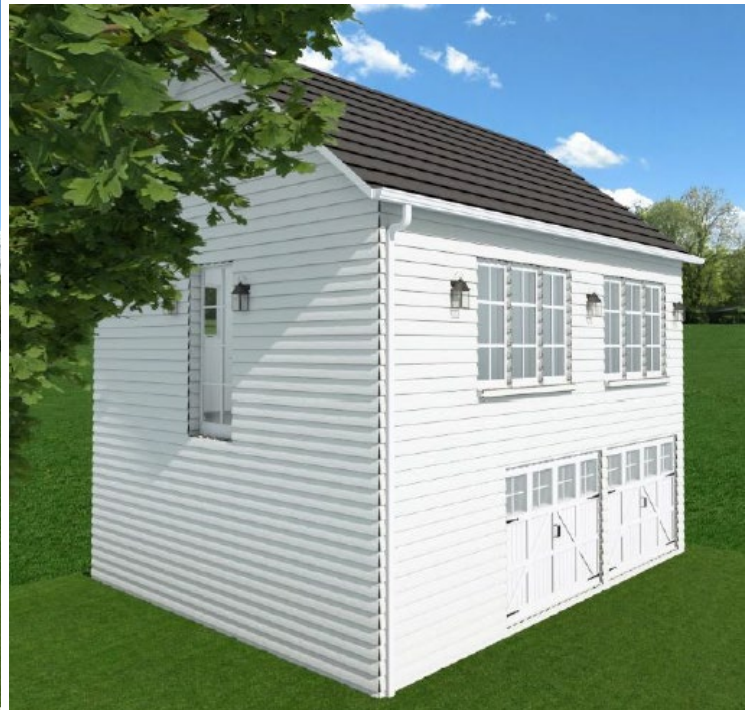
EXISTING (LEFT SIDE)- NOT VISIBLE FROM STREET

Window	Describe Damage
<i>Ex. A1</i>	<i>Glass is broke, window is inoperable, rail is rotten, and frame is broken</i>
G3	N/A
G4	Wood swollen - will not close securely at lower sash - security issue
G5	Wood swollen - will not close securely at lower sash - security issue
G6	N/A
G7	N/A
G8	Wood swollen - will not close securely at lower sash - security issue
G9	Wood swollen - will not close securely at lower sash - security issue
G10	Wood swollen - will not close securely at lower sash & damage to glass lites
H1	Multiple locks installed in same location compromising fit for security

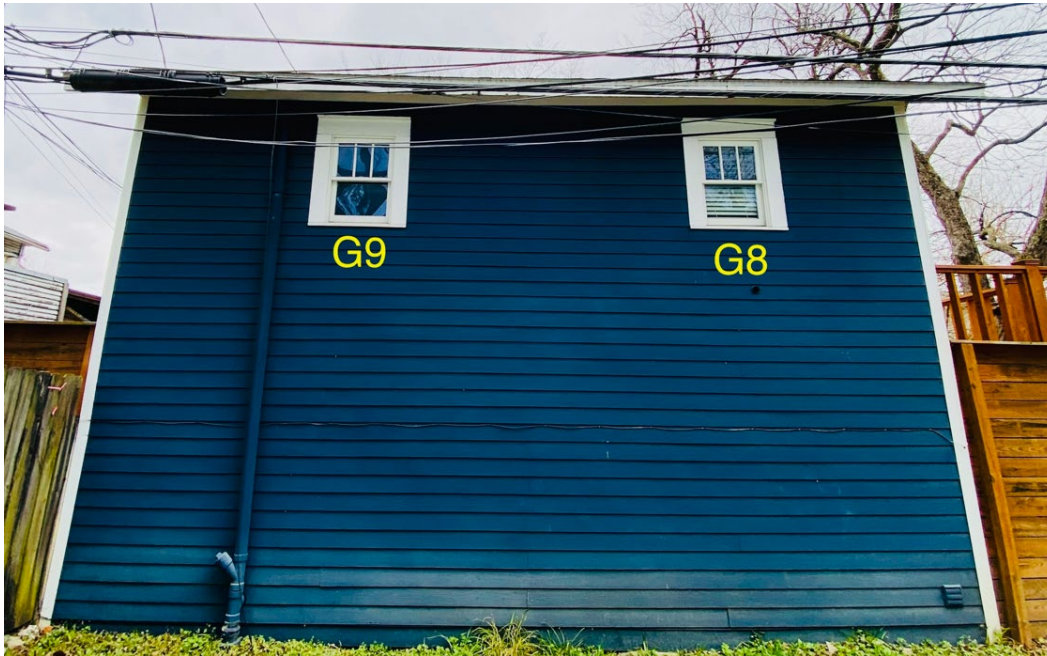
CURRENT PHOTO – GARAGE AT REAR (NON-CONTRIBUTING)

ENLARGE OPENINGS & REPLACE

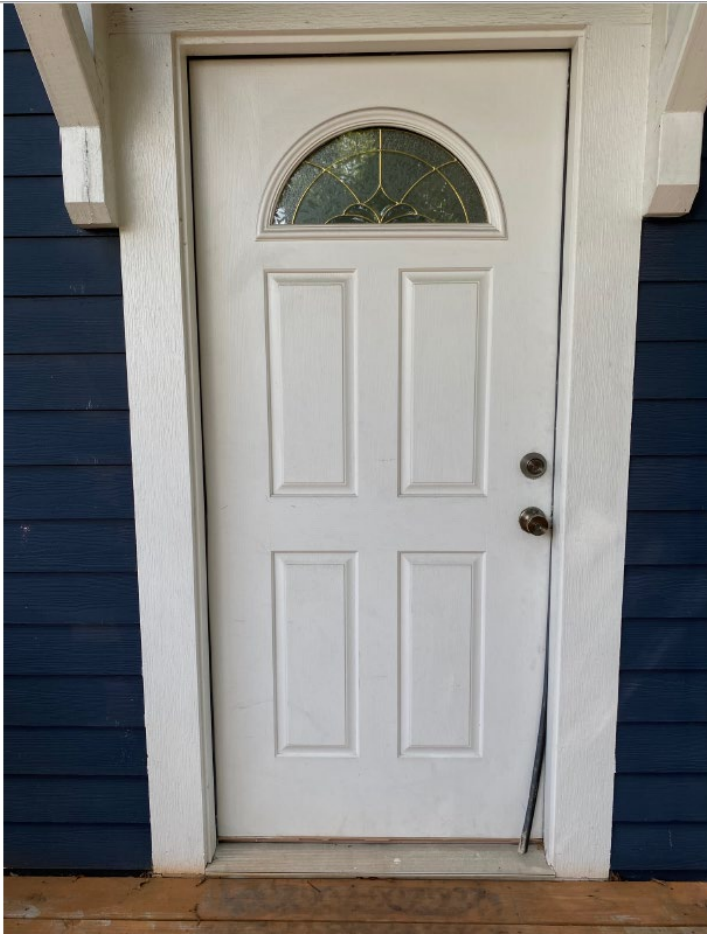
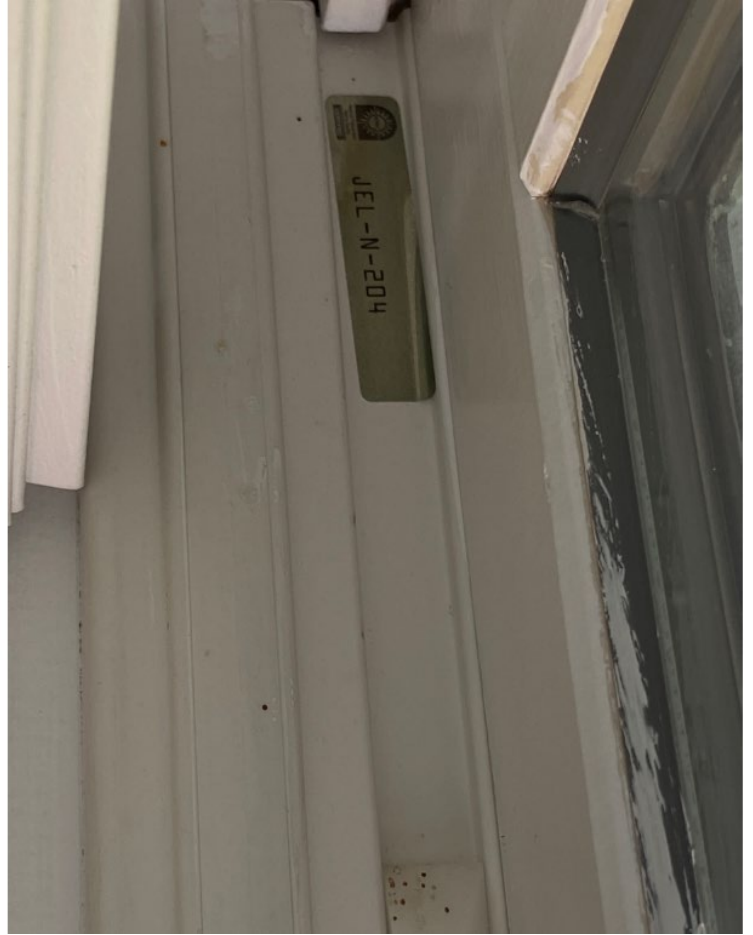
EXISTING /DOOR- 2ND FLOOR (NOT VISIBLE FROM STREET)

& WINDOWS - NON HISTORIC (JELD-WEN)
